Rehabilitation of the Ramalho Ortigão Viaduct

Structural Assessment

Repair and Strengthening Solutions

Strengthening and Rehabilitation Works

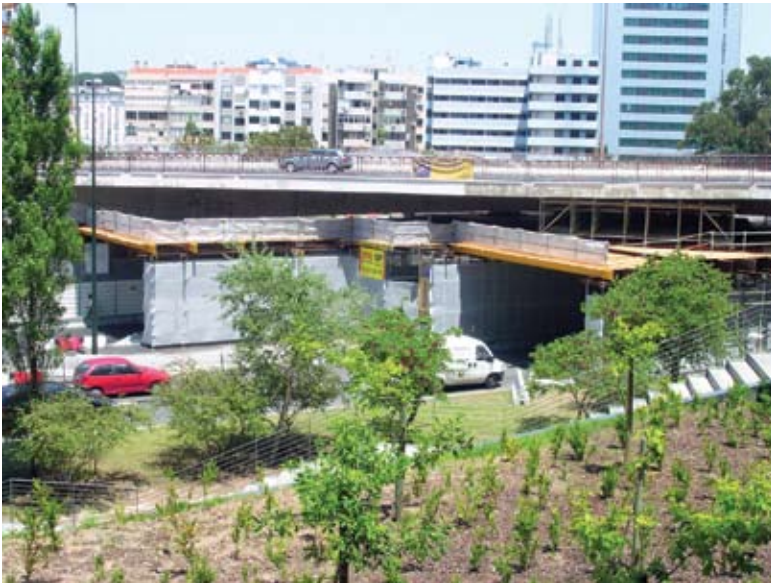
Assembly of the working platform

The first step taken was to put up a platform to protect the public thoroughfare and allow the work to proceed with traffic being affected as little as possible.

This structure was very carefully studied so it could be used for both the protection of the public thoroughfare and shoring up the central concrete segment during the phase when the latter was being removed.

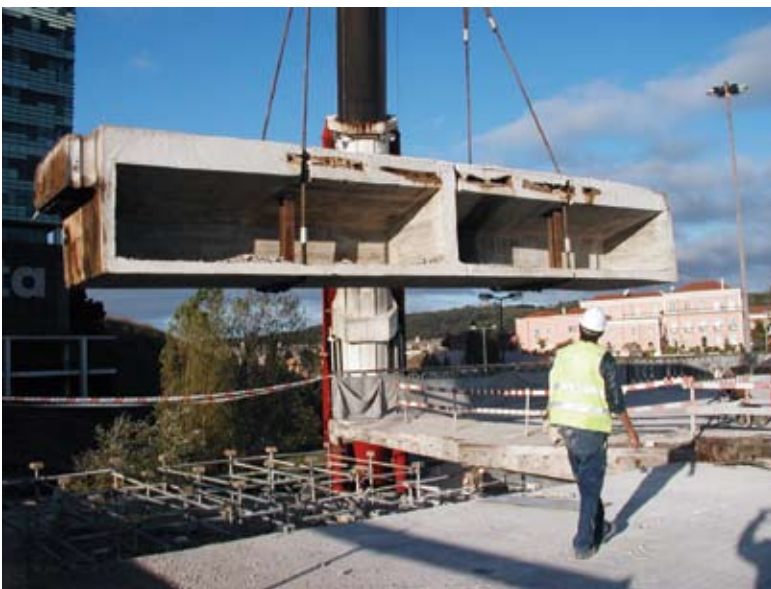
Removal of concrete

Removal of central concrete segment

As mentioned previously, the central reinforced concrete section was replaced by a composite steel and concrete section, thus achieving a substantial reduction in the weight of this structural element (approximately 50%).

The weight of the original central segment was approximately 275 tons (250 metric tons) and so it was necessary to divide this up into lighter units to be able to remove it quickly and safely.

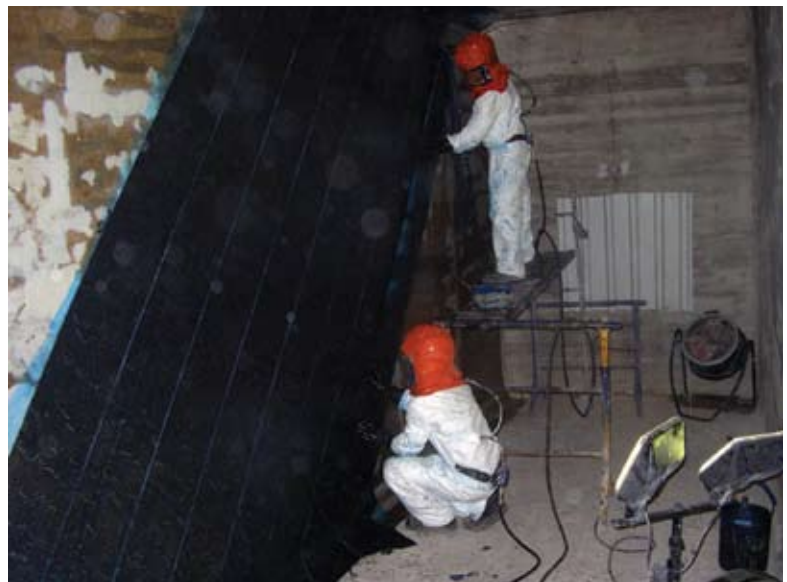
Internal reinforcement with CRFP fabrics

Application of carbon fiber fabric

The carbon fabric was applied in one or two layers, as per the final design, using automated equipment to impregnate the fibers with the resin.

The main difficulty in applying the carbon fibers was not related to any specific technical aspect but did concern ensuring the safety of the workers when applying the fibers to the interior surfaces of the viaduct cells. The work was mostly carried out in confined spaces and it was necessary to use ventilation equipment for the cells and to equip the workers with individual breathing apparatus to avoid any problems of intoxication through the inhaling of fumes from the epoxy resin used for impregnating the carbon fibers.

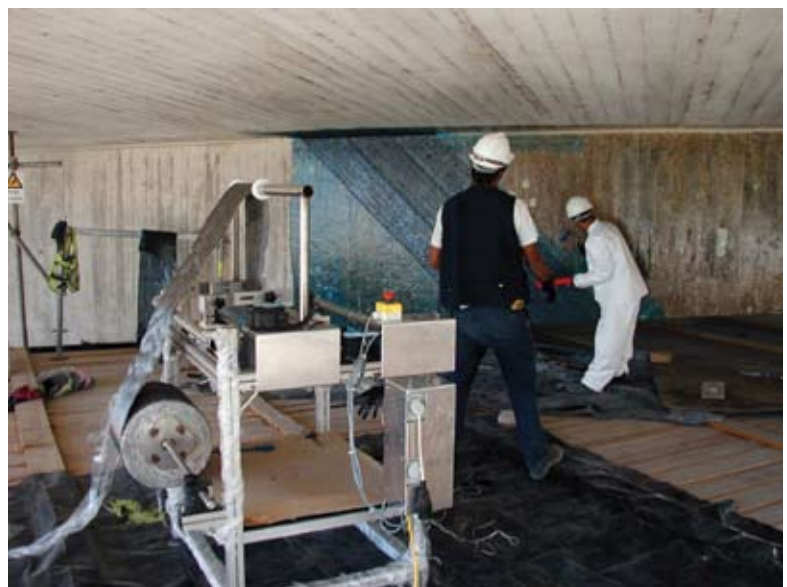
External reinforcement with CRFP fabrics

- Use of carbon fiber-reinforced polymer (CFRP) fabrics to increase the resistance of the longitudinal box girder to the lateral forces/longitudinal torsion; and

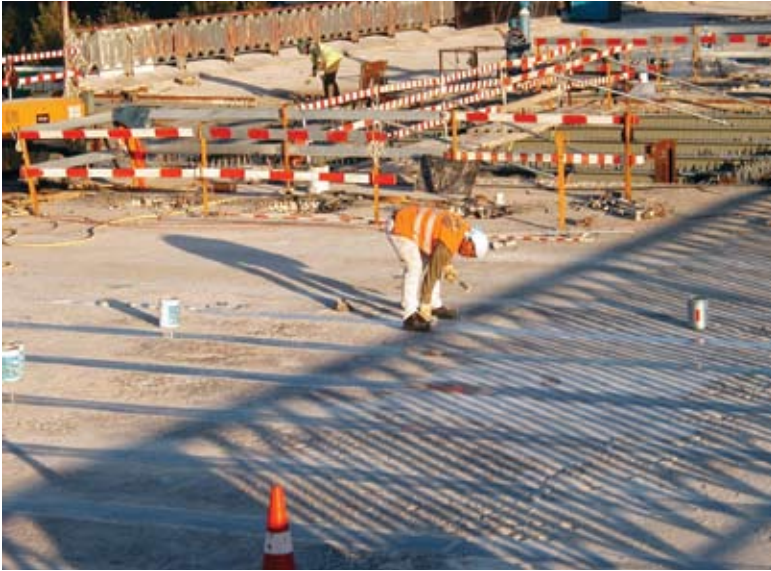
External reinforcement with CRFP laminates

Application of carbon fiber laminates

To guarantee the bending moment strength of the fixing sections of the lateral cantilever beams, carbon fiber laminates were applied to the upper side of the slab, in the transverse direction. The main difficulty of this operation was ensuring the correct surface moisture of the concrete (less than 4%) because there was heavy rainfall at the time the laminates were applied.

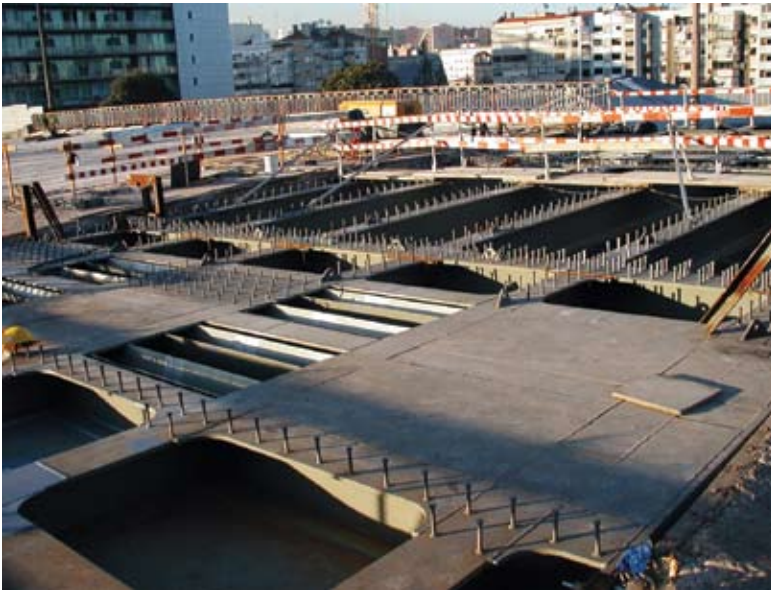
General view of the metal structure

Fitting of the metallic segment

The manufacturing of the metallic segment was studied to reduce the on-site fitting time to the minimum. Accordingly, it was prefabricated in the work yard and transported in nine main elements.

The various elements were put on top of the shoring structure so that they could be aligned and leveled using the shoring units and small hydraulic jacks. After all the prefabricated sections had been fixed in place, the closing steel plates were fitted along with the connectors that ensure the connection of the metallic structure to the reinforced concrete. The entire metallic structure was then covered with an epoxy protective paint.

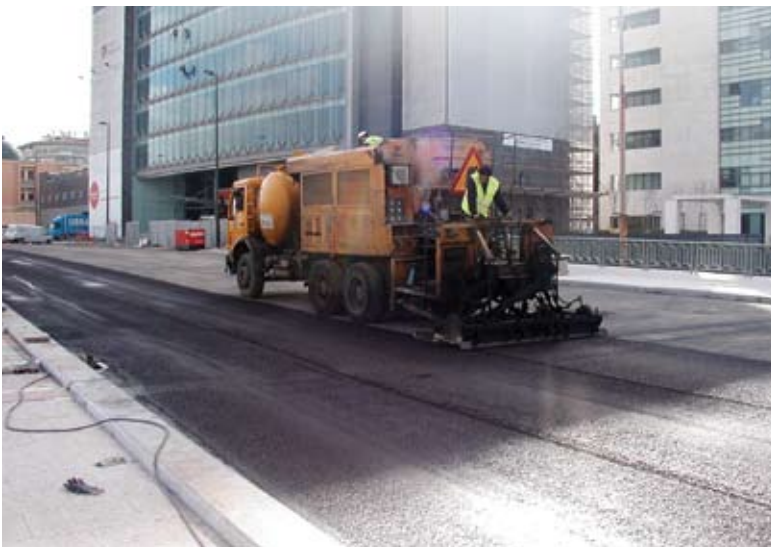
Application of cold asphalt

After the carbon fibers had been applied and the deck had been given its variable-thickness concrete coating, using the light structural concrete, it was decided to apply cold bitumen instead of standard bitumen, which reaches a temperature of up to 248 °F (120 °C), to prevent damage of the epoxy resin.

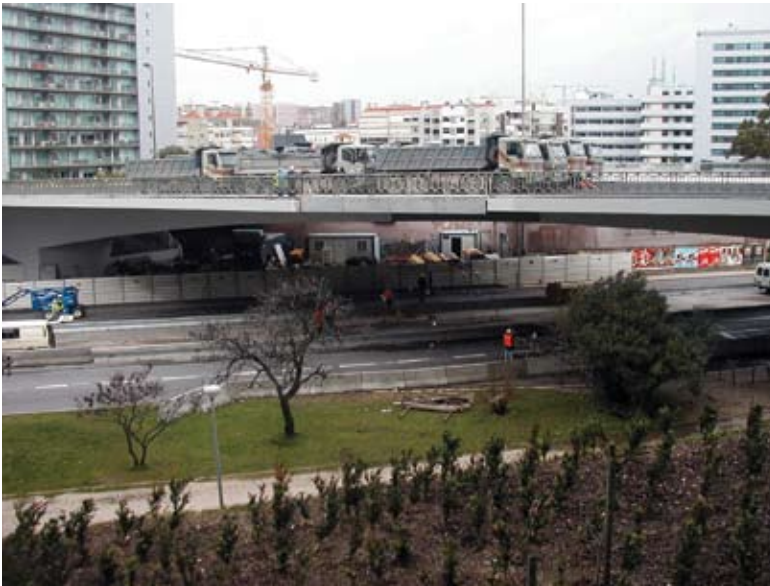
- Static load test
 - Good agreement of the experimental and the analytical results; and
 - Linear-elastic response for the load level adopted.

Load testing

- Dynamic load test
 - Good agreement of the experimental and the analytical results, particularly with regard to the vibration frequencies and modulus; and
 - Lower vibration amplitude of the structure caused by traffic, due to the absence of angular points.
