Parking Structures Category

# Auditorium Plaza Garage Repairs and Improvements

Kansas City, Missouri

Submitted by Structural Engineering Associates

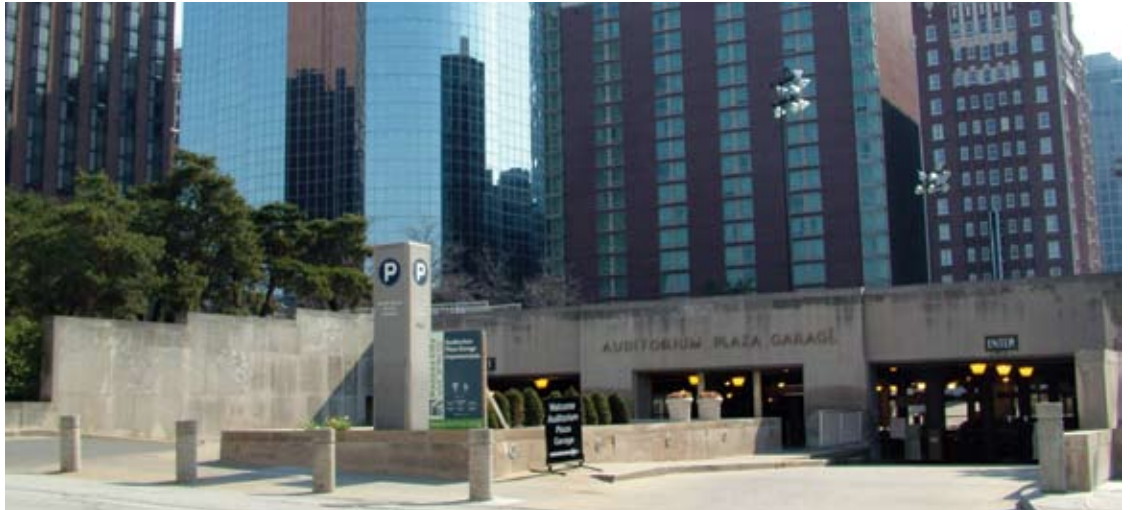
Central Street entrance to the Auditorium Plaza Garage

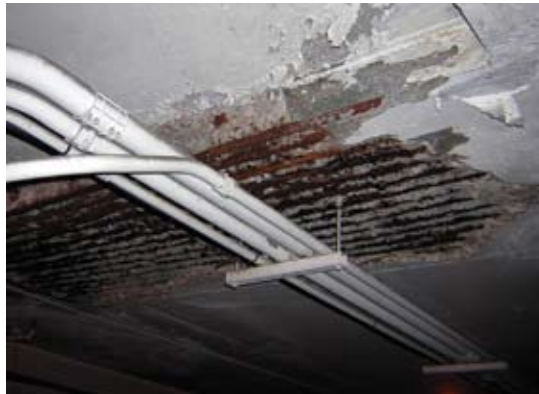
*Existing soffit corrosion (note the electrical conflicts/challenges)*

The engineer determined that a number of repair procedures were required, including conventional “chip-and-patch” concrete repairs for horizontal and vertical surfaces and the installation of galvanic anodes in the repaired soffit areas. Over 13,500 galvanic anodes, or “hockey pucks,” were installed in the three soffit levels to minimize the high corrosion rates and anodic ring effect in the 20,450 ft<sup>2</sup> (1900 m<sup>2</sup>) of delaminated soffit repairs. It is estimated that this passive form of cathodic protection will protect the repaired areas for 15 to 20 years.

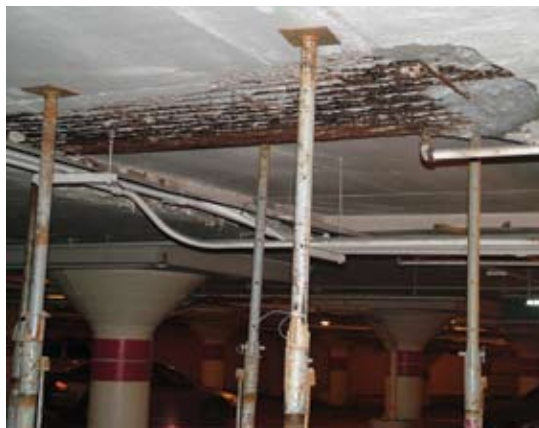
*Delaminated soffit repairs*

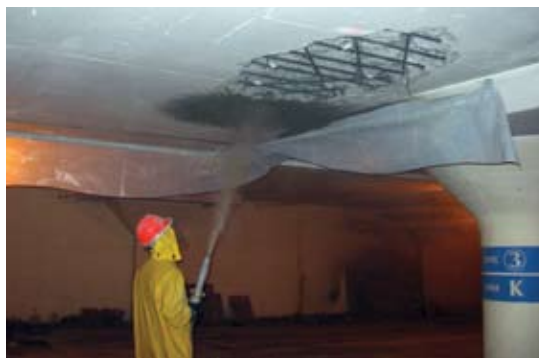
*Shotcreting a soffit*

The APG repairs and improvements project was bid in May 2005, and was initially budgeted at \$4.1 million. Work commenced in June 2005, and the general contractor and the repair contractors soon realized the many challenges of phasing extensive soffit and slab repairs with a mandatory operational parking garage. Each of the three parking levels was broken into smaller, more manageable repair sub-areas to facilitate vehicular and pedestrian traffic in the garage, while managing the constant, large amounts of dust and poor air quality during the hydrodemolition surface preparation (on both slab and soffit) and dry-process shotcreting work.

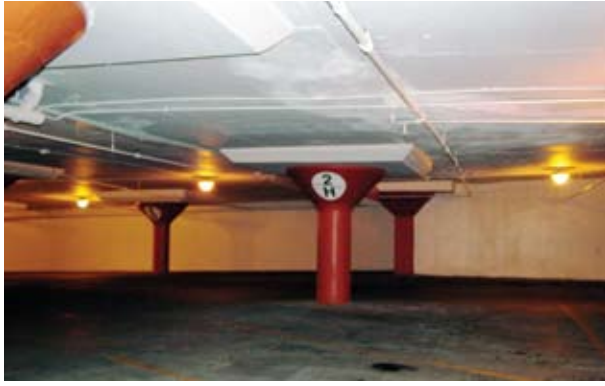
*Garage, Level 2, following concrete repairs and painting*

Following completion of all repairs to each of the three levels, all columns, walls, and soffits were painted and new signage was added.

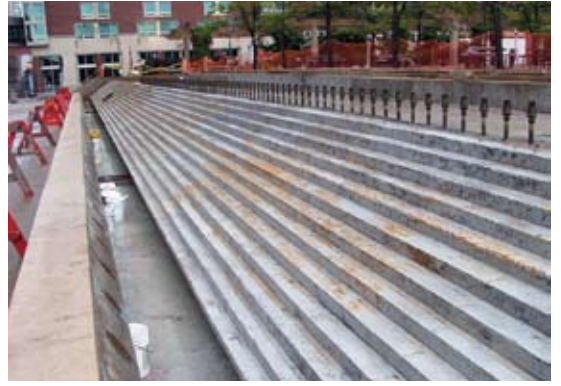
*Water feature repairs underway*

An existing reflecting pool and cascading water feature bounds the north side of the plaza above, and is completely over the garage below. The pools were drained and the deteriorated waterproofing membrane was milled and scraped off the concrete substrate, while the granite waterfall stones were removed and marked for the new surface-applied waterproofing membrane. Some concrete, plumbing, and lighting repairs were also necessary, and each and every granite stone on the waterfall was cleaned and restored with a cleaning agent, and re-anchored.
