Strengthening Category

Structural Reinforcement of Jaime Roldós Aguilera Bus Terminal

Guayaquil, Ecuador

Submitted by BASF Construction Chemicals

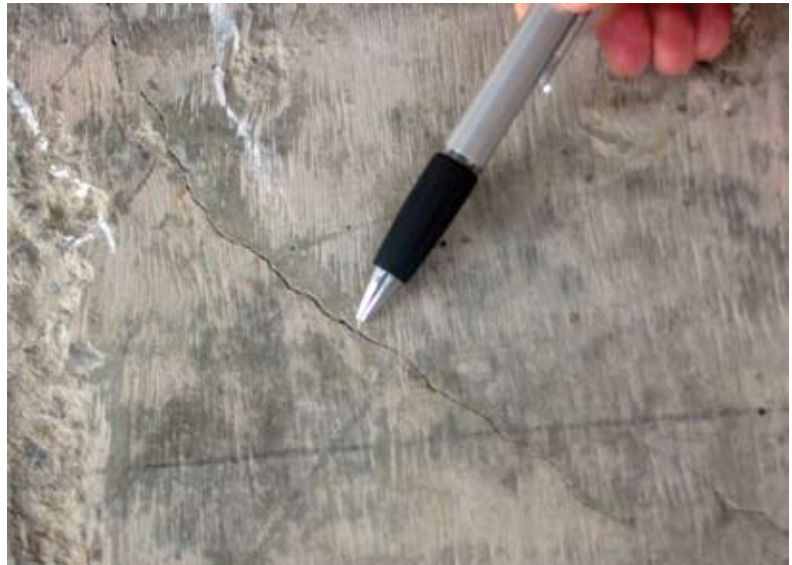
Fig. 3: Diagonal cracking on the columns

blocks in the longitudinal direction because there were no beams in this direction. The only contribution of the stiffness was provided by the joists of the slab. Consequently, there was no frame action in this direction; as a result, columns displayed diagonal cracking (Fig. 3). In the transverse direction, there were frames made of columns and beams.

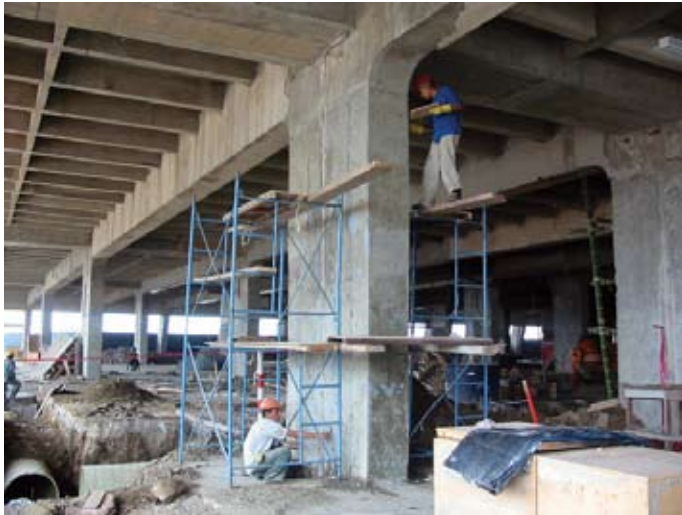
Fig. 4: Filling the gaps with a special high-strength, low-shrinkage rheoplastic repair mortar

- This retrofit procedure was obtained by cleaning the existing joints and then filling the gaps with a special high-strength, low-shrinkage rheoplastic repair mortar (Fig. 4). Using state-of-the-art technology, carbon-fiber bands were used to wrap adjacent columns and to ensure that the 15 blocks behaved like one unit. This provided significant confinement to the columns adjacent at the joints, which provided an increased ductility in the seismic behavior of the structure (Fig. 5).

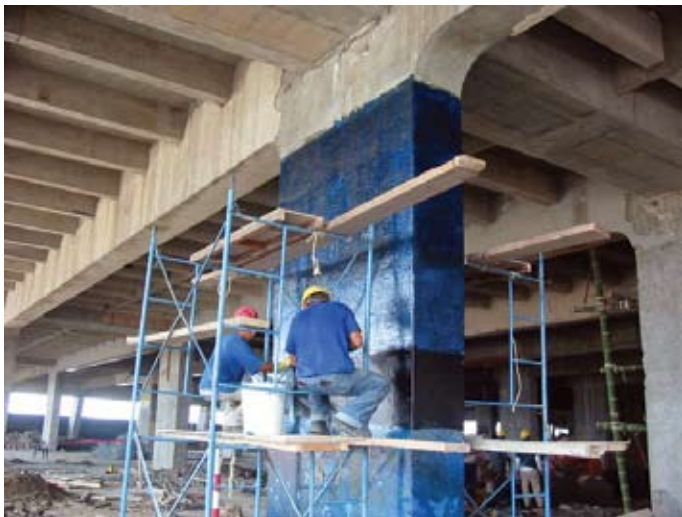
Fig. 5: Carbon-fiber bands were used to wrap adjacent columns and to ensure that the 15 blocks behaved like one unit

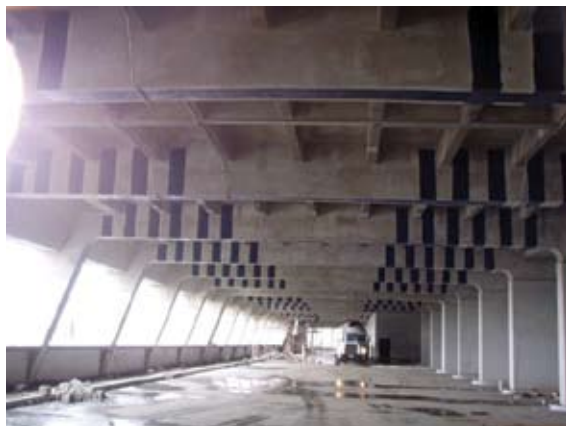
Fig. 6: Wrapping of the overhead ramp support beams

- Carbon-fiber bands were also used as reinforcement to increase strength (in flexure and in shear) to some existing beams that were subjected to additional vertical loads due to the new architectural requirements of the project. Figure 6 shows the wrapping of the overhead ramp support beams. The damaged beams and columns were repaired with a structural grade rheoplastic high-bond-strength repair mortar capable of developing a rapid modulus of elasticity.
