Casa Bonita II: New Approaches to the Age-Old Problem of Corrosion

By Stephen M. Bauer and William "Bud" Earley

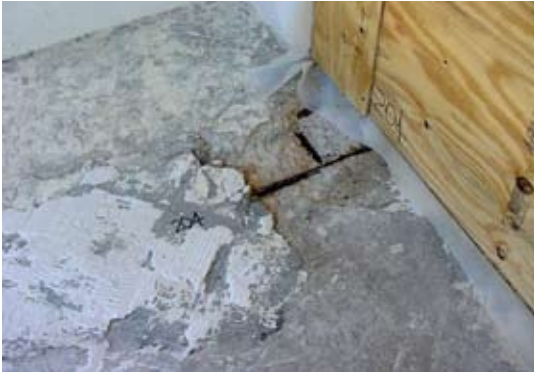
Corrosion of reinforcement along the internal edge of the balcony created great concern for future damage to the interior of the condo unit

The primary causes of the concrete reinforcing steel deterioration were due to constant exposure to sea spray from the Gulf, insufficient protective cover of the reinforcing steel and adjacent slab edges, and localized failures of previous repairs.

Repair was achieved by chipping further down to expose sufficient lap length of the clean unaffected bar. This allowed for the installation of a mechanical coupler. The diminished bars that continued into the concrete walls and columns were replaced with epoxy-set dowels that were fit into pre-drilled holes.

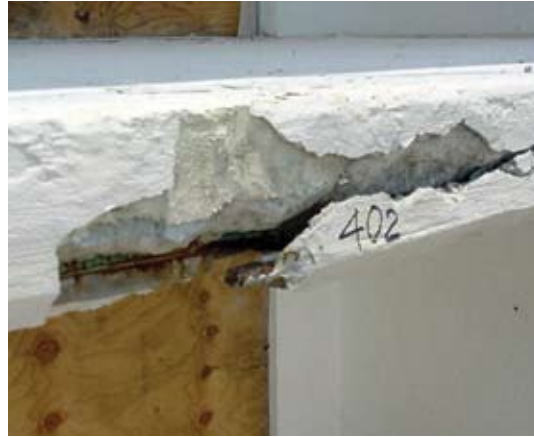
Typical spall on underside of balcony edge

The removal of spalled concrete was conducted in accordance with ICRI Technical Guideline No. 03730, which recommends removing concrete until clean steel is exposed. Following demolition, the substrate and reinforcement are cleaned by sandblasting to provide a clean, structurally sound

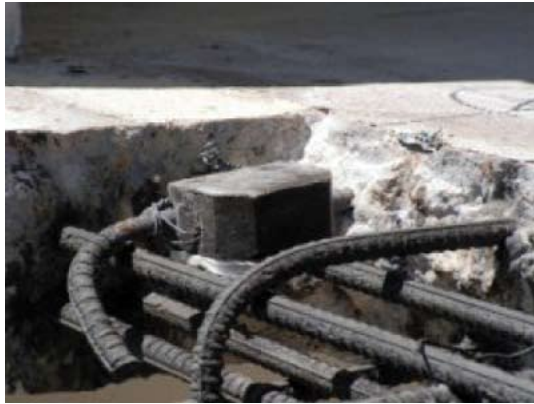
An embedded galvanic anode, with "V" notch easily attached to reinforcement before installation of repair mortar

Because the previous patches failed, the owners desired a system that could provide long-term durability. To achieve this, low-permeability repair mortars were specified along with a self-generating cathodic protection system of embedded galvanic anodes. This advanced corrosion mitigation system was chosen because of some of its unique design features. The exclusive insulating barrier will not dump current into the attachment bar, extending the life of the cathodic protection device. The intent here was to nullify the potential electrochemical activity between the various zones of differential alkalinity.

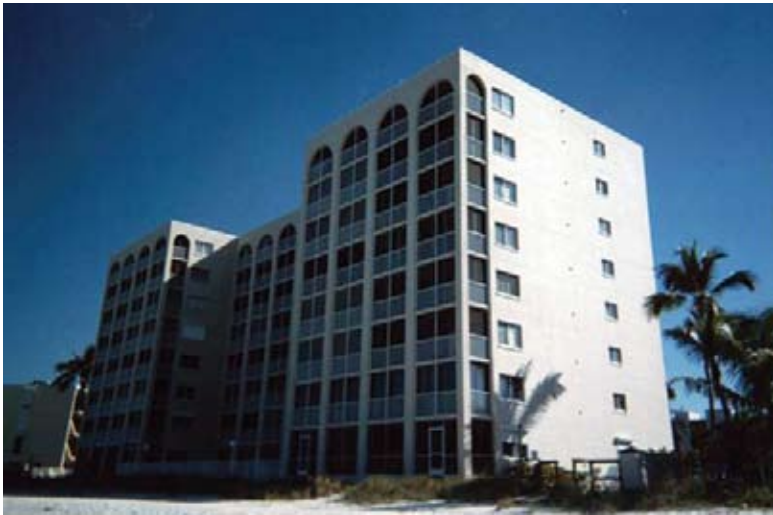
Completed balconies at rear elevation facing the Gulf of Mexico

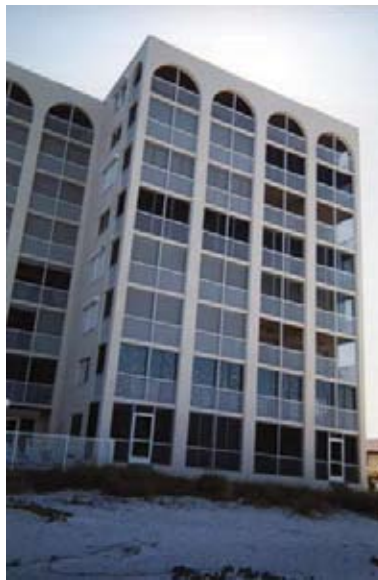
Balconies on Gulf side of building
