Hide Room Renovation at Beef Processing Plant

By Robert "Bob" Roberts

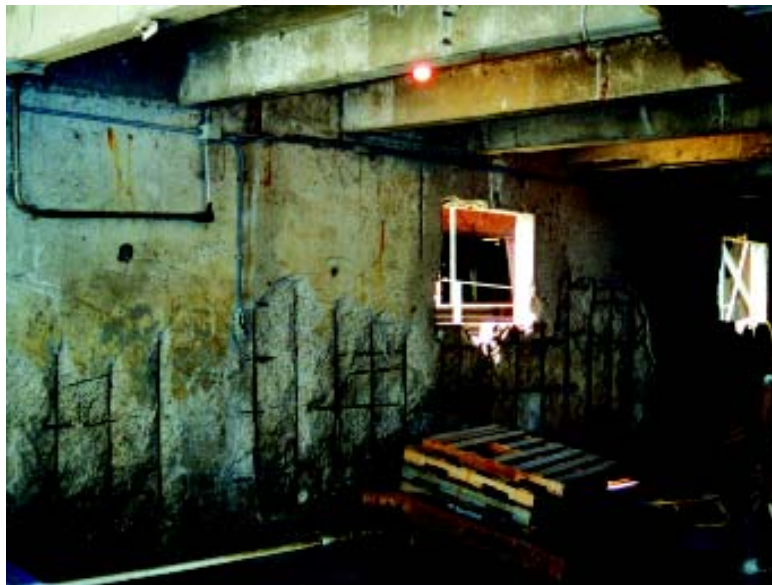
Our investigation showed that the continued unabridged bombardment of chlorides for so many years caused the internal #4 reinforcing steel mat to virtually completely degrade, and cause major spalling on the walls (Figure 1). The beams were also spalling excessively into the vat and surrounding areas (Figure 2), which was not only unsightly, but created a safety hazard as well. The structure was determined to be sound but in serious need of repair. The management needed a permanent, safe solution. To make matters more difficult, any repairs had to be made while the plant was in full operation.

Figure 1: West wall (prior to start) on south end of room

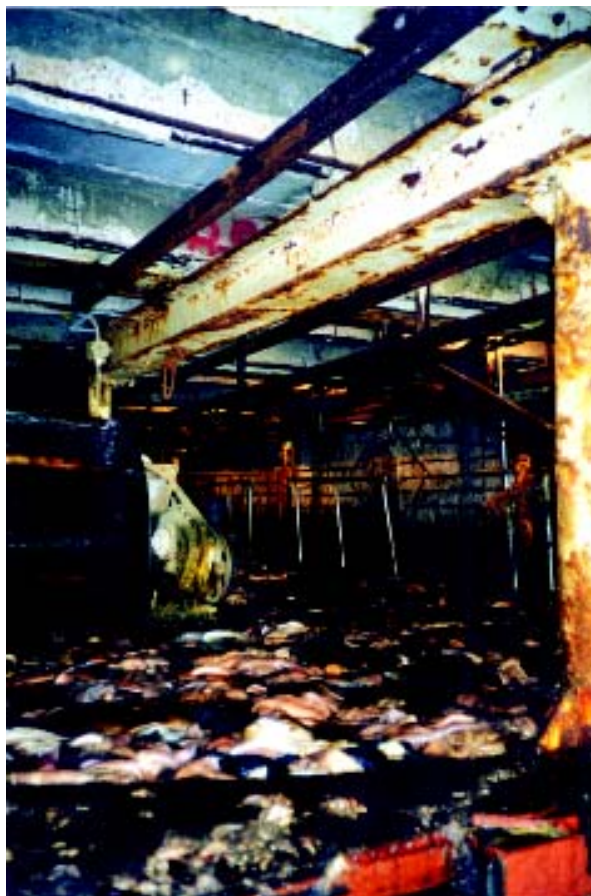
Figure 2: Beam deterioration over hide vat

The beams were prepared according to ICRI guidelines. The existing reinforcing steel, after aggregate blasting, was sealed with a multi-viscosity epoxy (two coats). Because of the tight workspace, a wood-box form, fabricated and fastened in place on the repair areas of the beam (Figure 6), worked better than no form. This method allowed shotcreting more beam area than without the forms. The shotcrete mix design used in the walls was used here as well.

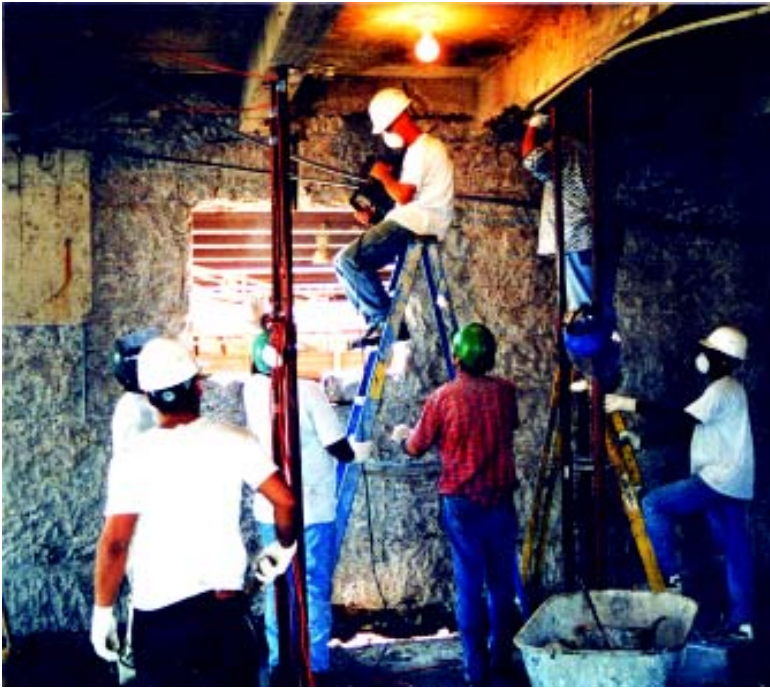
Figure 3: Workers remove deteriorated concrete

The work areas were shored. The concrete in these sections had to be removed carefully, using a lightweight electric 30-pound hammer with chisel tips (Figure 3). The concrete had to be chipped out at a 45-degree angle to avoid going through the wall or possibly fracturing the existing substrate.

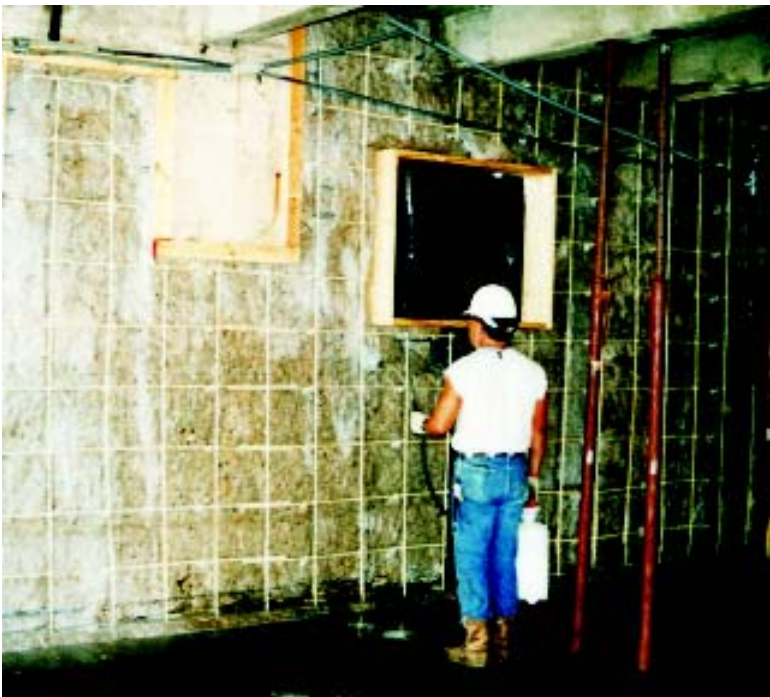
Figure 4: Application of bonding agent to concrete behind new fiberglass reinforcing prior to shotcreting

The next step was to “rebuild” a new concrete interior wall, and to make sure it bonded well to the existing surface. Shotcrete was chosen as the repair material. For these sections, dowels were epoxied into place at the top and the bottom of the repair area, and then tied into the mat. Asphalt-impregnated expansions were placed at all stops (joints). Prior to the application of the shotcrete (usually 24 hours prior) the surface areas were kept moist with water, and just before the application, the surface was saturated with a bonding agent (Figure 4). The shotcrete was a 7.5 bag mix, of the following design:

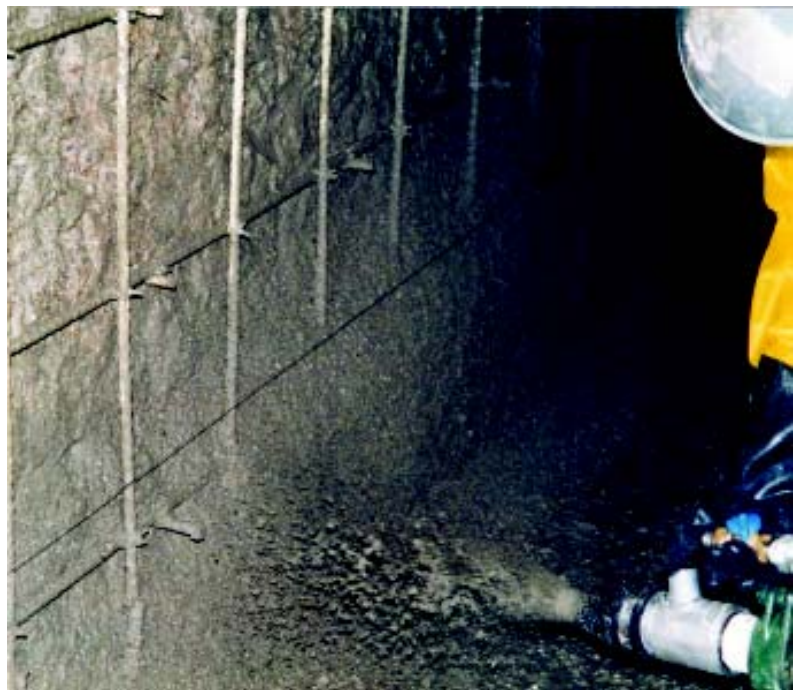
Figure 5: Shotcrete application

This mix had very low moisture, and a 1 to 2 inch maximum slump. The mix had to be pressed by hand in the hopper on the pump. The use of shotcrete enabled all of the prepared sections to be placed and finished in one afternoon (Figure 5).

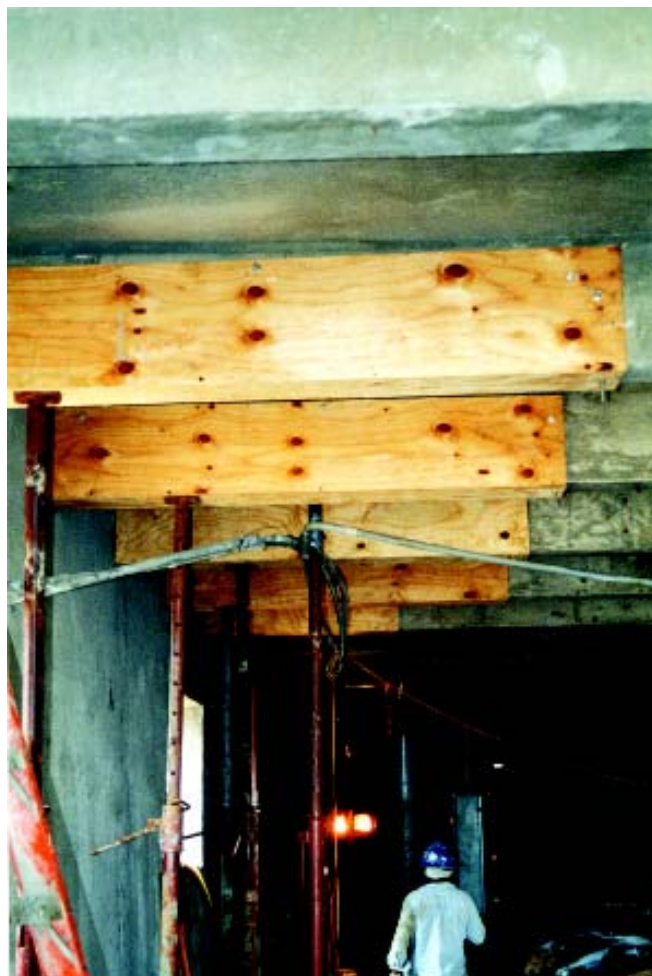
Figure 6: Wood box forms used for beam repairs
