Seismic Upgrade of I-80 Bridges in Salt Lake City using Carbon Fiber Reinforced Polymers

By Scott Isaac and David White, P.E.

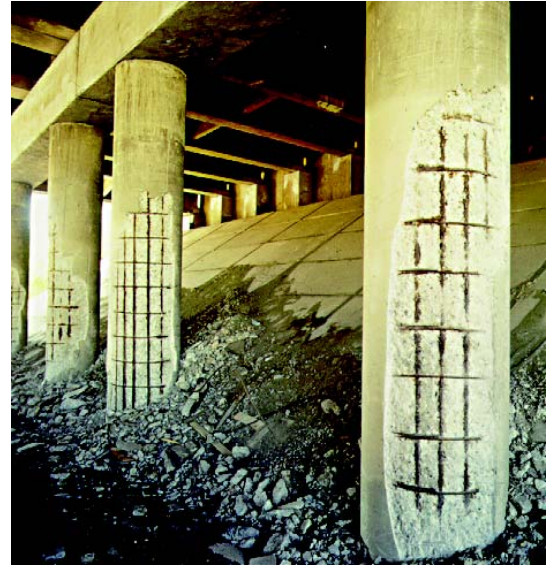
Typical corrosion damage on bridge piers

Twenty-five badly deteriorated bridges along a five-mile corridor of Interstate 80 in Salt Lake City, Utah, were in need of major repair. Most were showing advanced signs of corrosion due to prolonged exposure to the harsh environment and deicing salts. Of the 25 bridges, 12 were considered to be structurally deficient, which indicated that significant elements of each bridge needed repair. There was a significant amount of spalling concrete from the decks, pedestals, bent caps, and columns. Beams and bearing units were also in

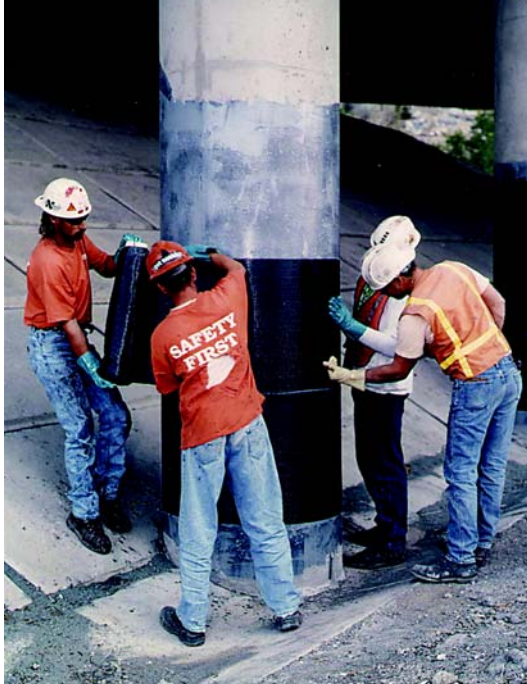
Wrapping bridge pier with carbon fiber fabric

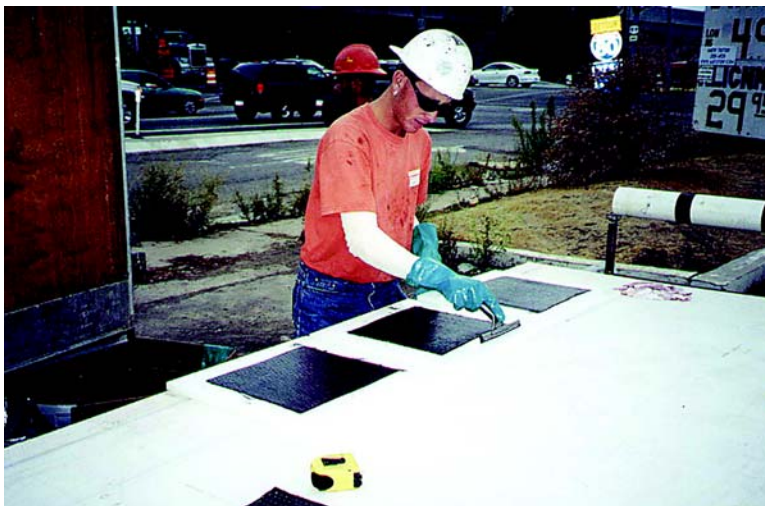
Preparing flat-panel specimens for QC testing

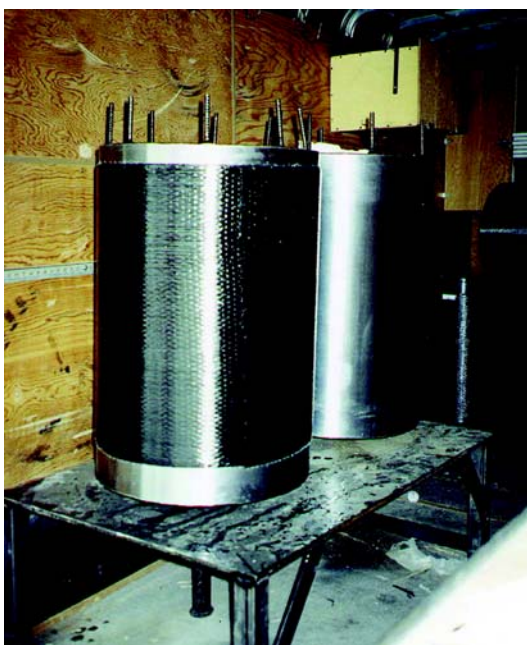
NOL ring specimens for QC testing

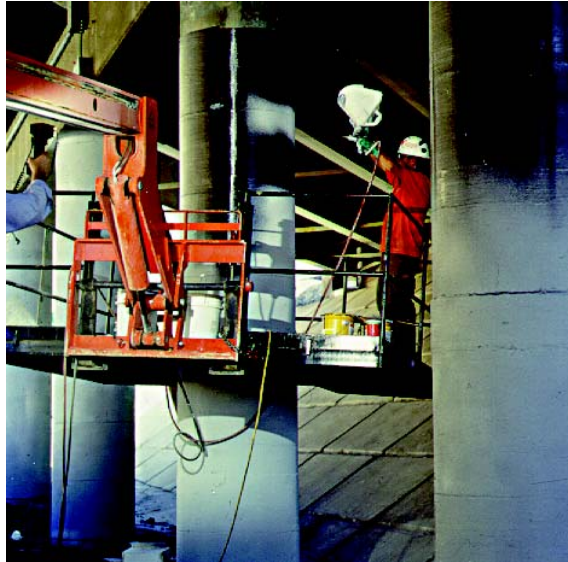
Spray application of acrylic coating for UV and abrasion protection

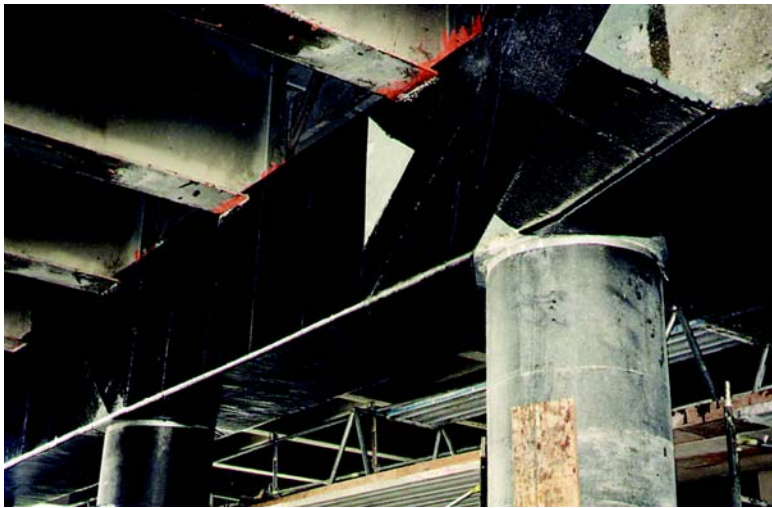
Bridge bent strengthening at State Street overpass
