Unique Solutions for Repair of a Seawall and Lighthouse Structure

By Hamid Vossoughi

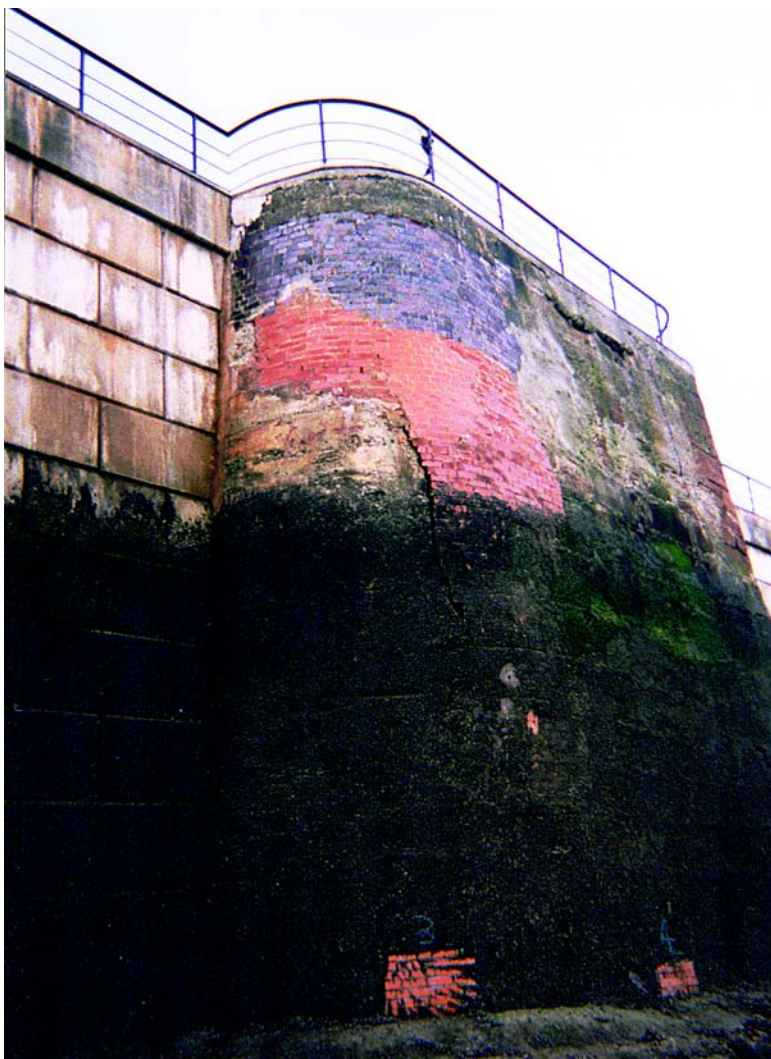
Seawall—The seawall is primarily constructed of sandstone blocks that are over 16 in. (40 cm) deep. The existing condition and distress in previously repaired areas (Fig. 3) was monitored and documented during low tides by town engineers. The scope of work included investigation of the existing conditions at 37 randomly located repair areas totaling 800 ft² (74 m²) and nondestructive testing with a boroscope to document the underlying condition of the wall. Following the investigation phase, the defective areas had to be replaced with new 8 in. (20 cm) thick matching sandstone blocks anchored to the backup, and the failed mortar joints in the rest of the repair areas had to be repointed.

Figure 3: Previously repaired area

Seawall—Our preliminary investigations identified hard grout backup and lack of anchorage between the previously repaired masonry and the backup. Demolition of the repaired areas required minimal effort, except at the larger areas where sequencing of the demolition and partial shoring was required. However, preparation of the backup, including removal of the randomly placed reinforcing

steel as wall anchorage, required more effort. The replacement stones, salvaged from a demolished structure; pre-bagged special repair mortar; and stainless steel anchors epoxied to the backup were used for the repair work. Stone blocks were lowered by a hoist and placed into position by the technicians (Fig. 6).

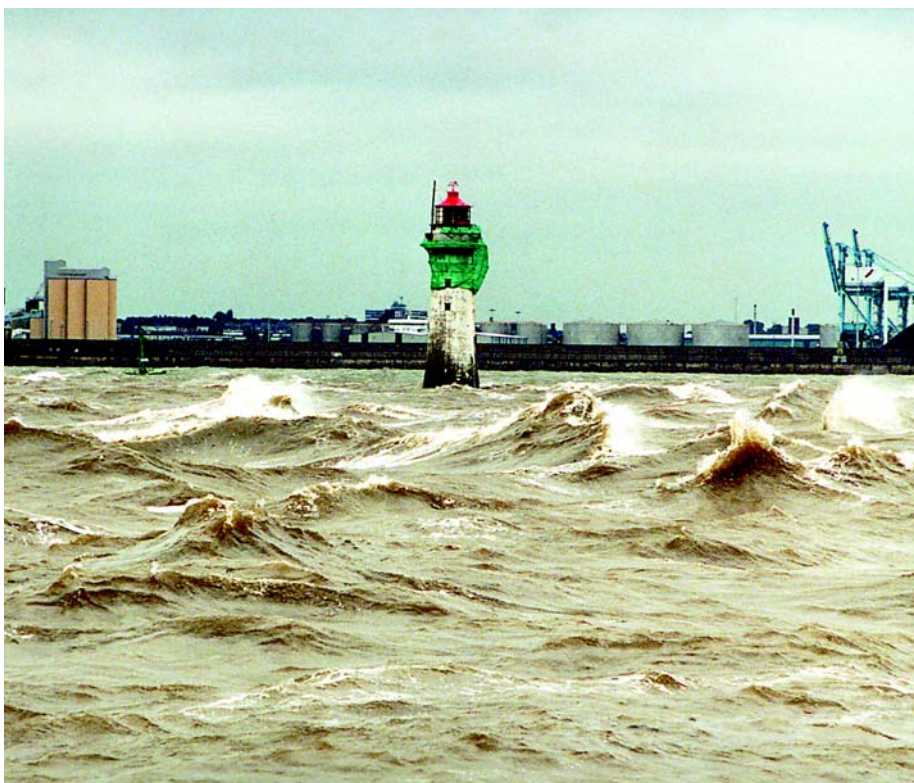
Lighthouse—The required scaffolding and other traditional means of access—extending to the base of the lighthouse, below the tide line, away from the shore (Fig. 4)—were deemed cost prohibitive.

Figure 4: Project site at high tide

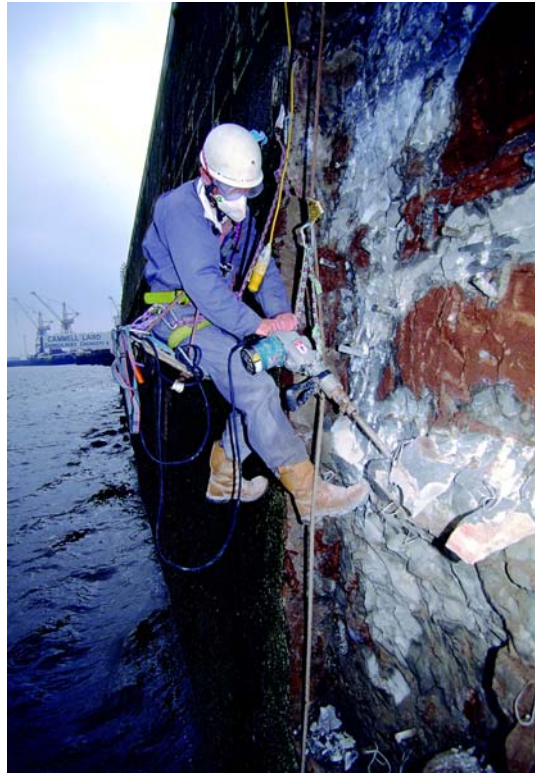
Access Solutions—The solution for access to both project sites was what is called Industrial Rope Access (Fig. 5). This technique combines specialized technical skills and equipment, originated in mountaineering and caving, and further developed for industrial use to safely access structures by descending and ascending, as well as laterally maneuvering on suspended or tensioned ropes. Using a double rope system, each with separately redundant secured anchors, in combination with full body harness, a technician is fully supported in tension or suspension in such a way that fall from height is prevented or restricted. Use of a seat

Figure 5: Technician utilizing Industrial Rope Access techniques

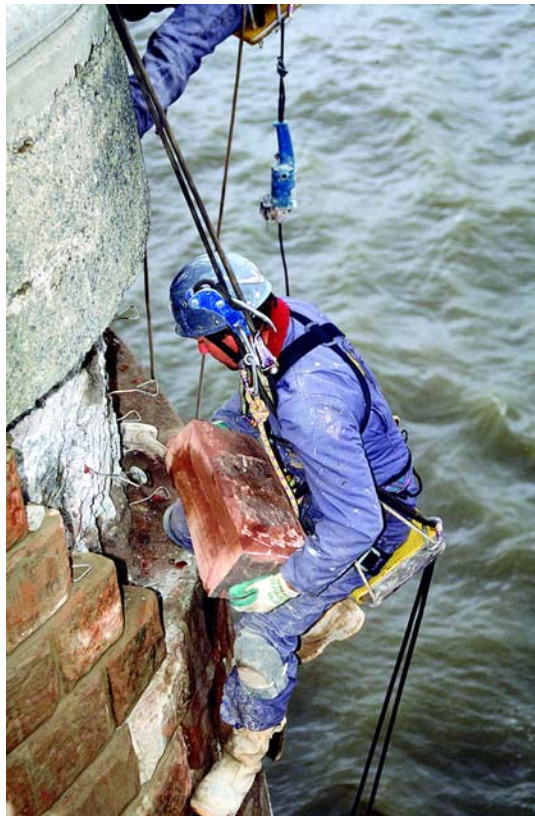
Figure 6: Rebuilding of the seawall

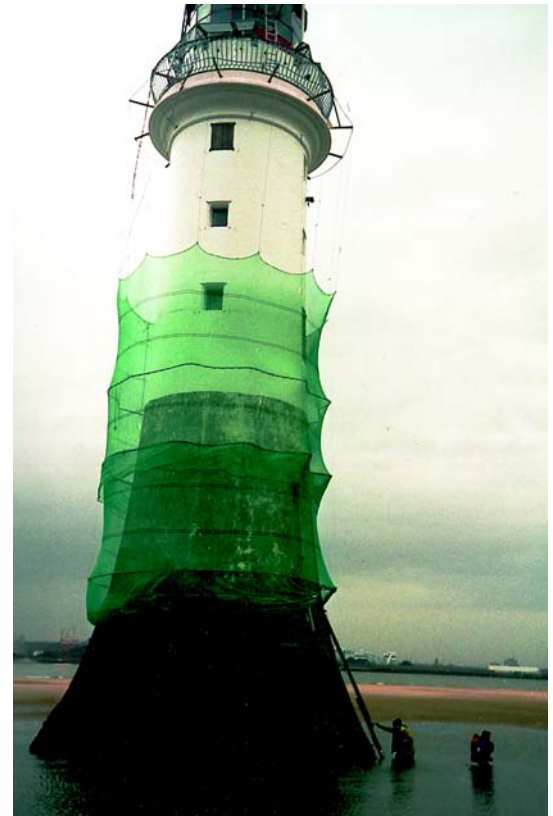
Figure 7: Containment net positioning

Lighthouse—Due to environmental requirements for containing the debris, the lighthouse was shrouded with containment netting (Fig. 7), draped similar to a curtain with steel rings to effectively position the netting along the height of the structure. The delaminated coating was power-washed, stored, and disposed of. Stripping and coating of the lighthouse was performed in five segments. Cracks and uneven surfaces were prepared with pumpable quick-set repair mortar, and minimal patching and dutchman repair of the blocks was required. Silane-based coating was used to coat the surface of the lighthouse (Fig. 8).
