From Abandoned Buildings to Aquatic Resource Center

By David White and Dave Clarke

Fort Wetherill Aquatic Resource Center

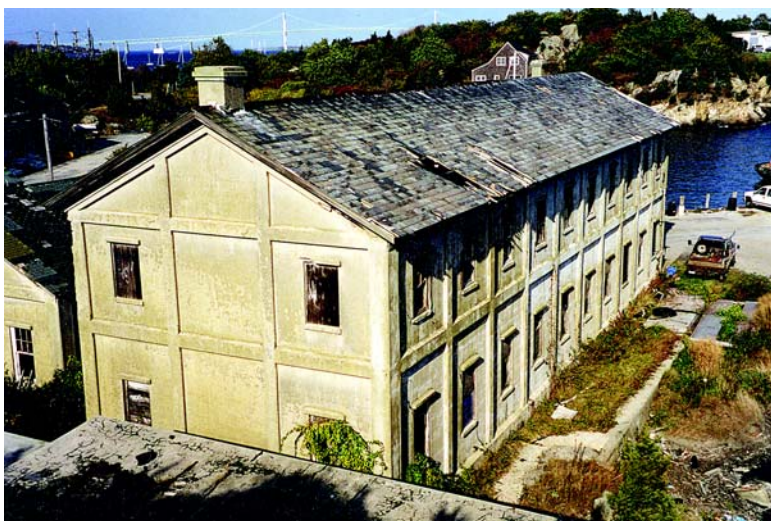
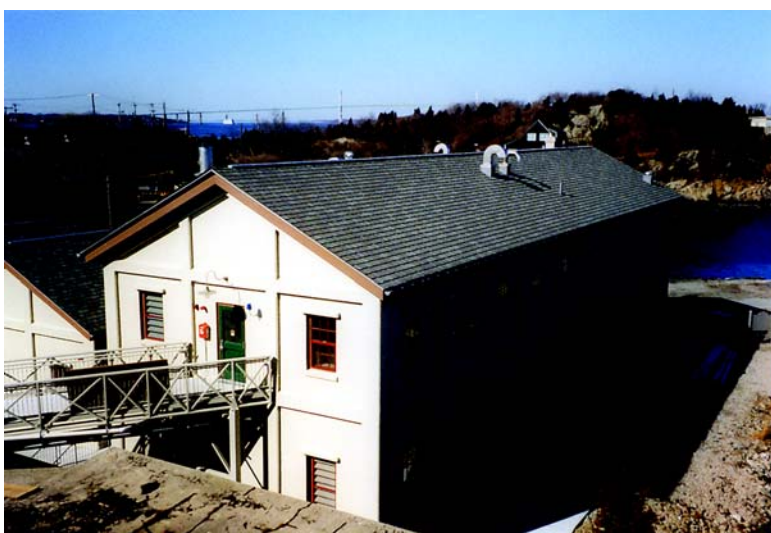
Before and after complete repair and protection system application

The testing showed classic causes of corrosion and concrete deterioration. The environment and concrete cover of the reinforcing steel in combination with carbonation and chlorides were contributors to corrosion and a subsequent increased rate of corrosion. The amount of corrosion and deterioration of the concrete varied with the elevation and its exposure. Once the cracking and spalling had begun, wetting-drying and freezing-and-thawing cycling

The concrete repair and protection system consisted of removing all deteriorated concrete spalled areas and saw-cutting around the patch perimeters to prevent feather edging. While removing the deteriorated concrete, if more than

half of the twisted bar was exposed, the concrete behind the reinforcement was removed. All exposed reinforcement received two coats of an anti-corrosion coating, and a bonding agent was used to bond the old parent concrete to the new patching material. For large spalled areas, the voids were formed and a polymer-modified silica-fume patching concrete was poured in. The polymer modification adds to the bond and the flexural strengths, and the silica fume adds to the density and reduces permeability. This bag concrete was mostly used at windowsills, window eyebrows, corners, spandrel beams and columns, and foundation areas. Smaller spall voids were hand-patched with a similar mortar.

To help combat the chlorides in the concrete, a migrating corrosion inhibitor was applied in two coats to the entire exterior concrete envelope. This inhibitor helped displace the chloride ions from the reinforcement and reduce the corrosion currents on the reinforcement steel. To combat carbonation, a leveling mortar and anti-carbonation protective coating was applied to the concrete. The leveling mortar was used to fill bugholes and smooth out imperfections to help in applying the protective coating in a uniform layer. The applied coating was breathable, flexible, and waterproof, blocking carbon dioxide from entering the concrete and lowering the pH.

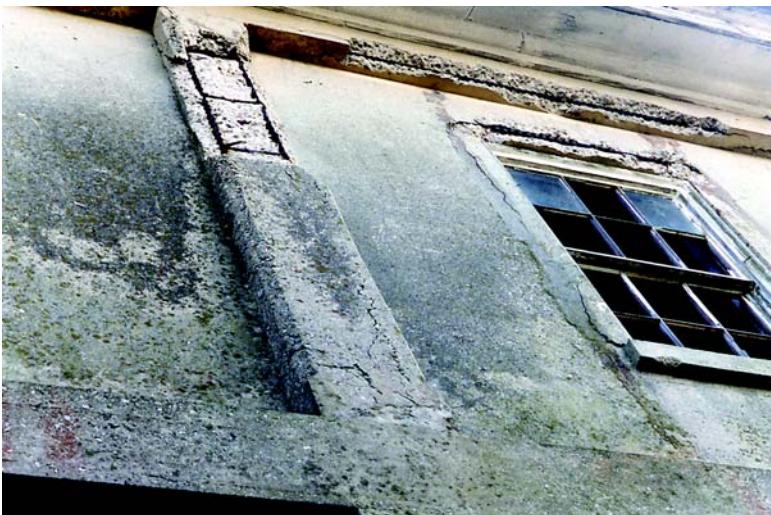
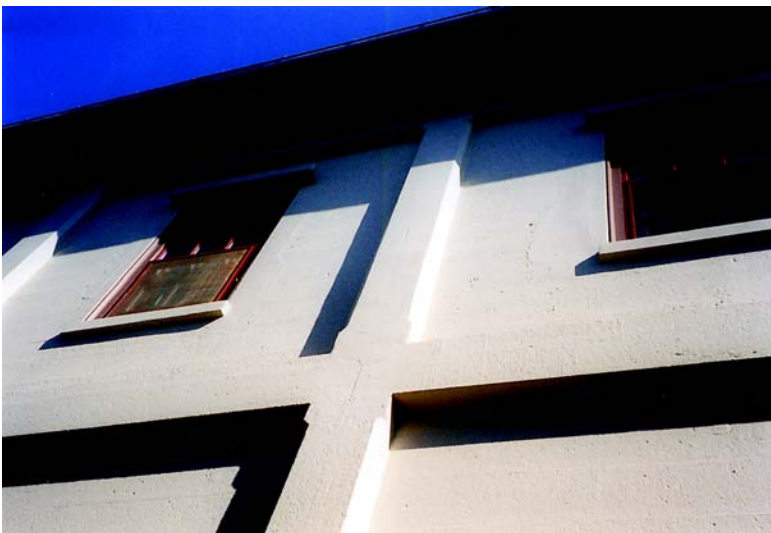
Before and after repair of spalls and window replacement

Special considerations were needed because of the historic nature of the buildings. The new roofs had to resemble the original slate roof look. The windows were replaced, flashed, and sealant applied with a wood window identical in appearance to the original window, and doors were restored to match the original construction; hardware was reused where possible. The protective coating colors were chosen to match the colors that would have been selected in 1910.

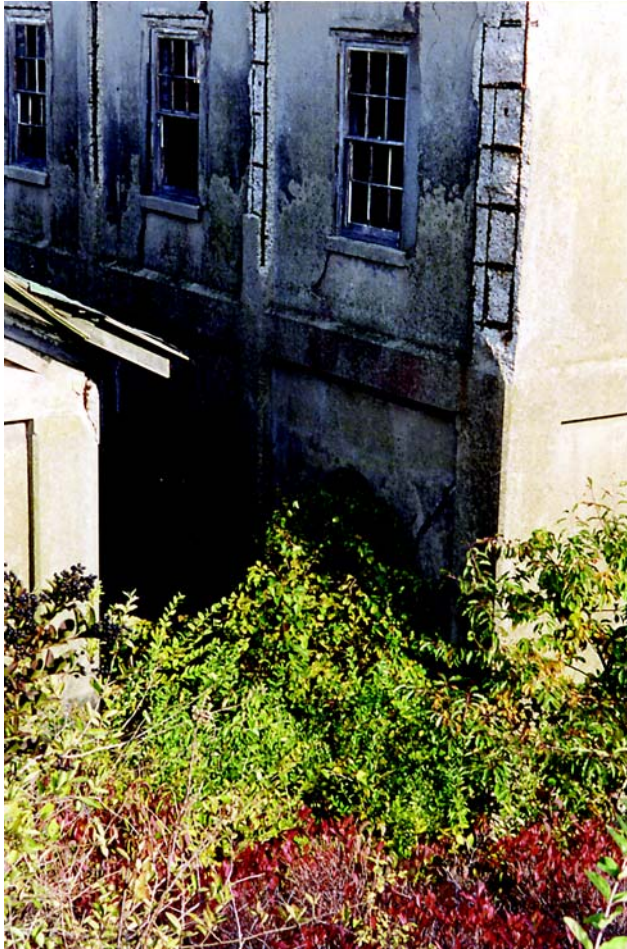
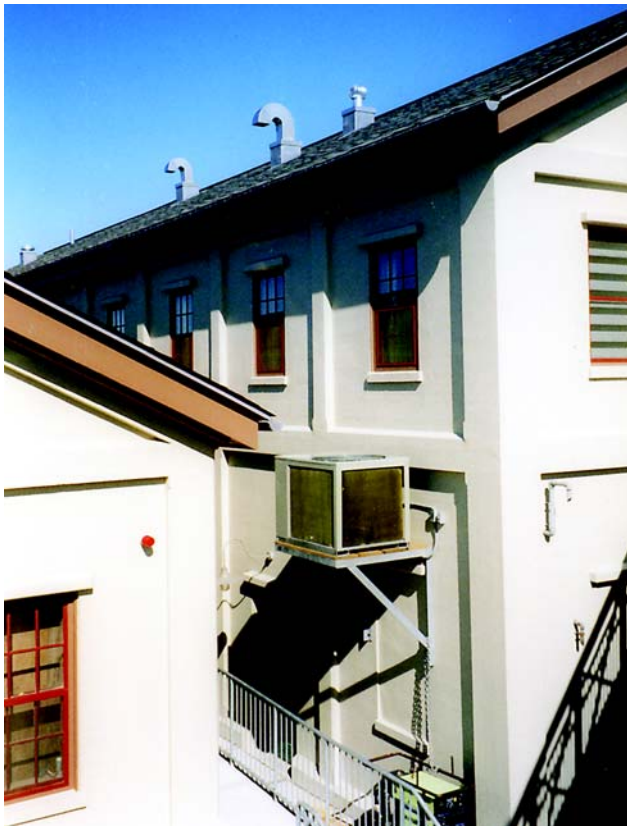
Before and after photo of repair of spalls and corner detail

Large cracks were treated the same as the spalls and repaired with patching mortar. The smaller, nonmoving cracks were injected with epoxy to structurally bond the concrete together and to stop water from entering. Other cracks determined to be possible moving cracks were saw-cut, filled with sealant, and tooled flush to be coated.
