HARRIS COUNTY ADMINISTRATION BUILDING

HOUSTON, TEXAS

SUBMITTED BY SIKA CORPORATION

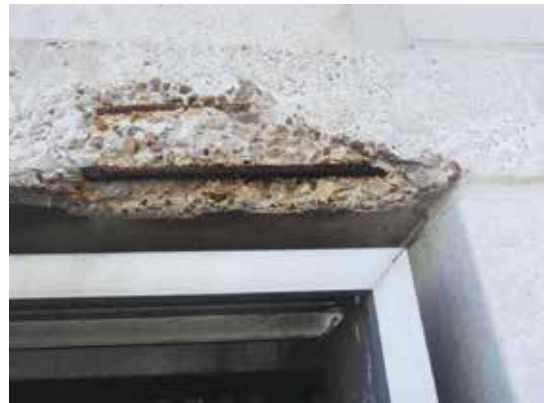
The HCAB has suffered from the results of poor construction practices since it opened 38 years ago. The reinforcing steel throughout the building was placed too close to the surface and generally poor workmanship allowed the elements of weather and time to deteriorate the structure overall. Most of the concrete members contained some degree of spalling (Fig. 2), cracking, and honeycombing (Fig. 3).

Fig. 2: Major spall due to rebar corrosion on building façade

being made off the swing stage. All cracks were filled with epoxy, utilizing pressure injection equipment. The surface bug holes were filled with an epoxy paste and the honeycombed concrete was repaired as well. The deep concrete spalls were repaired with a pre-bagged, cementitious, polymer-modified, self-consolidating concrete mix and the thin repairs were made with a pre-bagged, one-component, cementitious mortar designed for vertical and overhead repair.

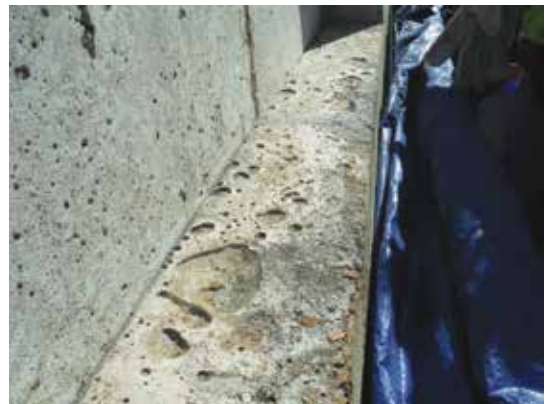
Fig. 3: Honeycombing damage on concrete beams

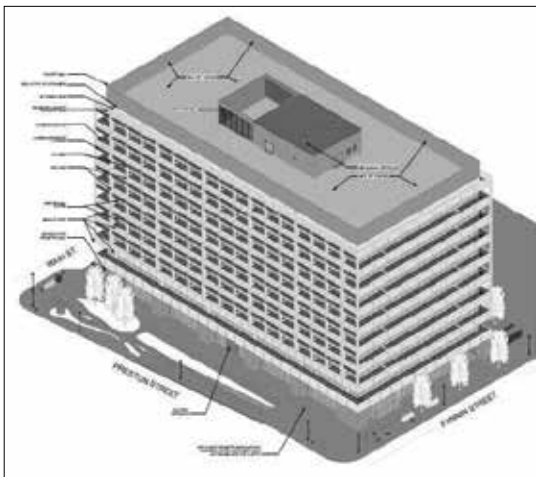
Fig. 4: Southeast isometric view of Harris County Administration Building

The entire exposed façade of 180,000 ft² (16,725 m²) was grinded as part of the surface preparation requirements (Fig. 4). Pressure washing was allowed but the City of Houston did not allow any runoff into the storm sewers. Instead, a collection basin was set up on the first floor and water was gathered and vacuumed into a water tanker. The original engineer's estimate called for only 400 ft (120 m) of cracks to be epoxy injected. However, it became apparent early on that this quantity was way off. Ultimately, over 12,000 ft (3660 m) of cracks were identified and epoxy injected, although no additional time was added to the schedule for this extra work.

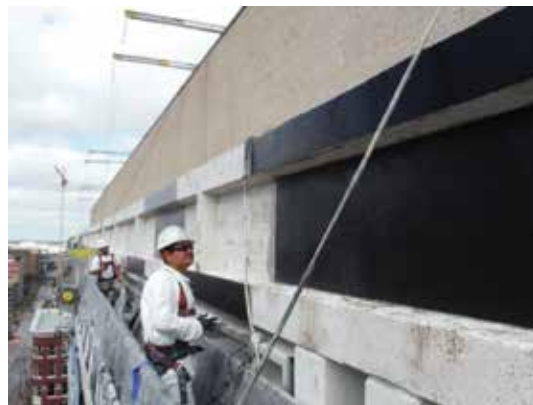
Fig. 5: Swing stage equipment used for CFRP repairs

All repairs made on the exterior of the building were accessed from swing stage scaffolds (Fig. 5 and 6). The challenge for the erection of the swing stage was the presence of an oversized parapet wall on the roof which was 12-15 ft (3.7-4.6 m) tall. Scheduling and sequencing of the work was critical to remain on schedule because different repairs were

corners between the sunshade and outrigger beams where cracking was prevalent (Fig. 7) A double-bias, +/- 45 degree CFRP fabric was installed on both the interior and exterior faces of the web to provide shear reinforcement (Fig. 5 and Fig. 6). The finished fabric was then leveled off with a silica-fumed-enhanced epoxy resin and painted with a pigmented acrylic coating to complete the repair.

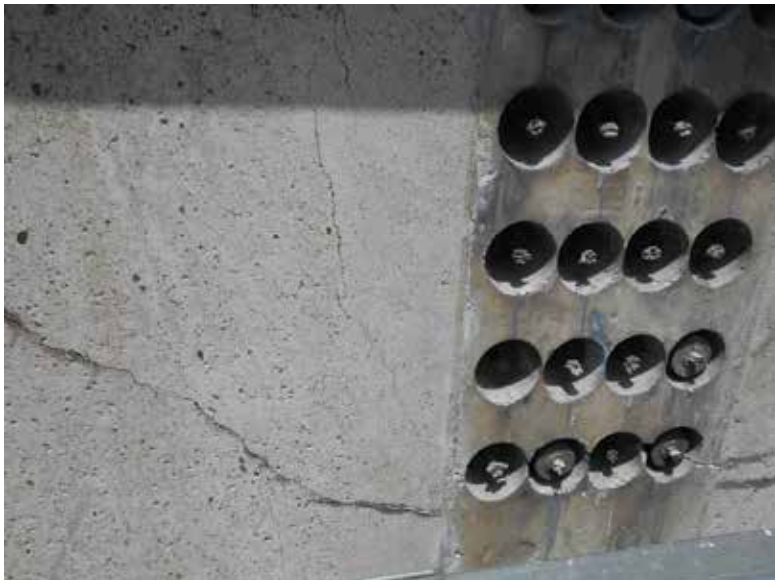
Fig. 8: Shear cracking at post-tensioned cable anchorage

Significant corrosion was detected on the ends of the post-tension cables on the north and south elevations and also at the button head anchors located on the east and west elevations. All steel plates and button heads were exhibiting flaking paint and rust, as were the inside of the button head anchors. To repair these anchorage zones, the precast concrete caps were removed and steel rust was cleaned, repaired and painted with an anti-corrosion rust inhibitor. Carbon fiber repairs were made to strengthen the concrete that was overstressed and severely cracked. Finally, the caps were replaced with new concrete using a form and pour technique.
