## AWARD OF EXCELLENCE

PARKING STRUCTURES CATEGORY

# University of Houston East Garage Fire Emergency Response

HOUSTON, TEXAS

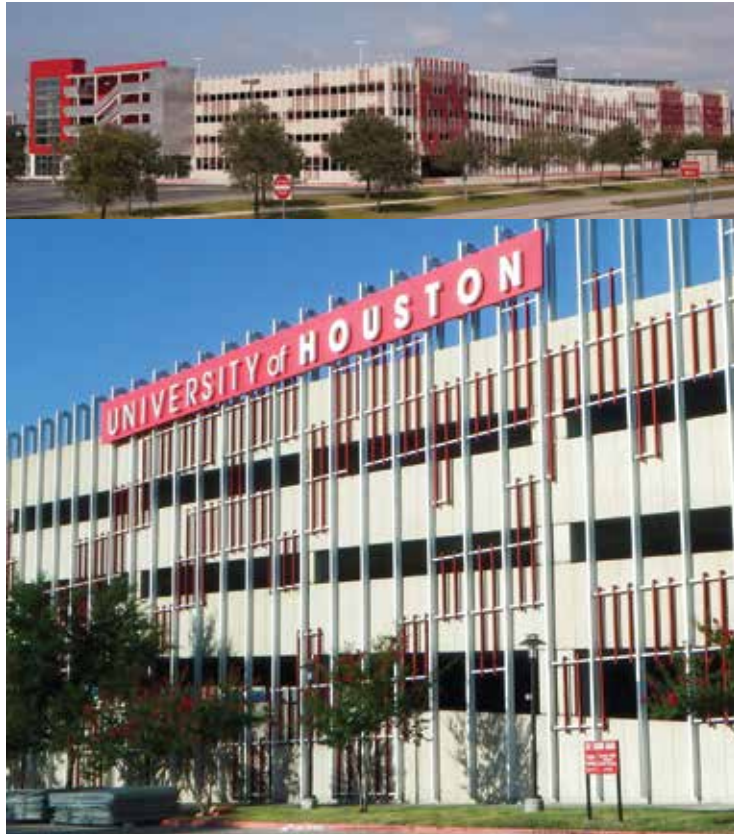
Fig. 1: University of Houston East Garage (top) and fire-damaged area after repair (bottom)

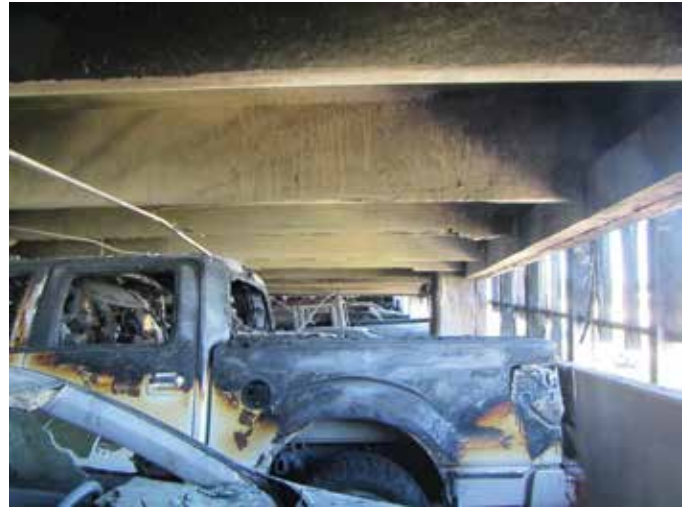
In April 2018, The University of Houston (UH) suffered a multiple-vehicle fire on the third level of the four-level East Garage (Fig. 2). Significant structural damage occurred to two columns, the framing of the level above, and the exterior signage (Fig. 3). Before any testing could be performed, shoring was installed to prevent the risk of collapse (Fig. 4).

The visual reviews and delamination survey indicated that fire-related distress had occurred in the form of concrete cracking and spalling, including delaminations identified in several crucial structural beams and columns. The concrete distress was more severe at members near the expansion joint. Core compressive strength testing did not show degradation of compressive strength as a result of the fire event. However, the petrographic examination of the concrete cores indicated the extent of surficial concrete damage as a result of exposure to fire-elevated temperatures was up to a depth of 0.4 in (10 mm).

Significant carbonation and cracking were also observed in several core samples and correlated with the NDE (UPV and pulse echo) results at multiple locations at each structural member. GPR scanning of cracked double tee beams with significant longitudinal cracking showed that these cracks were located along the prestressing strands, thus indicating possible debonding between the strand and concrete with subsequent reduction in structural capacity. The petrographic examinations also indicated that the concrete members were exposed to elevated temperatures possibly reaching around 1,400°F (800°C).

Fig. 2: Fire damage on Level 3 of parking garage

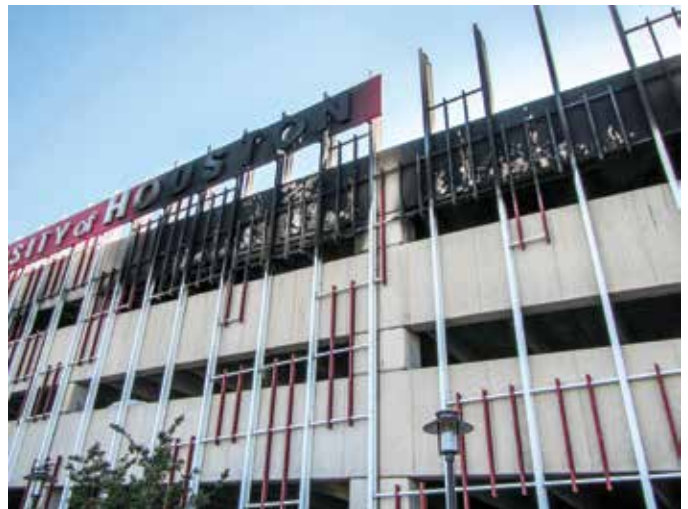
Fig. 3: Fire damage at exterior of garage

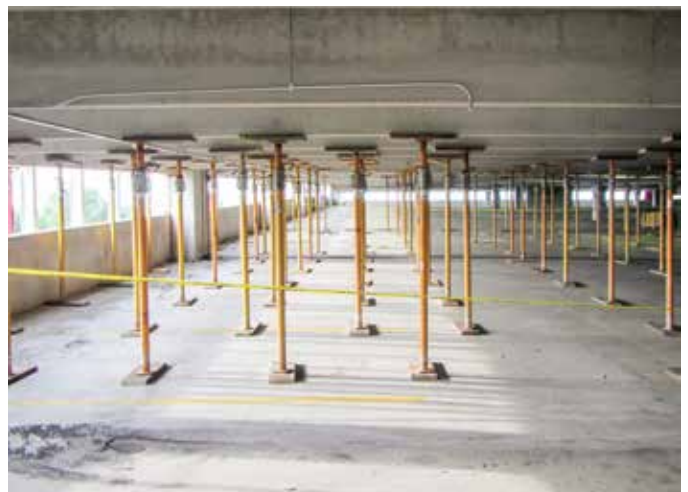
Fig. 4: Shoring installed in affected area

Emergency shoring addressed initial safety concerns for assessing the damage and reducing the threat of a possible collapse. With student finals around the corner at UH, it was understood that the East Garage would need to remain in use on all undamaged levels. This presented another challenge to the construction team: safely making localized repairs to damaged elements with limited intrusion to occupants while considering the safety and comfort of students and staff during the construction.

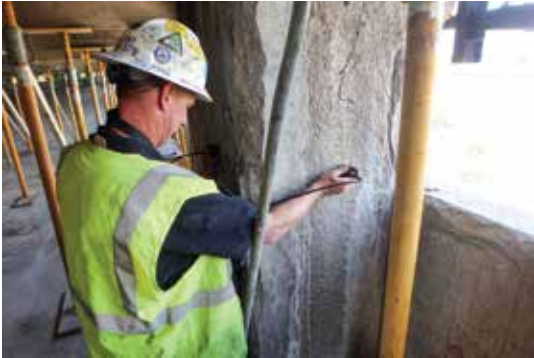
Concrete testing was performed (compressive strength and petrographic examination) and non-destructive evaluation (NDE) was conducted to determine the severity of damage and repair approach. NDE methods included ground penetrating radar (GPR) survey, ultrasonic pulse velocity (UPV) testing, and pulse-echo scanning (Fig. 5).

Fig. 5: Nondestructive testing performed at damaged column

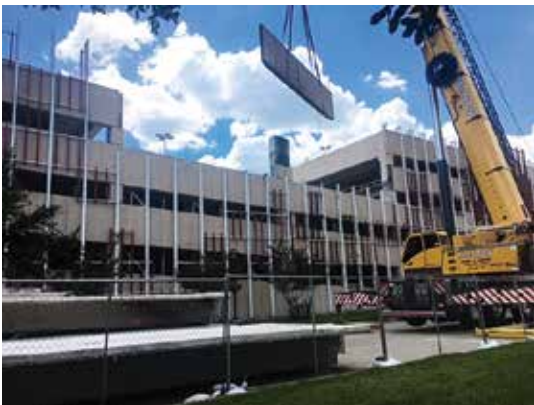
Fig. 6: Spandrel beam replacement

existing damaged precast double tees, cores were drilled at each of the four pick points, allowing a sling to be wrapped around the stem for each double tee. A 350-ton (317,500 kg) crane was used to bring down each damaged precast double tee, with a total of six removed and four new double tees reinstalled. Two of the damaged double tees were found to be salvageable, temporarily placed on the ground, and repaired after they were placed back in their final position. Two existing spandrel beams were hoisted down, hauled off, and replaced with new members (Fig.6). New replacement double tees were hoisted into place for final repairs (Fig. 7).

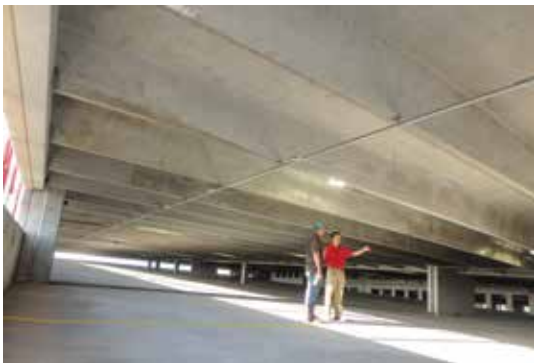
Fig. 7: New double tee beams

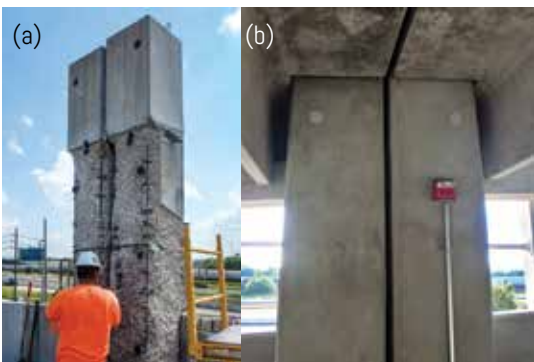
Fig. 8: Column repair (a and b)

Other repairs included the concrete columns supporting Level 4 (Fig. 8), spandrel beams on Levels 3 and 4, double tee members on Level 4, topping slab replacement on Level 3, and waterproofing on Levels 3 and 4. The damaged expansion joint system on Level 3 was replaced and a new expansion joint system was installed on Level 4. Joints were tooled in the topping slab and sealed above the double tee flange-to-flange joints, and construction joints were routed and sealed. Cove sealant was installed at the perimeter bumper wall and columns.
