# Evaluation and Repair of Shear Walls of a Parking Garage

Hemant S. Limaye  
Concrete Science, Inc.  
Hayward, CA

# ConRAC

# Concerns

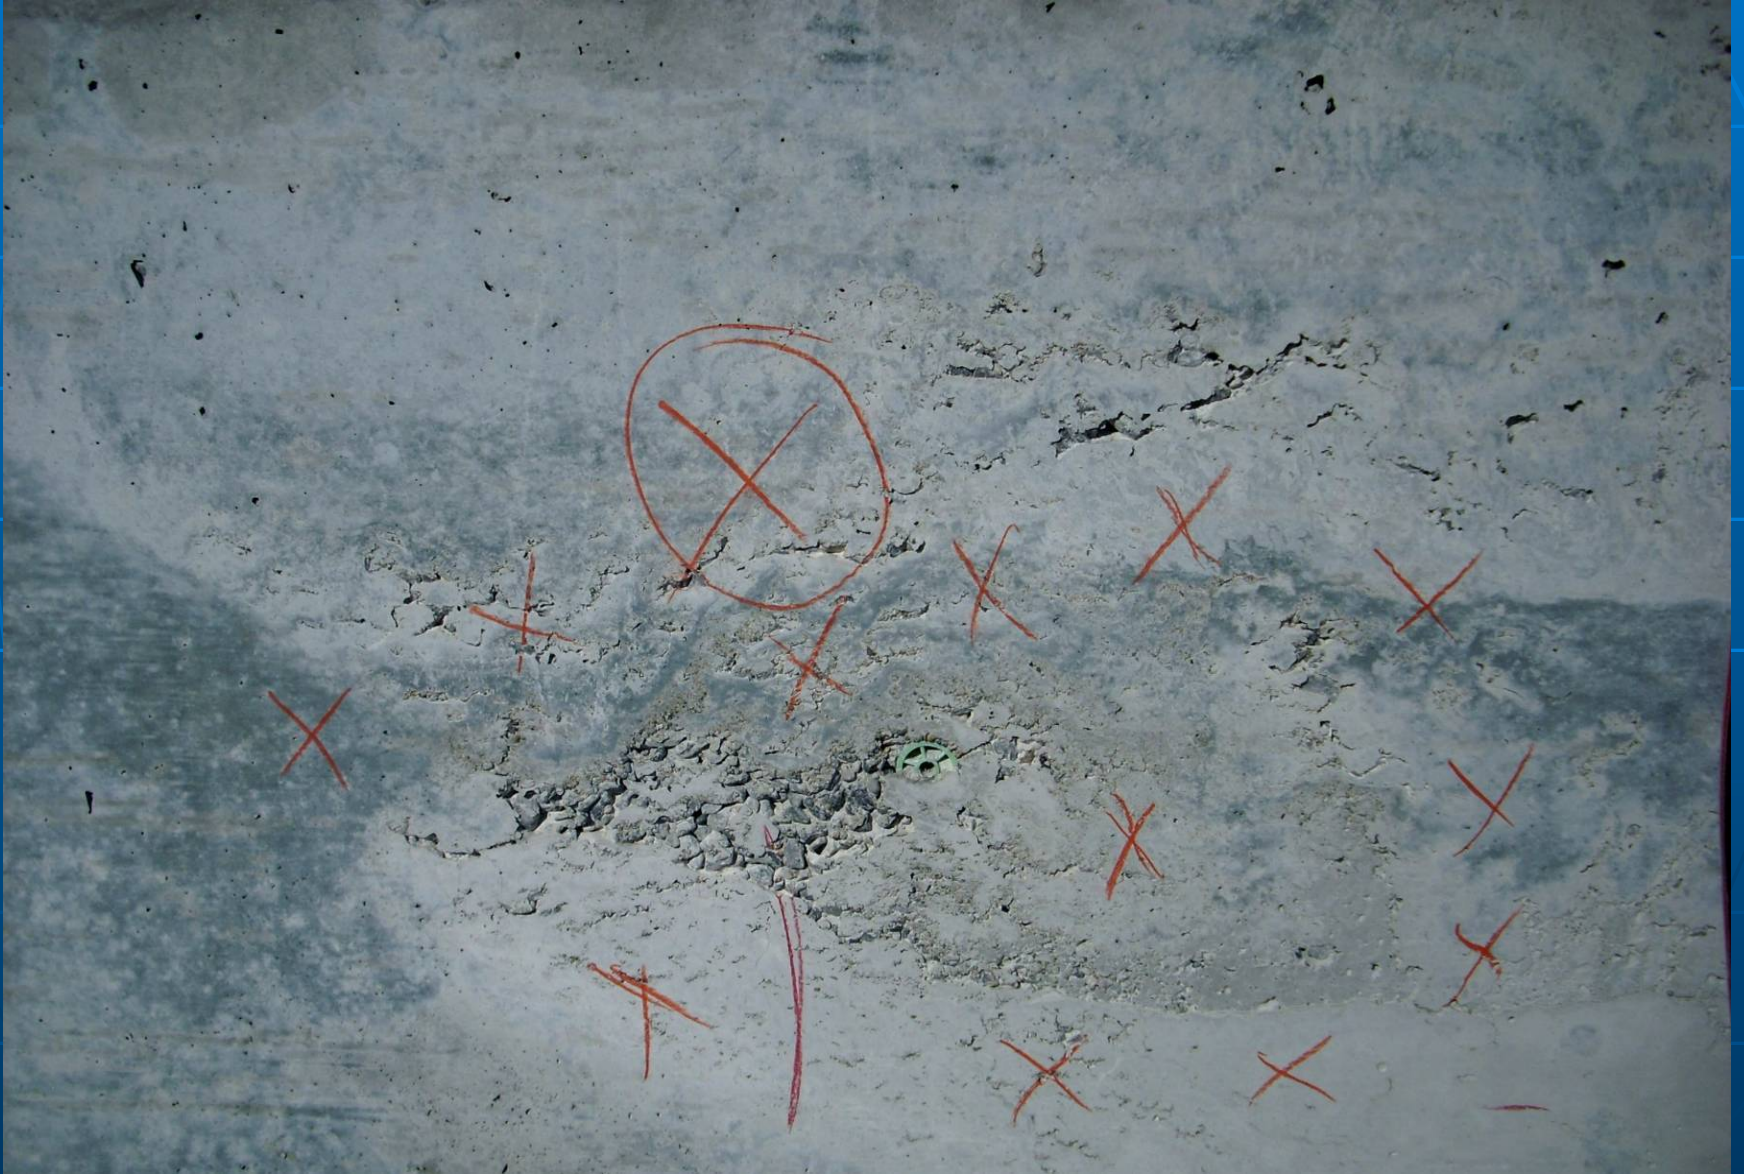
# Honeycombed Concrete

- 32" Thick Shear Walls Between 1<sup>st</sup> & 2<sup>nd</sup> Floor
- After Removal of Forms Revealed Minor to Severe Honeycombing in some of the Walls
- At a Few Locations Unconsolidated Concrete Extended Through the Entire Depth

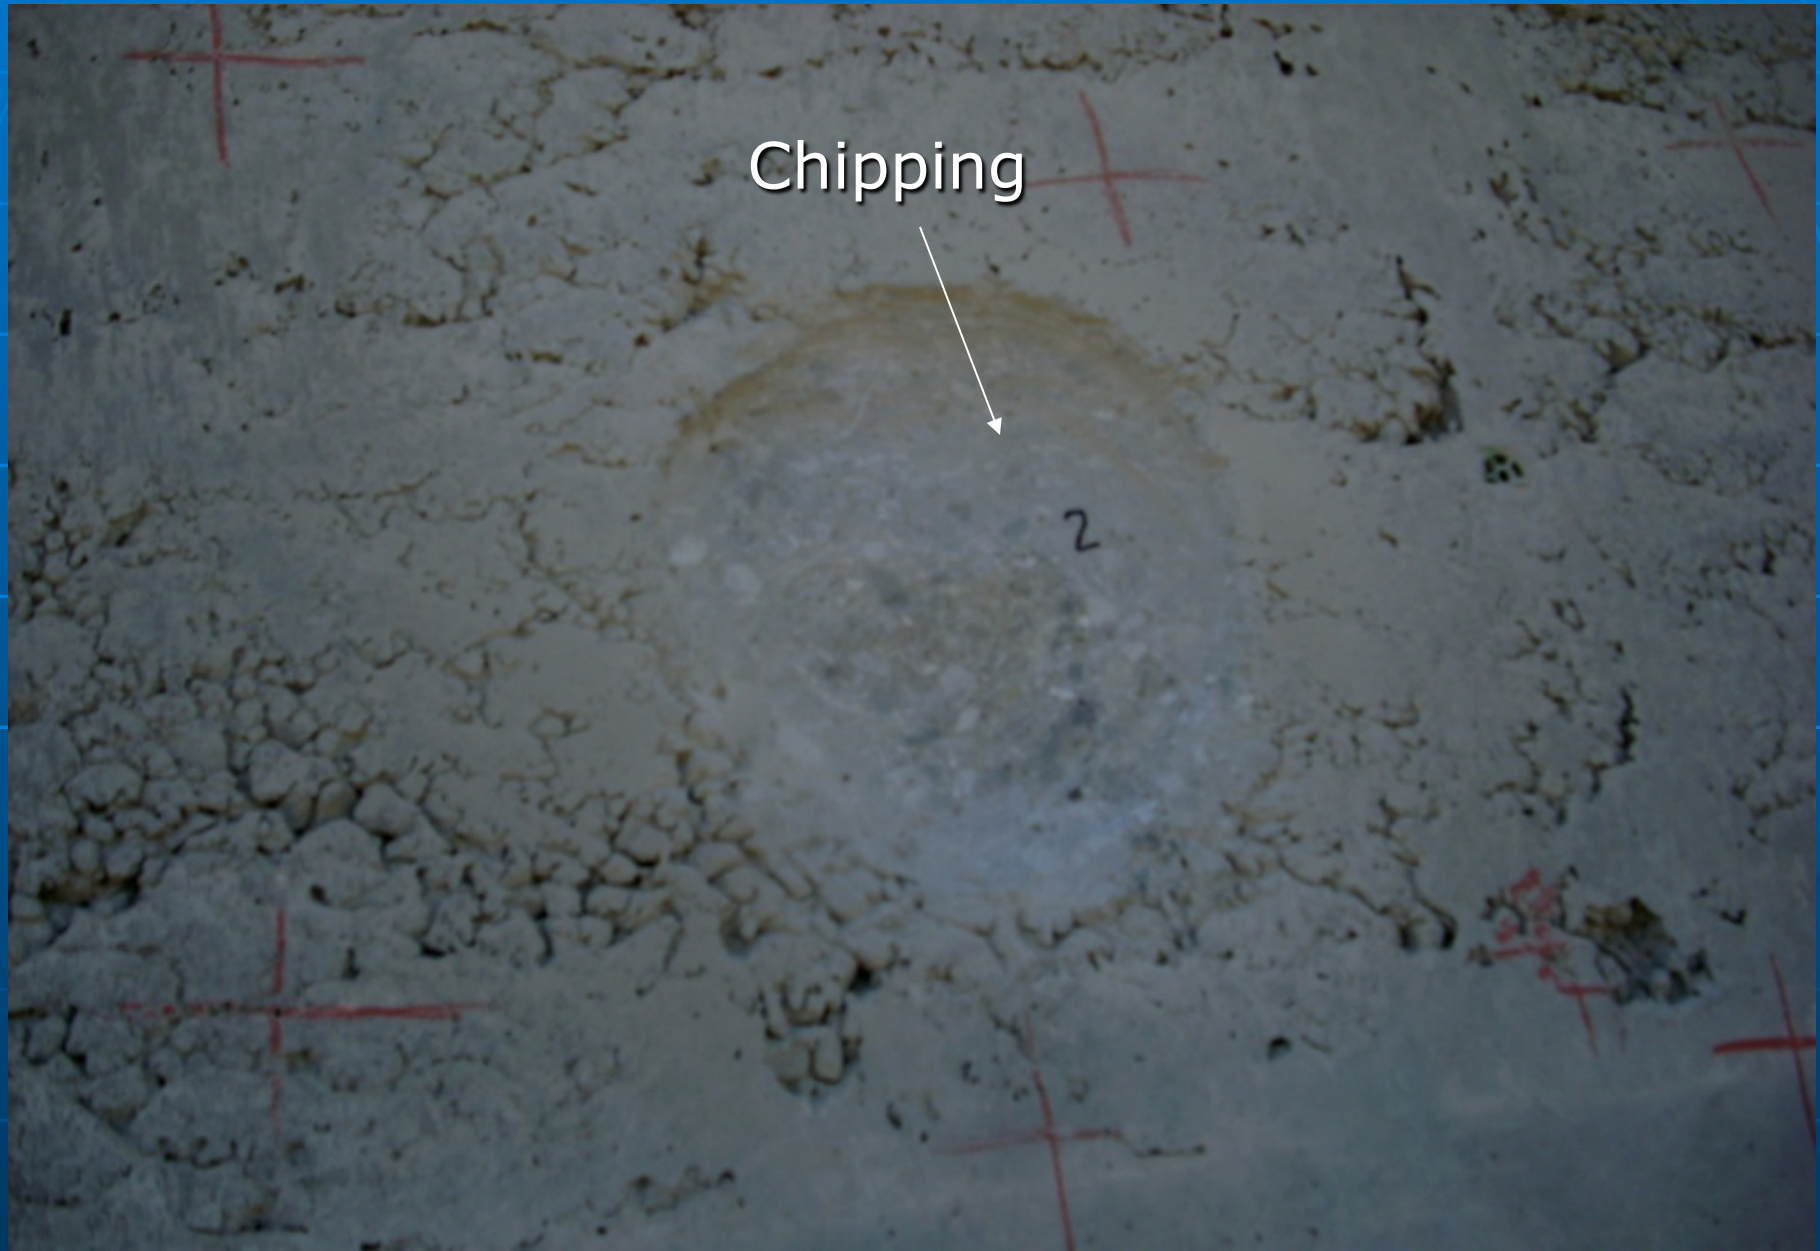
# Verification of Test Results

- Majority of the Locations Did Not Contain Through the Depth Voids
- A Few Locations Contained Unconsolidated Concrete up to 40% of the Depth

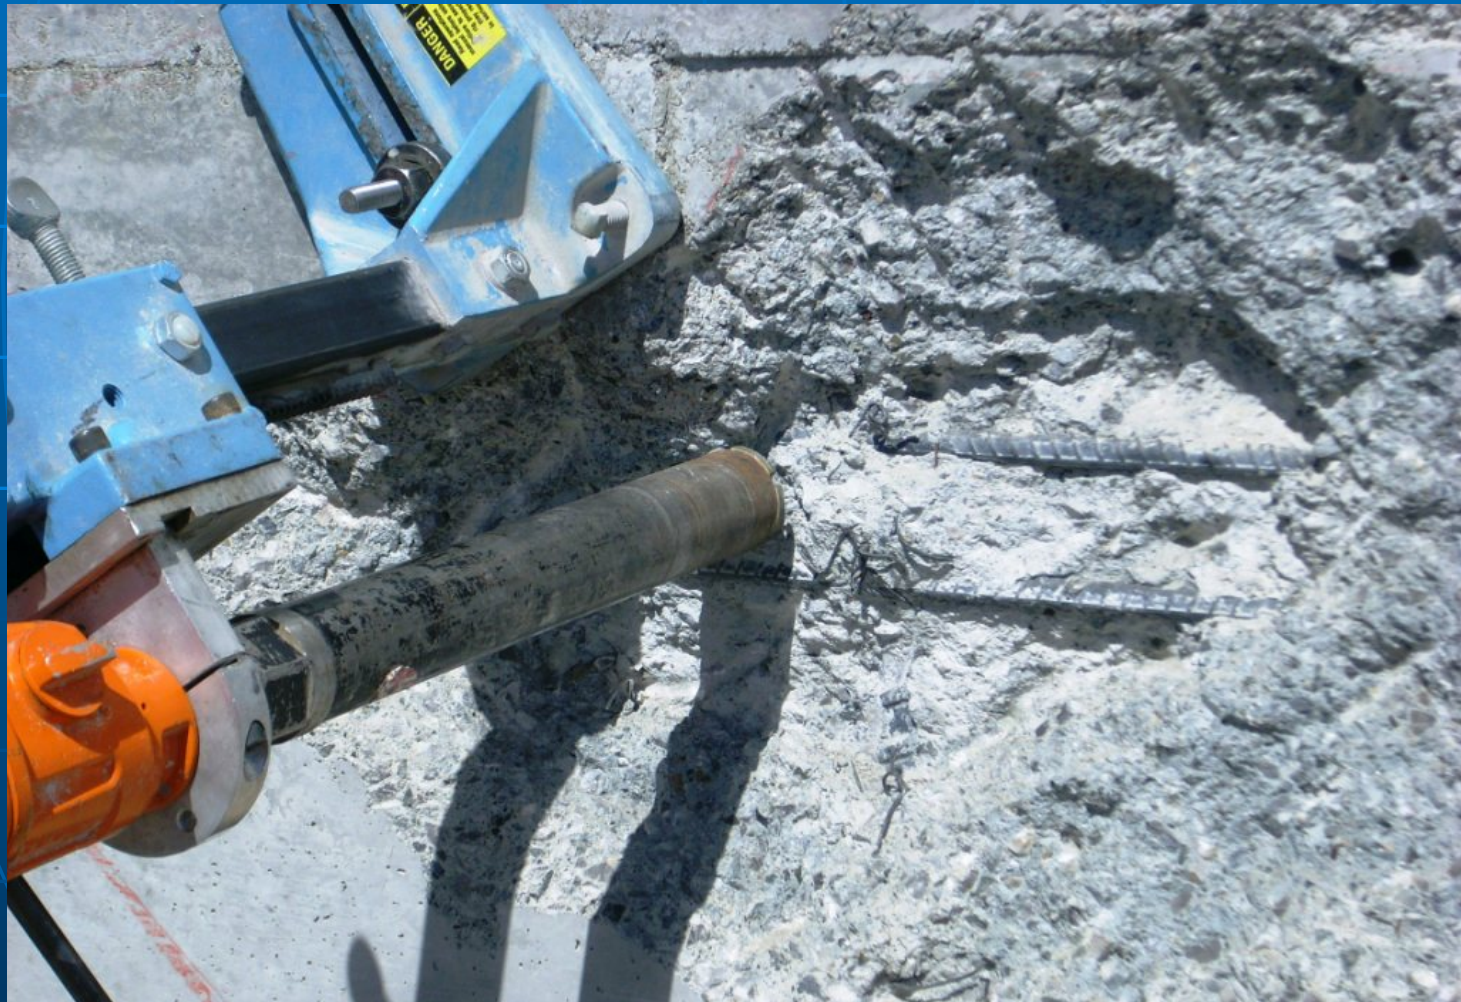
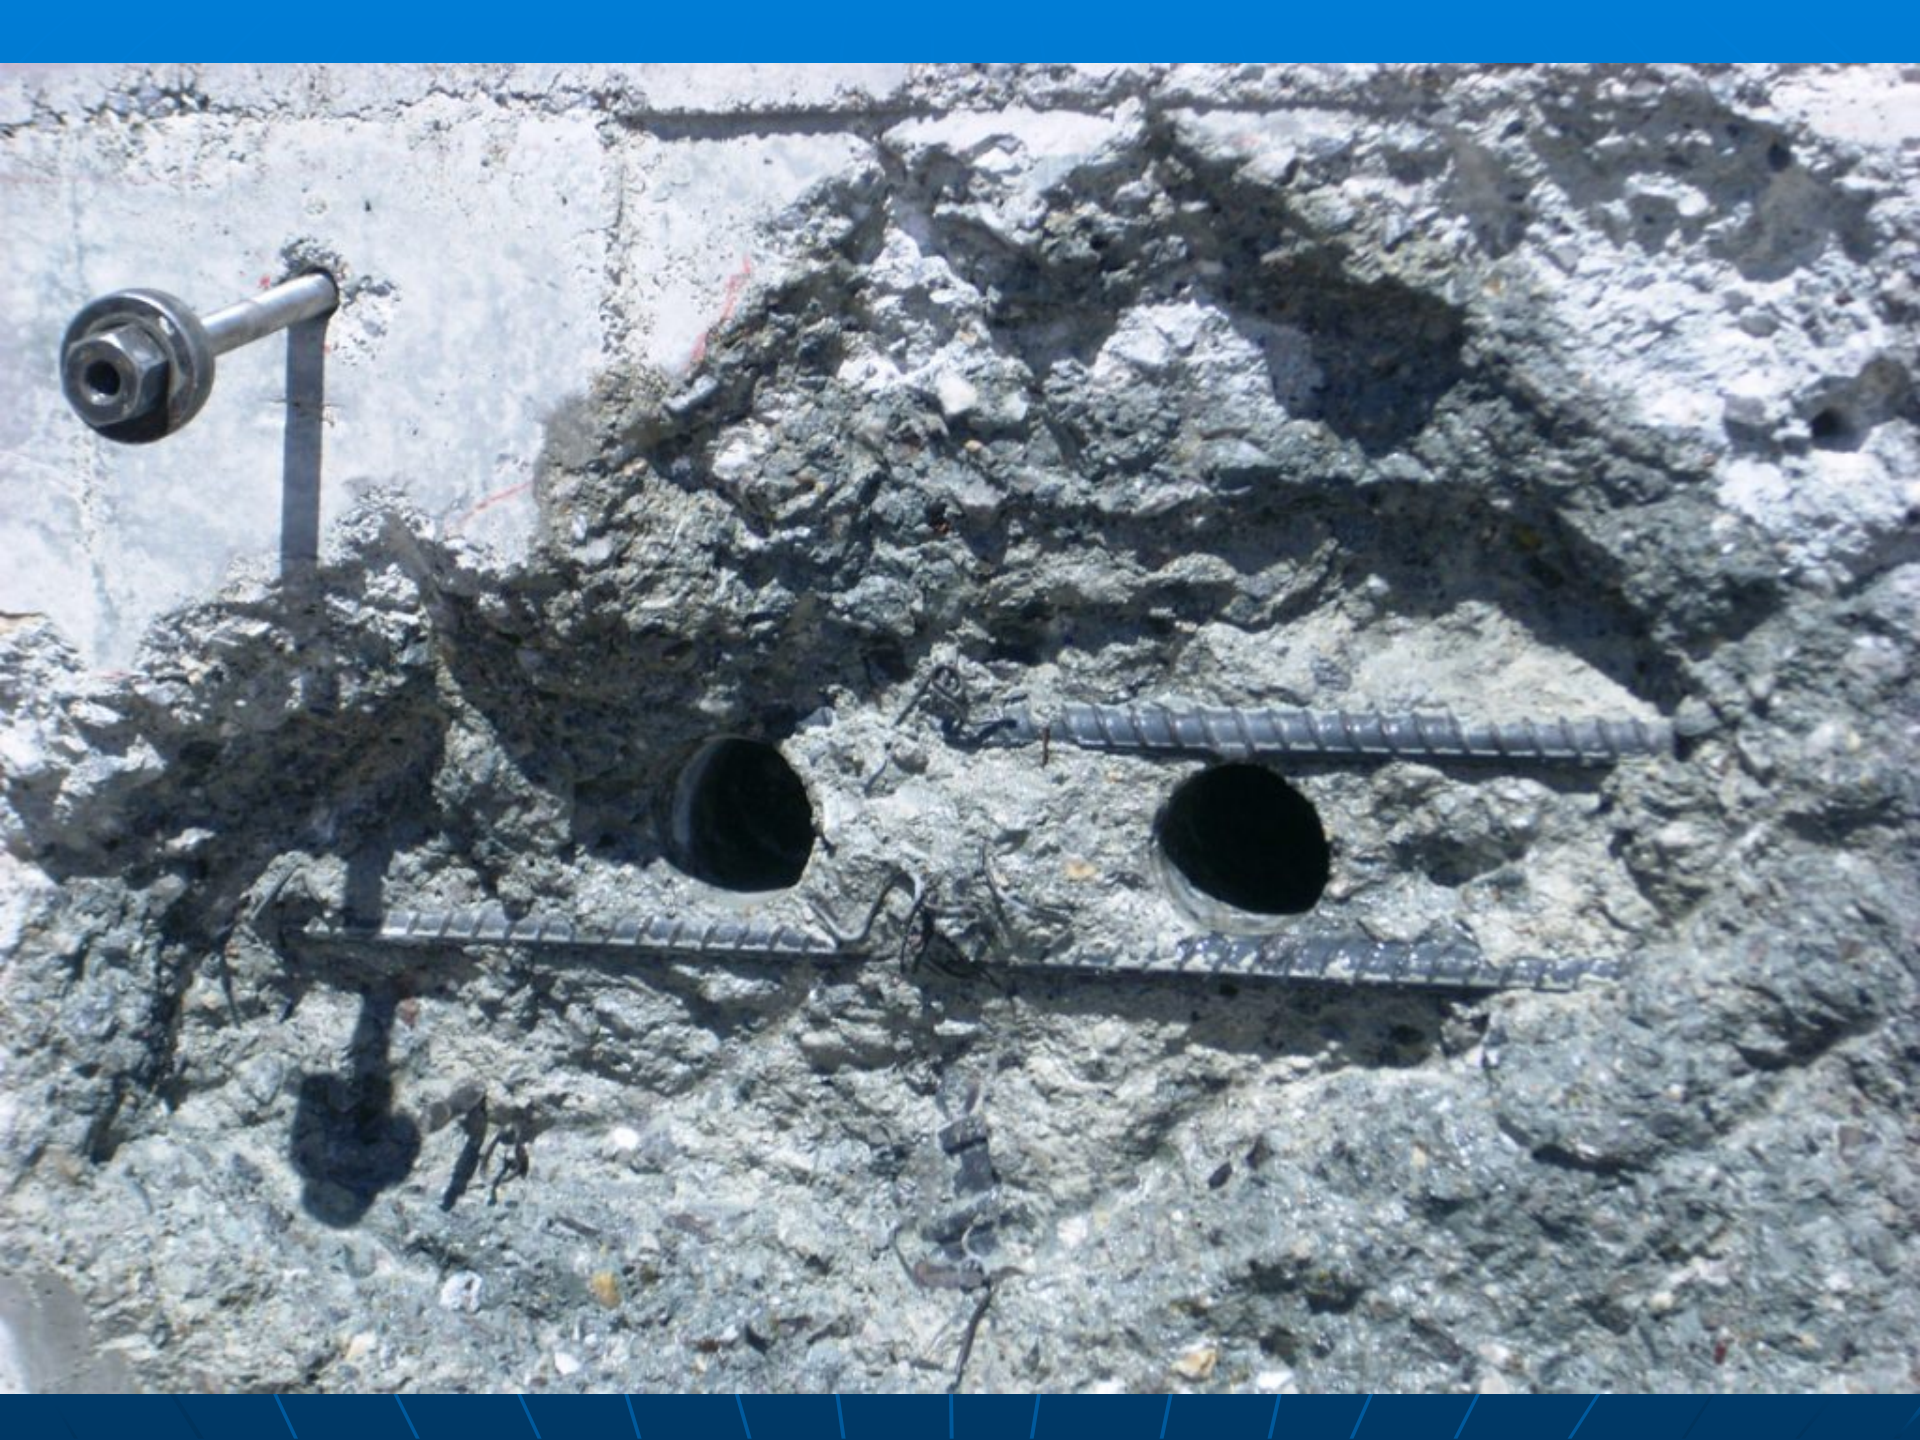
# Shear Wall- More Add' L Work

- Drilled and Removed Partial Depth, 2" dia. Cores Close to the Interior Rebar

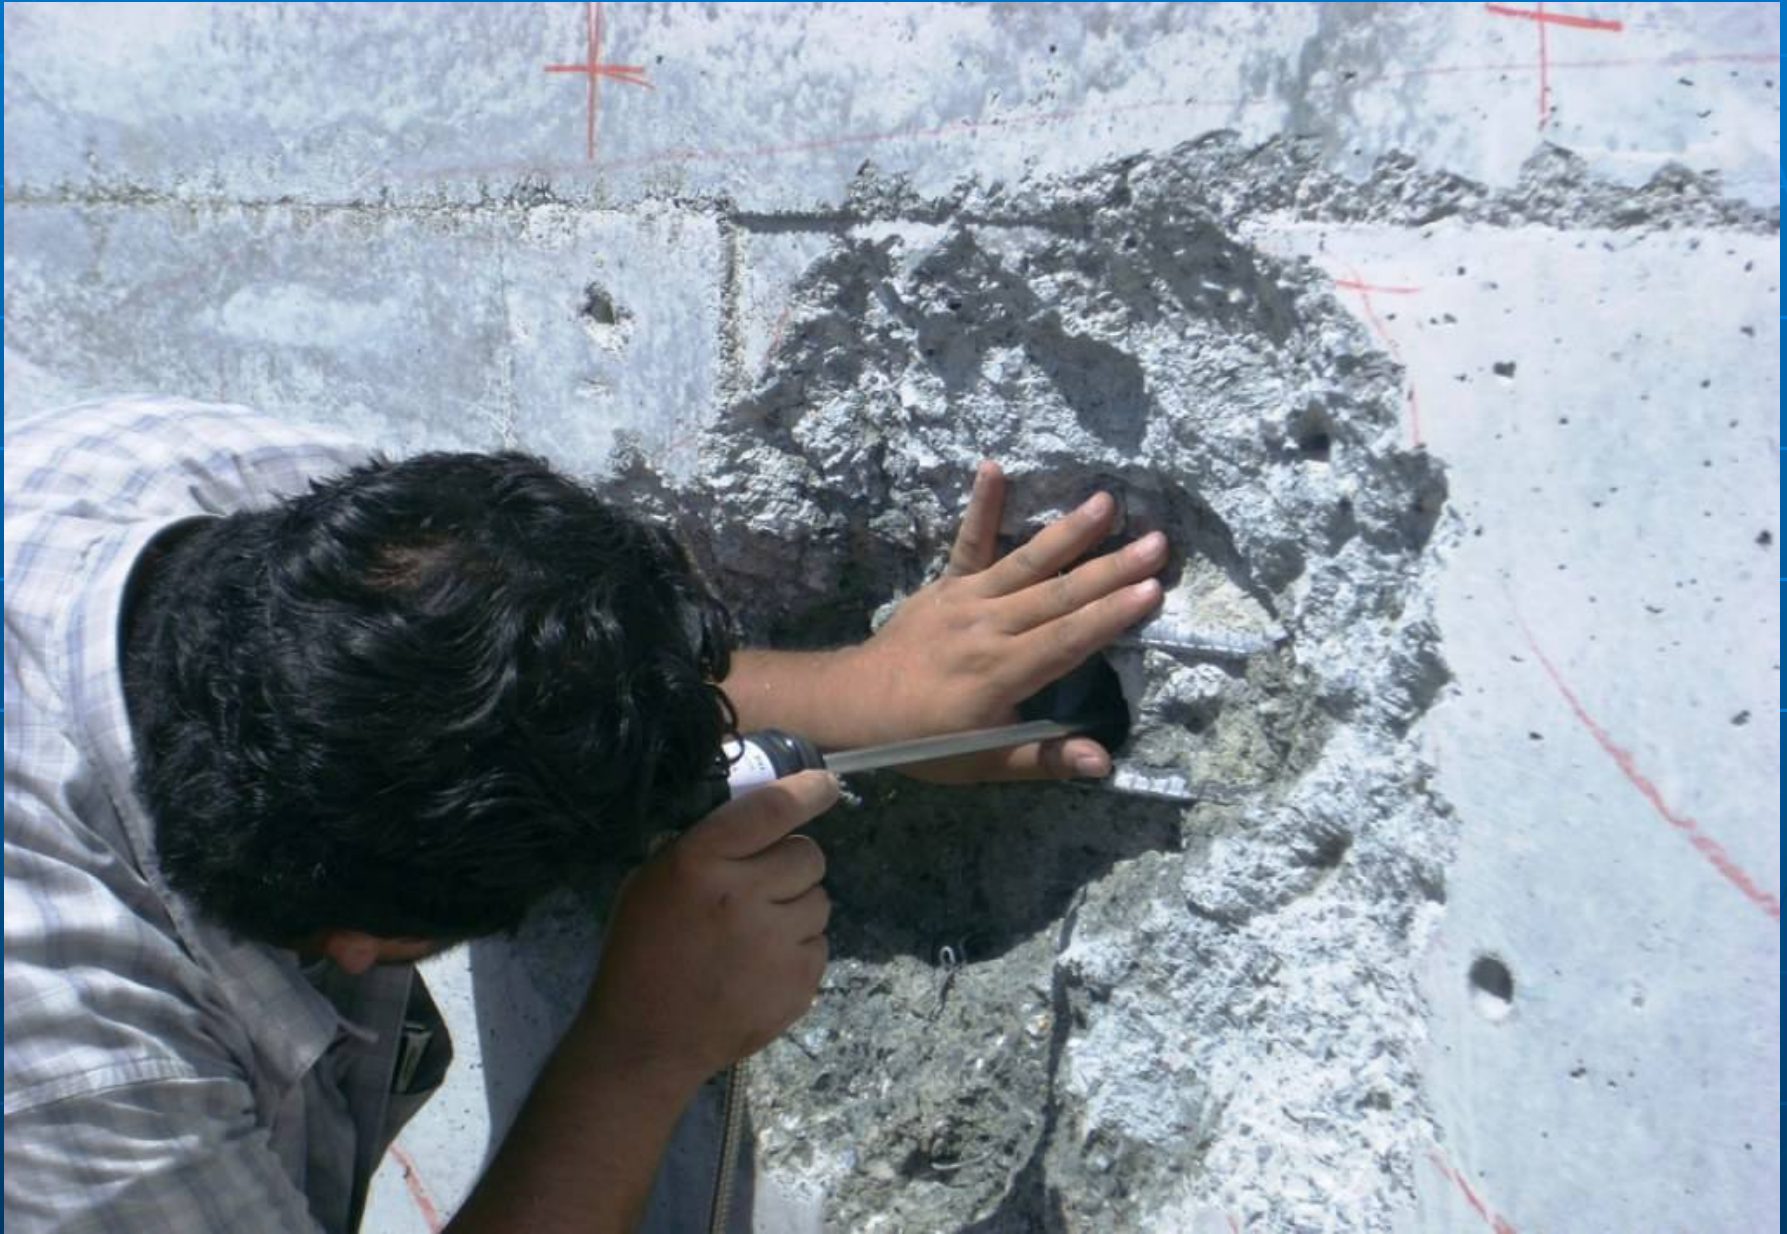
# For Borescope Observations

- Interior Delamination
- Bug Holes in One Hole, Depth: 8-9"
- Crack in Another Hole; Depth: 9-10", Color Change in Material
- Crack in Third Hole; Depth: ~8", Color Change in Material Starting at 6.5"

- Perform Microscopic Examination to Characterize the Concrete
- Chip the Area Concrete to Examine the Interior Condition

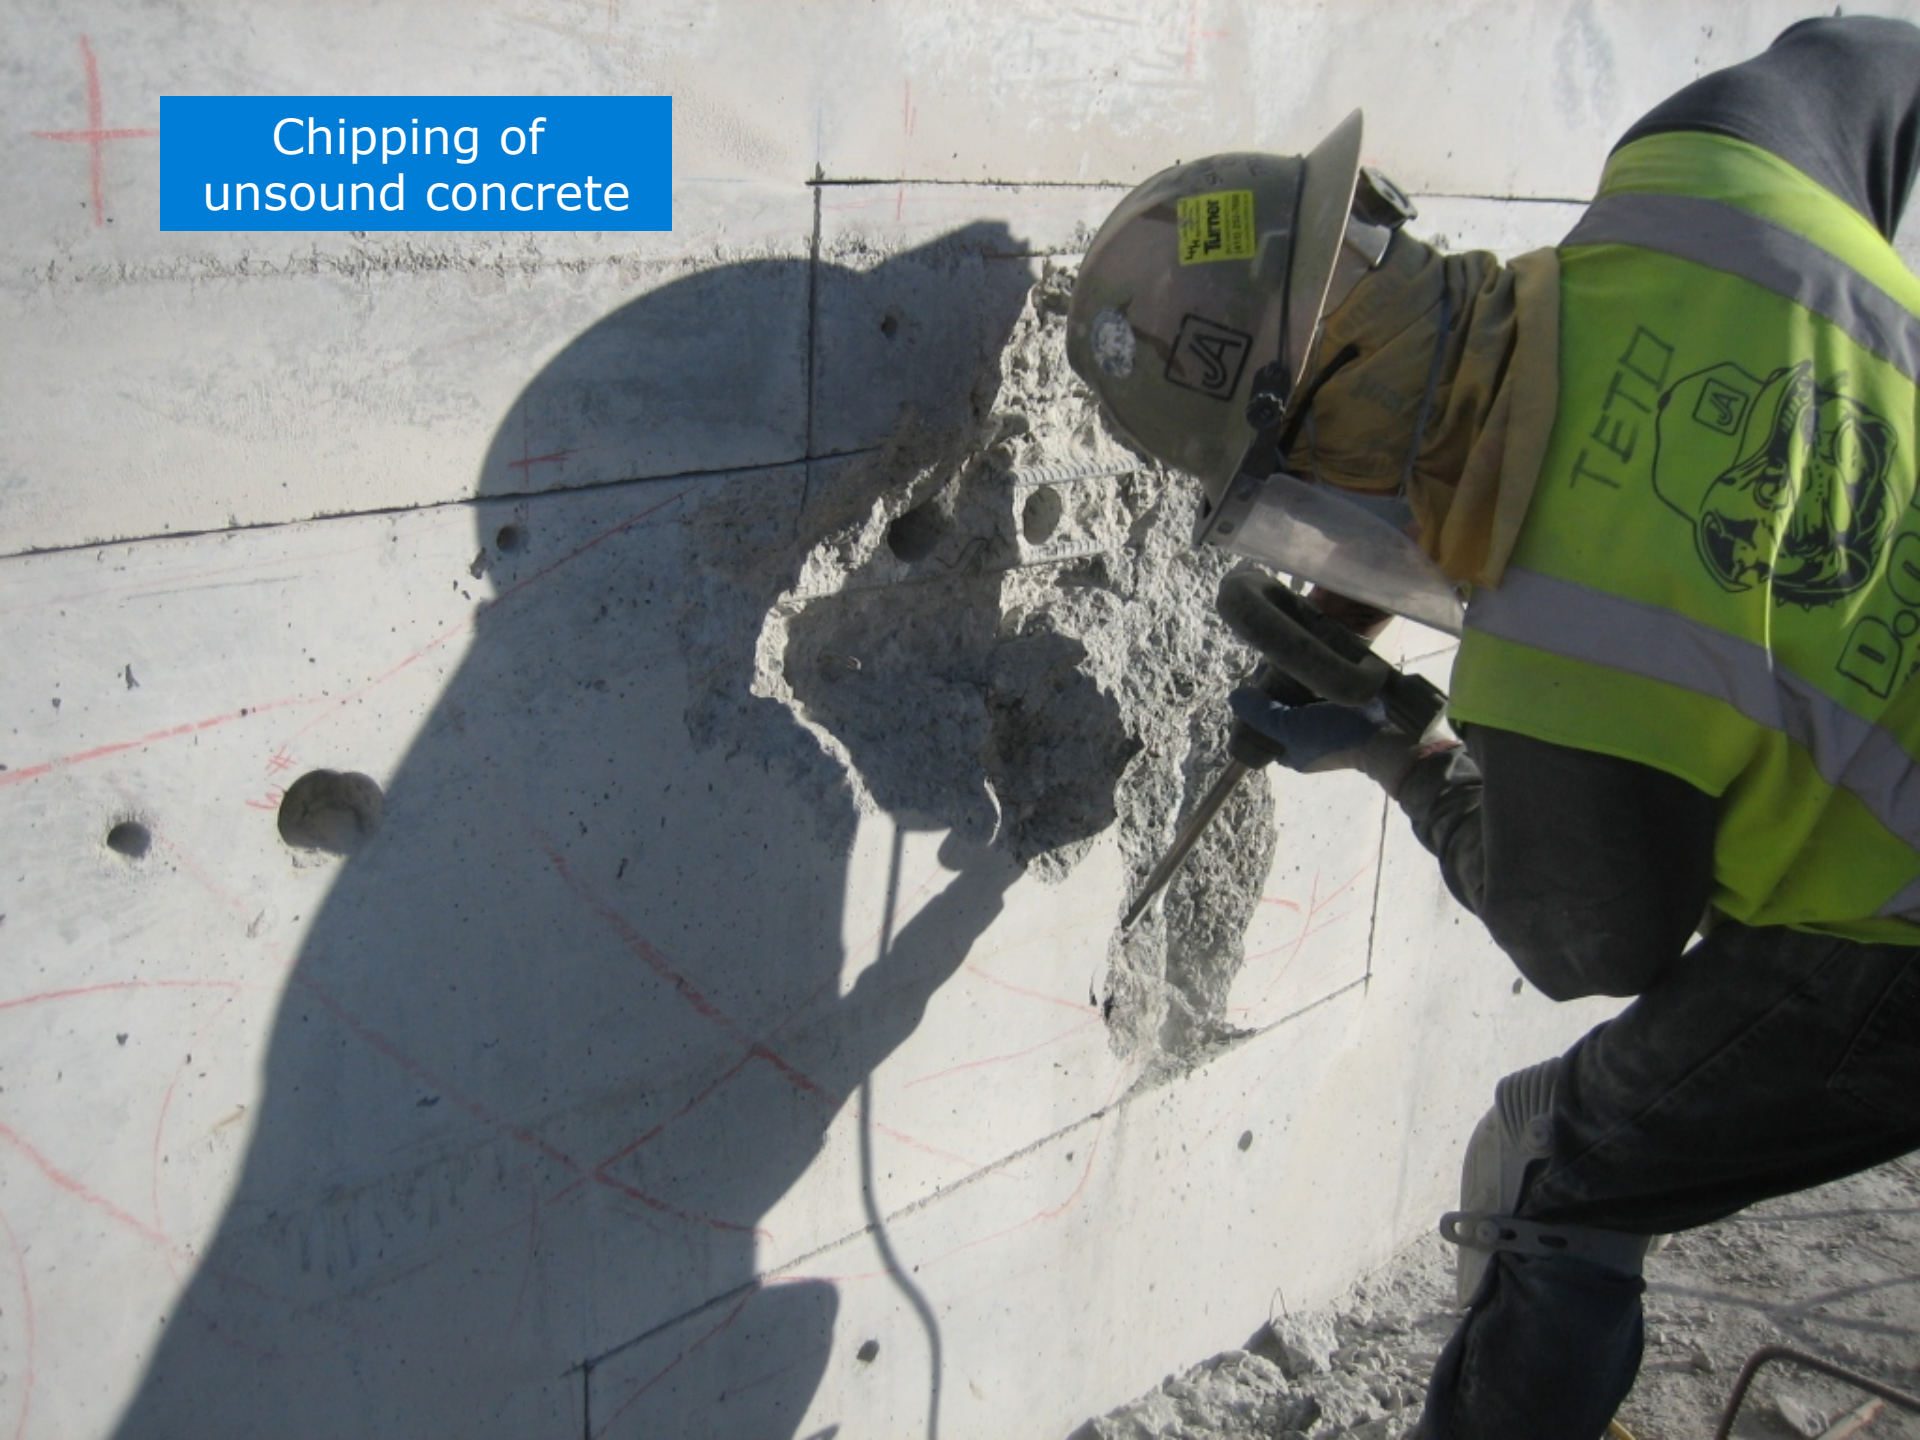
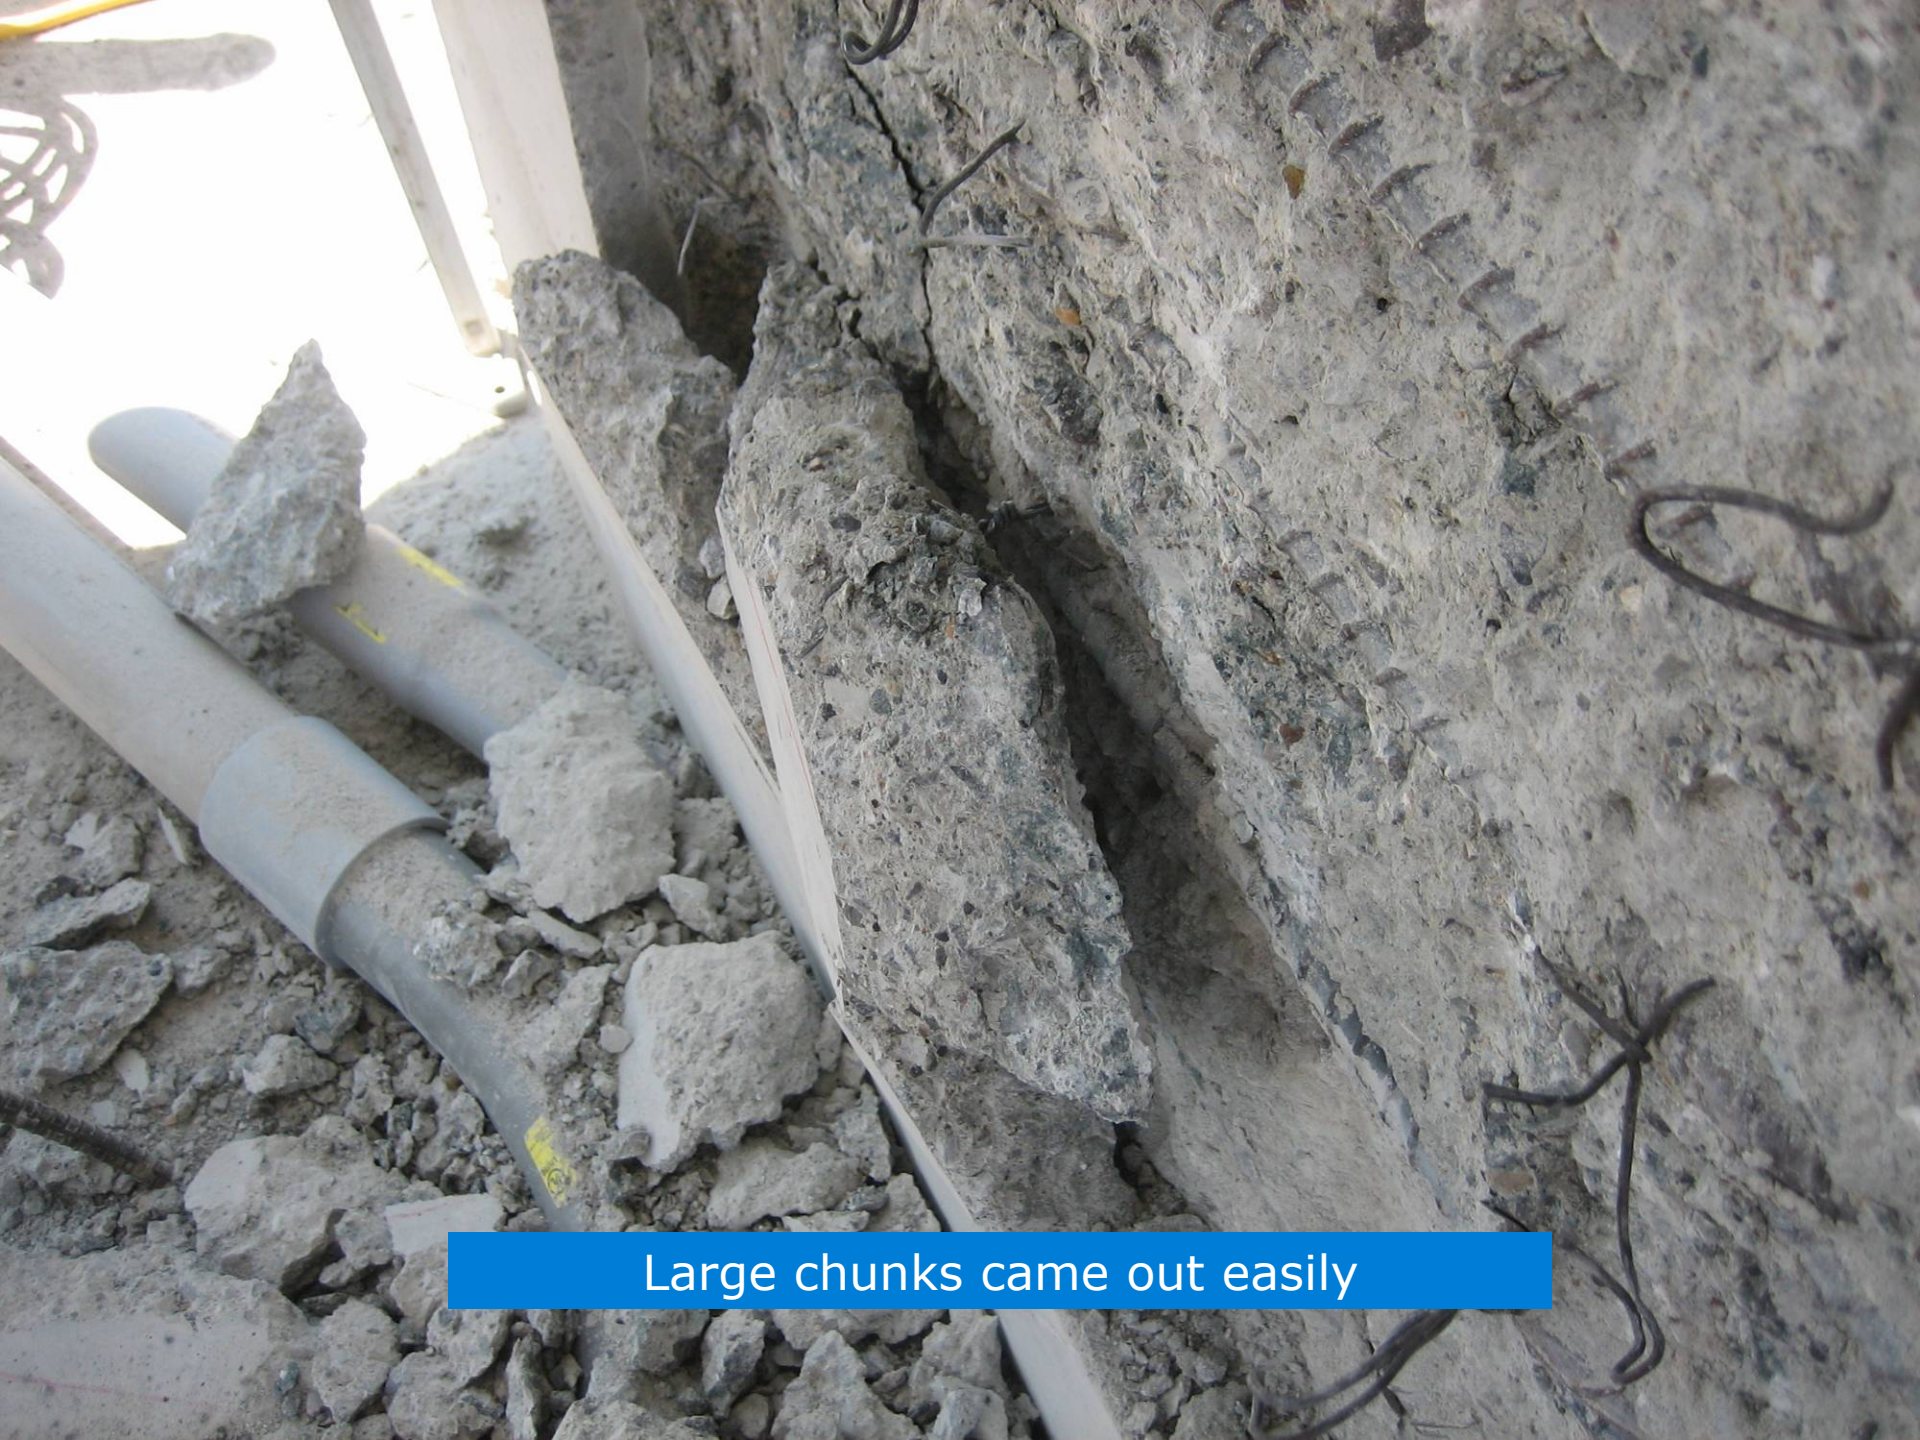
Chipping of  
unsound concrete

Large chunks came out easily

Significant delamination at  
the rebar depth

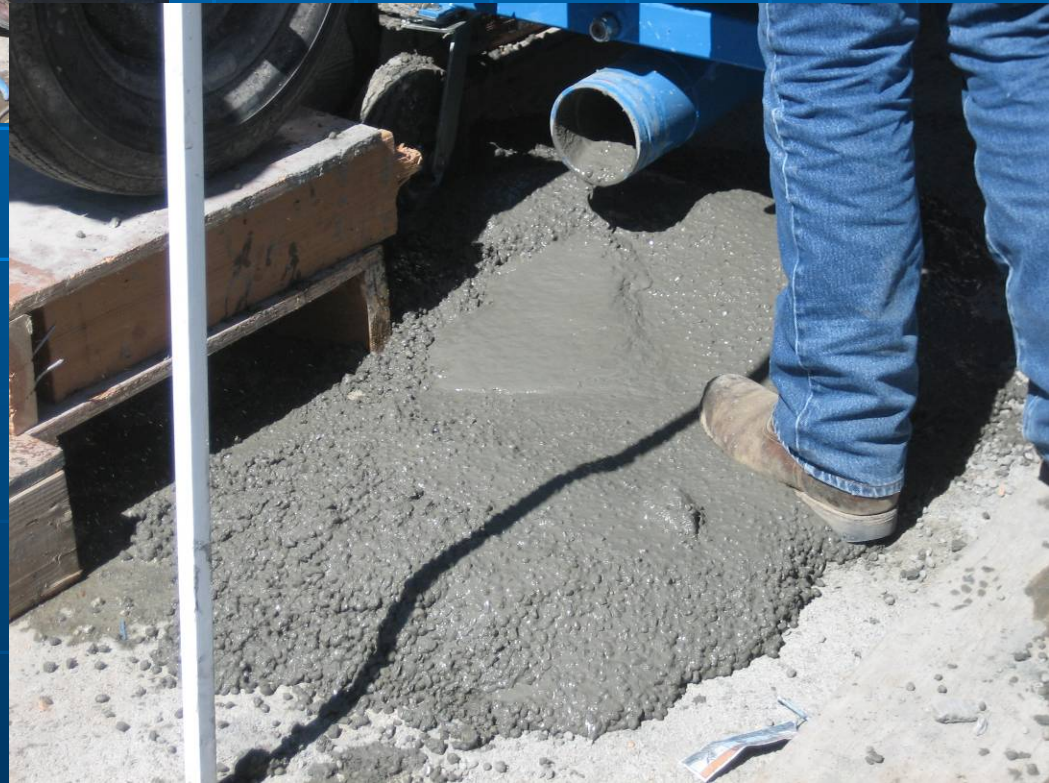
**Faced a few challenges with leakages  
and bulging forms**
