# Façade Restoration on Historic Hyatt Hotel

By Richard Reese and  
Chris Clausen

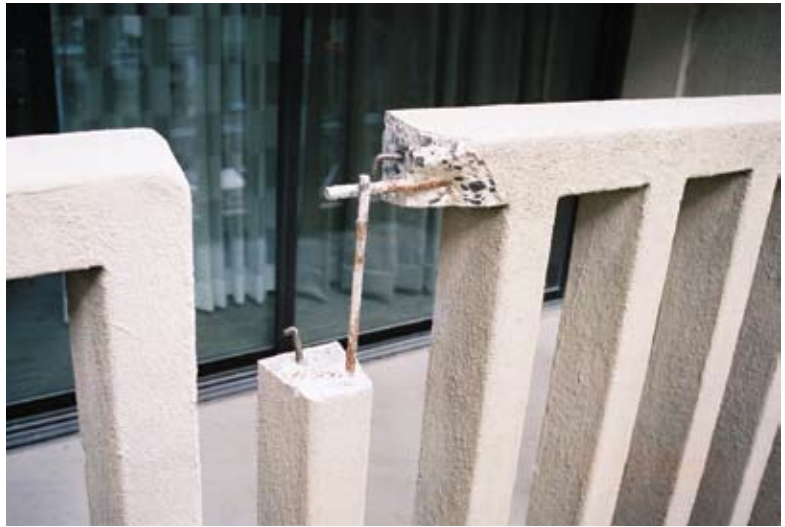
*Balcony railing being prepped for repair*

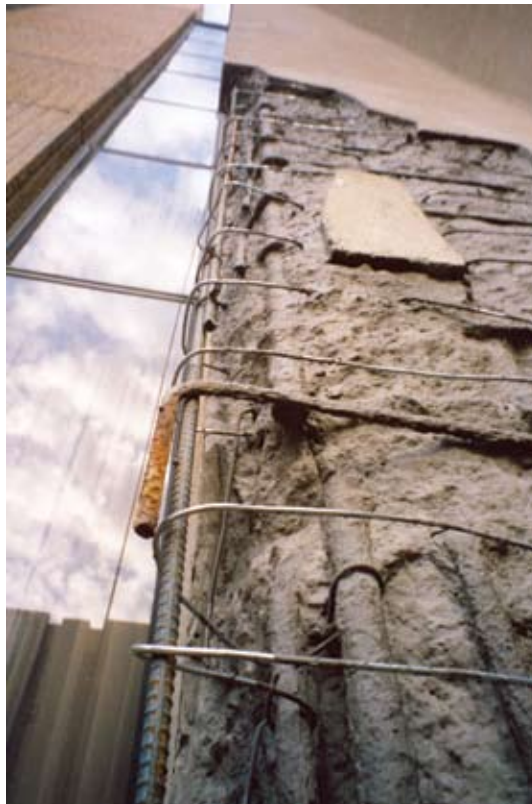
*Chipped-out repair area*

More than 3500 spalls were removed by chipping hammer to sound concrete. Saw cuts were used to square patch edges to a depth of 1/2 in. (1.3 cm). Near-surface reinforcing steel was removed at numerous locations, following consultation with the repair engineer. All vertical and overhead spalls were mechanically anchored by either heavy-gauge hanger wire staples set in epoxy or by removing concrete from behind existing reinforcing steel. The patch anchorage method originally specified and mocked up—5/16 in. (0.8 cm) stainless threaded rod bent into 90-degree hooks and set in epoxy—was abandoned because the 90-degree bend was significantly weakening the patch anchors at the point of the bend.

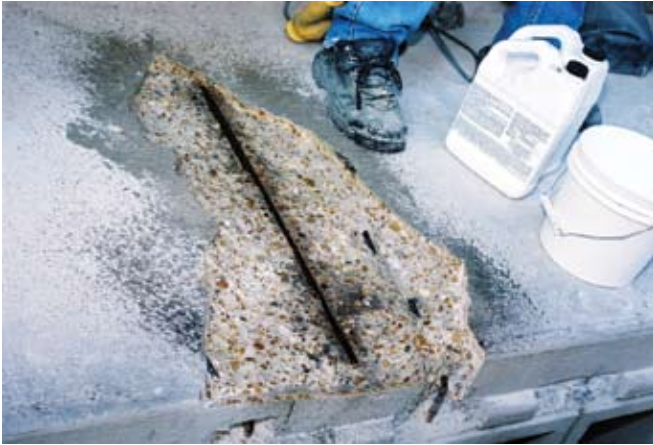
*Patch prior to repair*

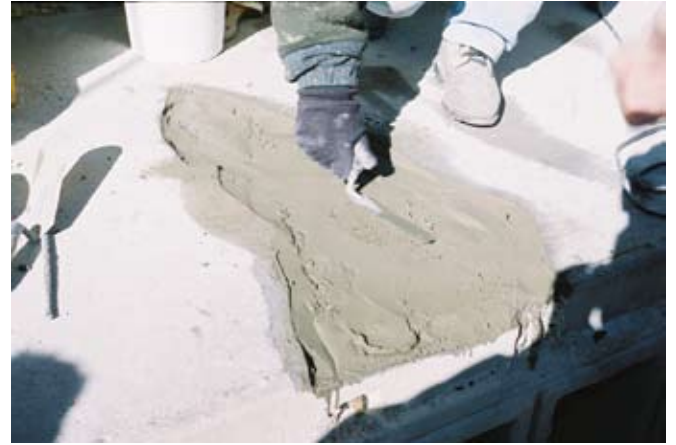
*Repair mortar being applied*

Patches were completed by application of a rust inhibitive coating to all surfaces, followed by the application of a pre-proportioned, polymer modified repair mortar suitable for unformed vertical and overhead work. New aggregate matching the existing was added to patches in the exposed aggregate areas. Patches varied in size from a few square inches to extremely large, with one location in a cast-in-place fin wall on the 18th floor that grew to 18 ft (5.5 m) high by 3 ft (0.9 m) wide by 2 1/2 in.

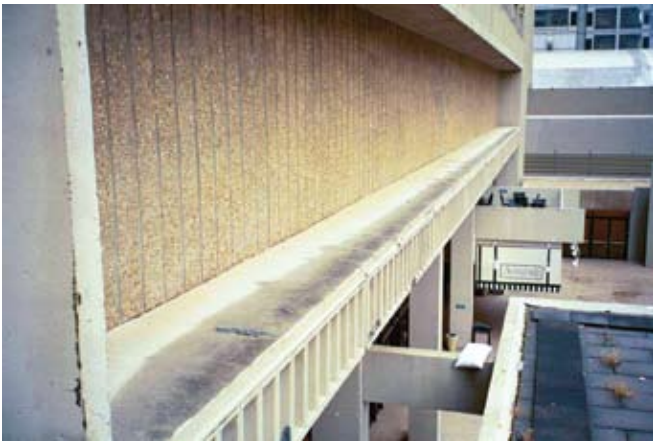
*Before repair*

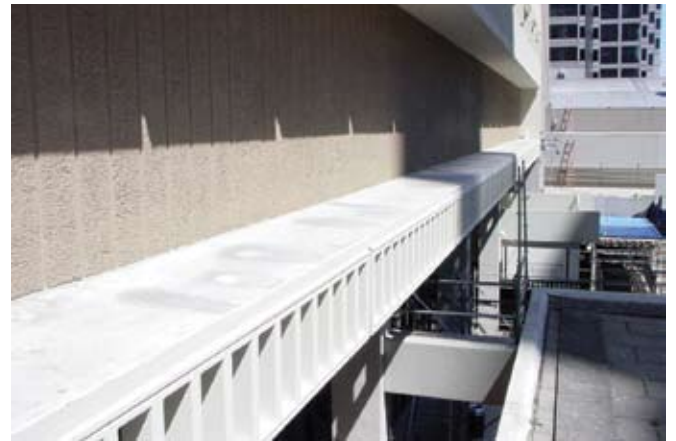
*After repair and coating*

After all the patches cured, the entire façade was pressure washed and two coats of a protective acrylic concrete coating were applied to all formed and smooth concrete surfaces. Approximately 8000 gal. (30,283 L) of coating was applied to roughly 350,000 ft<sup>2</sup> (32,516 m<sup>2</sup>) of exposed concrete surface.

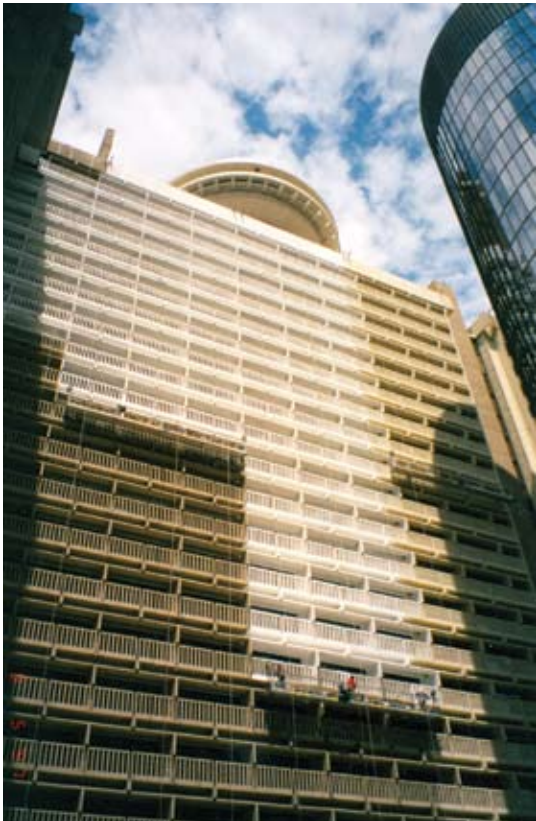
*Balconies being repaired*

By adapting tools and using selected two-man teams for all tasks, the contractor was able to patch and coat the narrow, false balconies on the International Tower by working entirely from the exterior, without removing the guest room sliding glass doors or access to the guest rooms. Sealant-formed drips were added to the underside edge of the balcony slabs at the balcony drainage spaces between the railings to keep the undersides of the balcony slabs dry. Also, approximately 1200 gal. (4542 L) of urethane-based pedestrian deck coating was applied to all balcony floors.
