MASONRY FAÇADE ANCHORAGE FAILURES

THE NEED FOR GREATER INVESTIGATION PRIOR TO REPAIR

BY BLAIR E. BATES

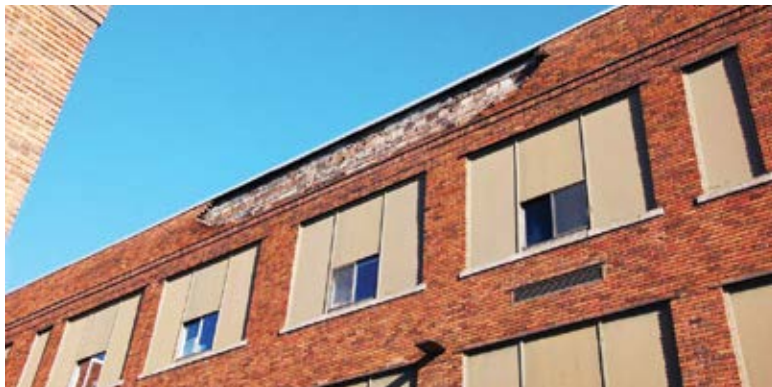
Fig. 1: Brick veneer failure at upper parapet wall of an elementary school, which occurred while school was in session

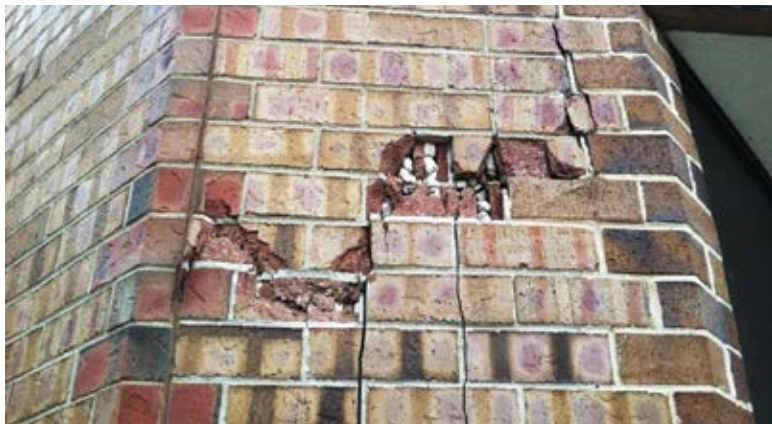
Moisture intrusion, negative—Many buildings have been found to have a negative vacuum at the interior of the building. This is common due to an imbalance in mechanical systems. The building shown in Fig. 2 has a severe negative vacuum at the interior. Thus, moisture is being pulled through building weeps and other void spaces within the veneer,

Fig. 2: Above this vertical shear in the brick masonry, 200 ft (61 m) of jumbo brick wall moved both vertically and horizontally, requiring immediate shoring and investigation for permanent repairs

which has resulted in deterioration. The deterioration is a result of freezing-and-thawing where water has been trapped within the veneer.

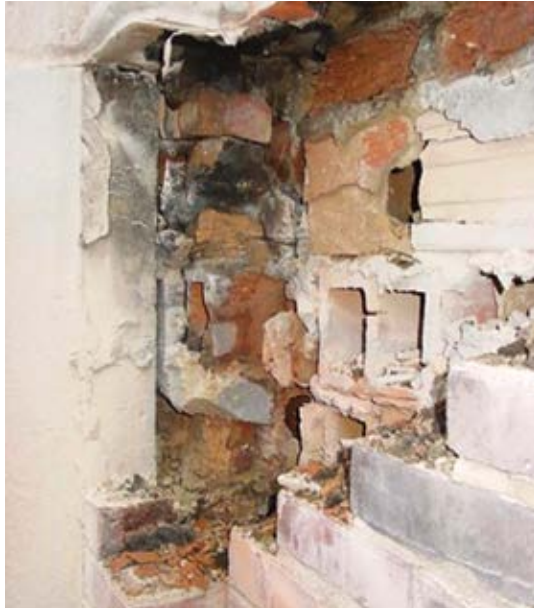
Fig. 3: Materials of different behavioral properties, including cast stone, clay brick, sand lime brick, terra-cotta tile, and polyurethane joint sealants. Previous leakage through joint sealants has caused deterioration of the brick

Joint sealant maintenance—While masonry-clad buildings give the impression of permanence (brick and mortar), the Achilles heel is the sealants at expansion joints or around openings. Until recently, these sealants have typically been urethane with a typical life expectancy of 5 to 7 years. A predictable maintenance schedule is rarely followed after initial construction is complete. Therefore, once the joint sealant deteriorates, water can leak behind the veneer for years prior to corrective action being taken (refer to Fig. 3).

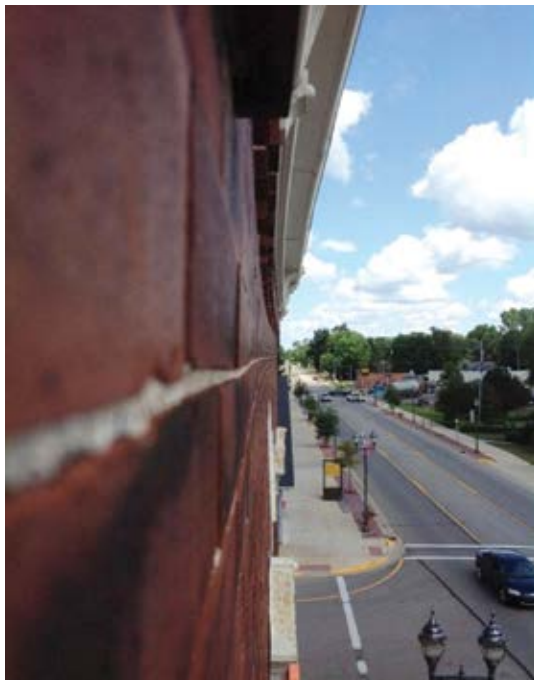
Fig. 4: A 1.5 ft (0.5 m) inner bow not visible from the sidewalk

Checking the vertical and horizontal planes for straightness can give a good indication of stress action on the façade (refer to Fig. 4). If the wall has begun to bow, then the veneer is moving and the anchors are giving way in either the veneer or the substrate.

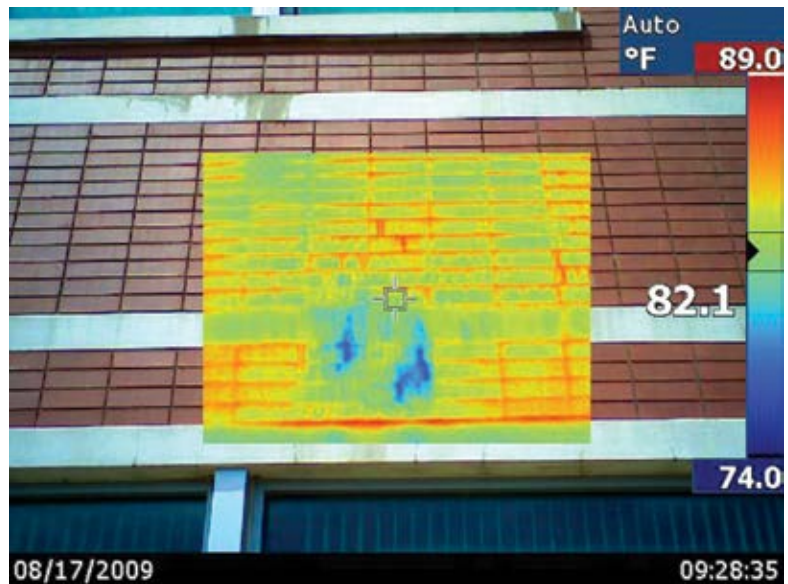
Fig. 5: The dark blue images show water on the surface, while the green areas show moisture behind the brick

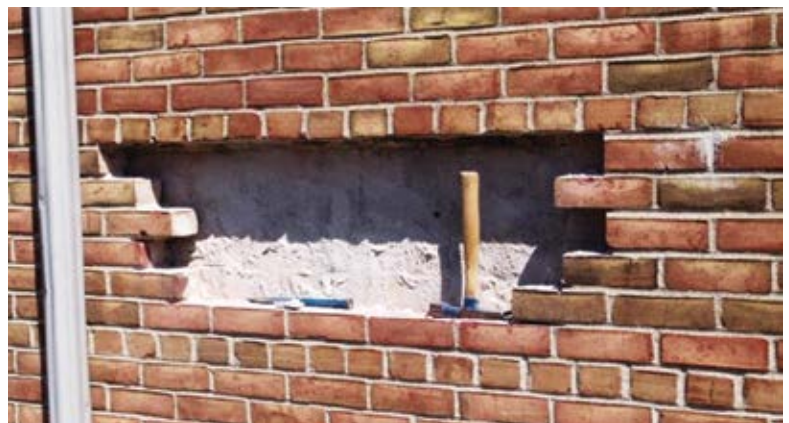
Fig. 6: Destructive removals of the veneer system found that the backup structural block system was parge-coated during construction for waterproof integrity. The tie brick was actually inserted into the block wall system

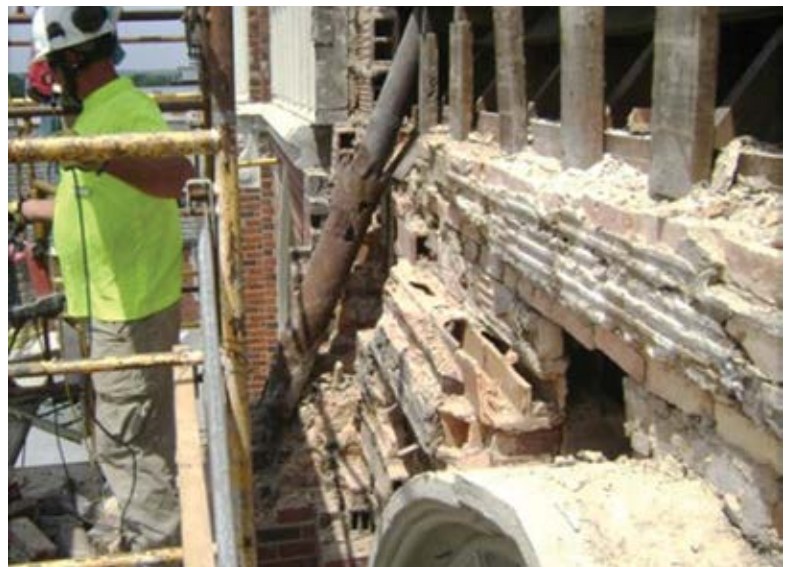
- Mortar and veneer removal—Selective mortar removal allows for visual assessment of the mortar condition and consistency. The mortar on the exterior may visually appear to be good, but if the sample is repointing mortar, the remaining original mortar may not be up to par. If the existing mortar is to be relied on for a tension-holding device (helical anchor), it should be tested for its capacity. Most mortars that are pure lime have low to zero tensile capacity. Figure 6 shows the identification of the backup structural system following brick veneer removal. Figure 7 shows a variety of load-bearing materials used for a 1920 building construction.

Fig. 7: 1920 construction consisted of a variety of load-bearing materials including cast stone, hard- and low-fired brick, terra-cotta tile, steel, hard dense pointing mortar, and lime sand mortar

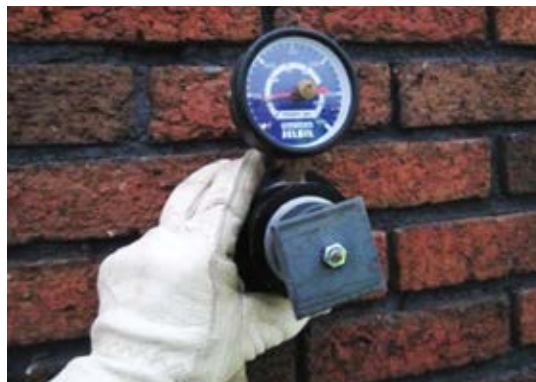
Fig. 8: Anchorage testing—two tests should be performed: one on the backup material and another on the brick or mortar at the exterior veneer surface. Without these two independent tests, verification of the veneer holding system is inadequate

Mockup testing—Once a method has been determined for a repair, it should be tested in place to determine if the prescribed solution is capable of meeting the requirements of the design. This testing should be performed on both the backup material and the new anchorage device to verify that each element is capable of obtaining the desired strength. Figure 8 shows a pull test being performed on a 1/4 in. (6 mm) stainless steel anchor rod inserted into modified cement, mortar grouted.
