LeJeune Road Flyover

By Clyde Ellis

Problems that Prompted Repair

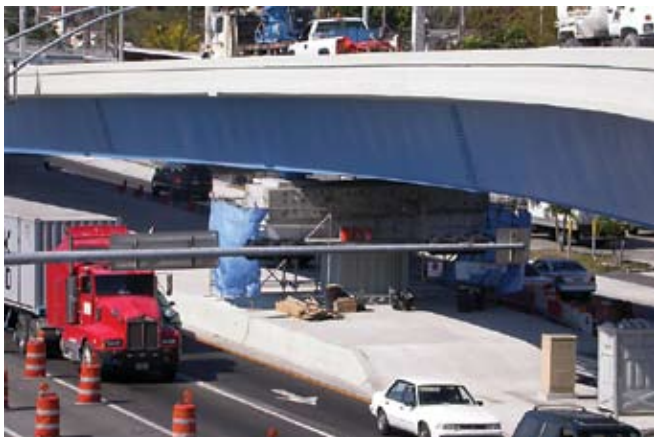
Fig. 1: Looking at Pier Three from scaffolding at Pier Two

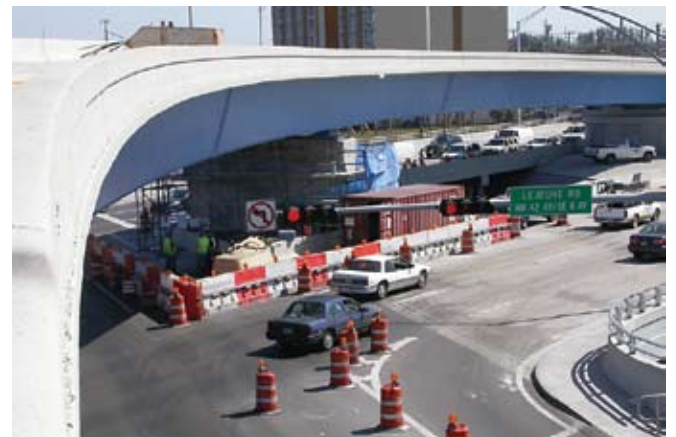
Only minimal repairs were necessary for Pier Three, which had cracks at the pier cap. In the middle of the T-shape, hammerhead pier cap, the same V-shaped crack pattern was discovered. As such, the pier cap needed strengthening horizontally (Fig. 2).

Fig. 2: Enlarged horizontal pier cap section at Pier Three

because of the cold joint between the new concrete and existing concrete. FDOT felt this option would have reduced the service life of the structure. Further, excavating at Pier Two would have dramatically added to the time needed to complete the repairs and would have significantly increased the cost. As such, all parties decided that if the post-tensioning tendons could be encased in and protected by the existing concrete, then it would be the optimal solution. It was decided that placing the tendons into drilled vertical holes would provide the necessary protection (Fig. 2).

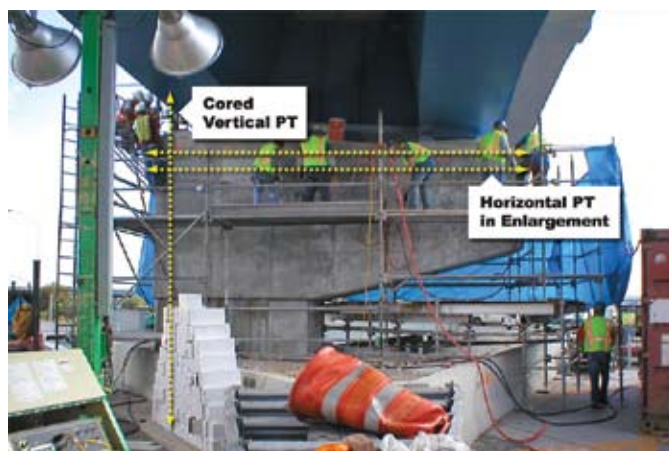
Fig. 3: Access via scaffolding and work platforms meeting OSHA standards

Because the site required working 20 ft (6 m) above the ground, scaffolding was erected at both piers. The repair solution also necessitated special access for core drilling equipment. As such, a 4 x 6 ft (1.2 x 1.8 m) work platform was created specifically for the core drilling machinery. Further, because Pier Two was over a canal, the repair contractor had to have a special platform for the scaffolding to set on as it bridged the canal below. This scaffolding was tested to ensure that it was properly designed for construction loads. To provide minimal impact to the existing landscape, protective tarps were installed around the work area so construction debris resulting from the concrete chipping process would not fall into the canal or onto surrounding traffic (Fig. 3).

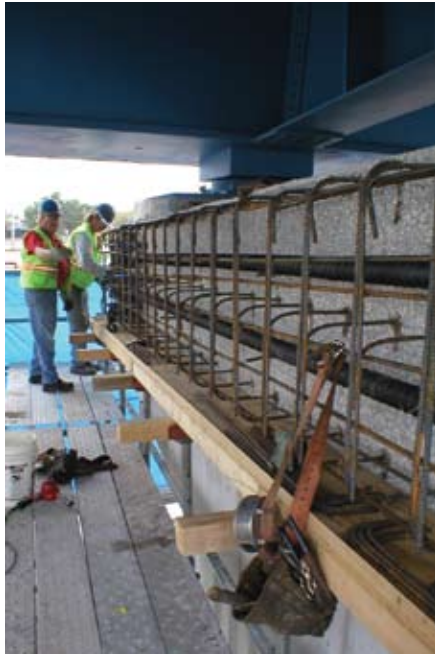
Fig. 4: Installing reinforcing steel cage and bursting steel around post-tensioned tendons on Pier Three

use of 15 lb pneumatic chipping guns to help achieve the desired 1/4 in. (0.63 cm) profile. This aggressive profile allowed for a good mechanical bond between the old and new concrete (Fig. 4).

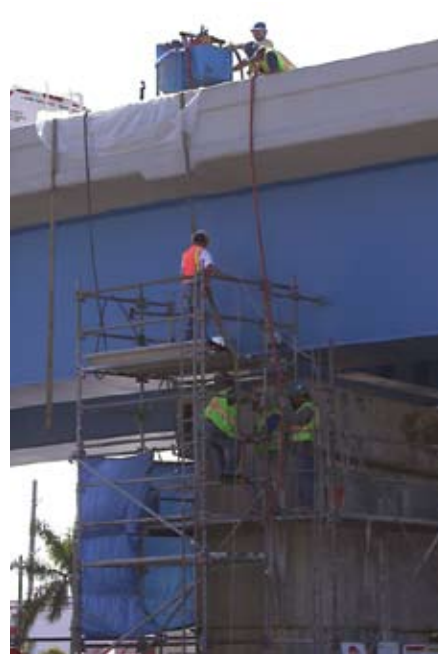
Fig. 6: Grouting post-tensioned tendons from colloidal mixing operation staged on top of bridge

duct sheathing for enhanced corrosion protection. Around the post-tensioning anchorage blockouts, an elastomeric coating was applied to ensure there was no penetration of water (Fig. 6).

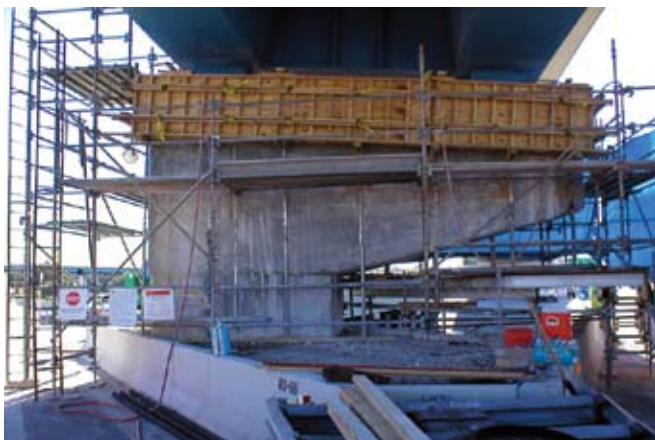
Fig. 5: Pier Two formwork for enlarged concrete pier cap section

To open the pores of the concrete, the structure was then water-blasted. This ensured that the pores of the old concrete were open and ready to receive the new concrete. Maximum compatibility was created by using the same concrete mixture proportions that was used in the original construction of the bridge piers (Fig. 5).

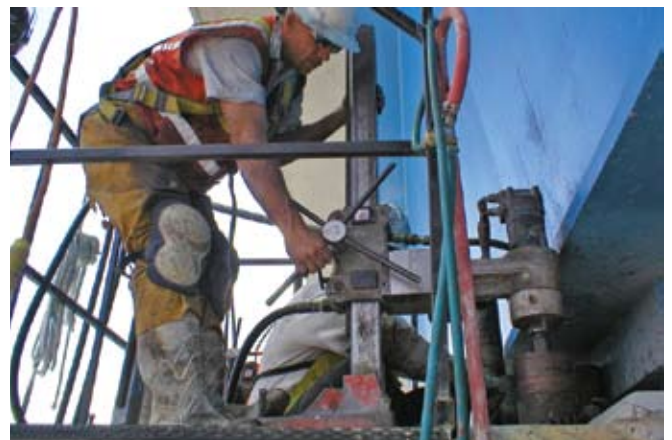
Fig. 7: Coring operation for vertical post-tensioning at Pier Two

The repair team opted to core two holes, 5.5 in. (14.0 cm) in diameter and 40 ft (12.2 m) in depth, into the top of the pier cap, stopping only a few inches from the bottom of the footing. The core was extracted in 12 in. (30.5 cm) depths until the maximum depth was reached (Fig. 7). Made of high-strength prestressing steel, the post-tensioning tendon was lowered into the hole and grouted in two stages. The first grout stage was at 15 ft (4.6 m) from the bottom of the cored hole and created a “bond zone” for the anchorage (Fig. 8). The hydraulic jack stressing operation was then performed at the top of the hole and the second stage of grout was pumped into the remainder of the hole (Fig. 9). This stage created corrosion protection by enveloping the strands in a layer of cementitious grout.

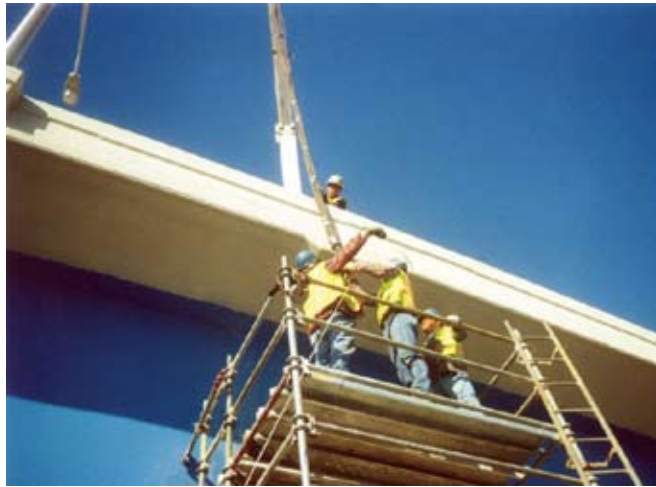
Fig. 8: Using crane to lower the post-tensioned assembly into the core hole

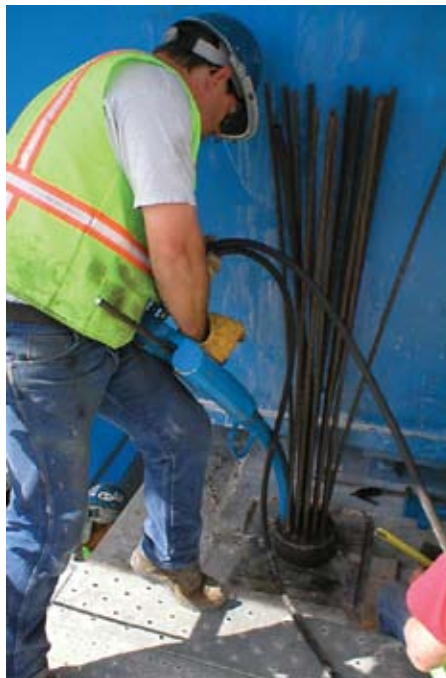
Fig. 9: Positioning of jack prior to stressing of post-tensioning tendon

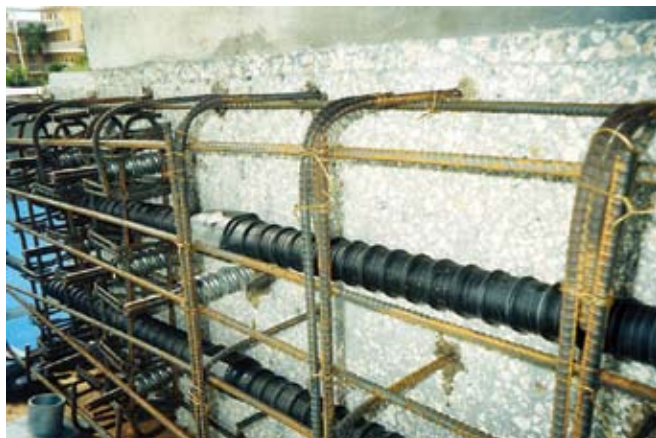
Fig. 10: Bursting steel around spin-lock anchors, two horizontal post-tensioned tendons, reinforcing steel dowels, and reinforcing steel cage

The repair of the “V”-shaped cracks at the pier cap and column connection on both Piers Two and Three required casting an enlarged section of concrete on both sides of the pier cap. High-strength, horizontal post-tensioned bars were cast in the concrete section. Reinforcing bar dowels were used to connect the new concrete to the old concrete. The post-tensioned bars were then stressed using a hydraulic jack to compress the old section. The compressive force was then transferred from the new concrete to the old concrete through the reinforcing bar dowel bars and high-strength spin-lock anchors causing the pier cap to squeeze together and reduce the crack widths (Fig. 10).
