Breathing New Life into a Post-Tensioned Parking Structure

By David A. VanOcker, PE

University of Pennsylvania Parking Structure

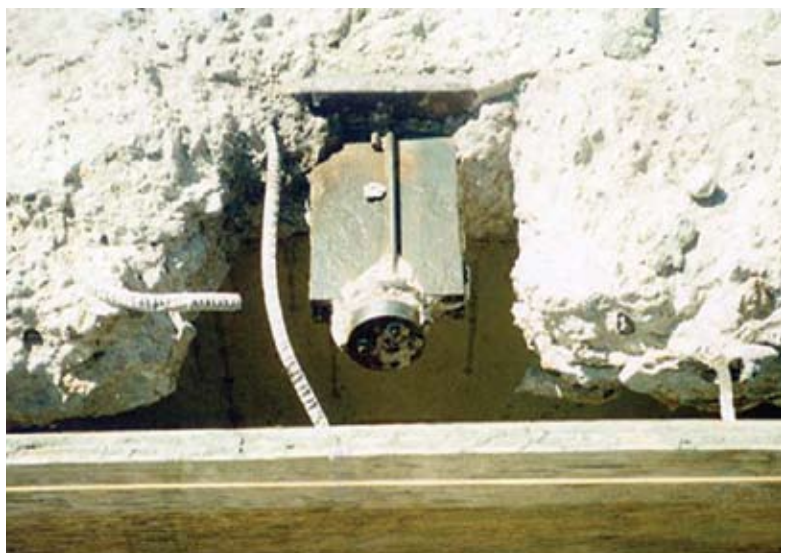
Preliminary probes done on the roof level during the 1996 EJ seal replacement work revealed an extensive amount of corrosion in the P/T anchors. While only a single noticeable tendon anchor rupture had occurred, individual wires were found to have failed in many instances, as evidenced by a differential shortening of certain

wires (Fig. 3). The initial visual examinations of tendon anchors were not completely conclusive, given that many of the wires couldn't be directly inspected. The initial assessment relied heavily on judging the visible concrete deterioration in the anchor regions on a comparative basis, using what was observed at the roof level, and extrapolating this information to visible concrete conditions on lower floor levels. While this method potentially had a wide margin of error, sufficient concerns over the structural integrity of the P/T deck slabs were warranted.

Fig. 4: View of exposed button-headed tendon anchor. Note failed wire on top side of spacer/shim plates

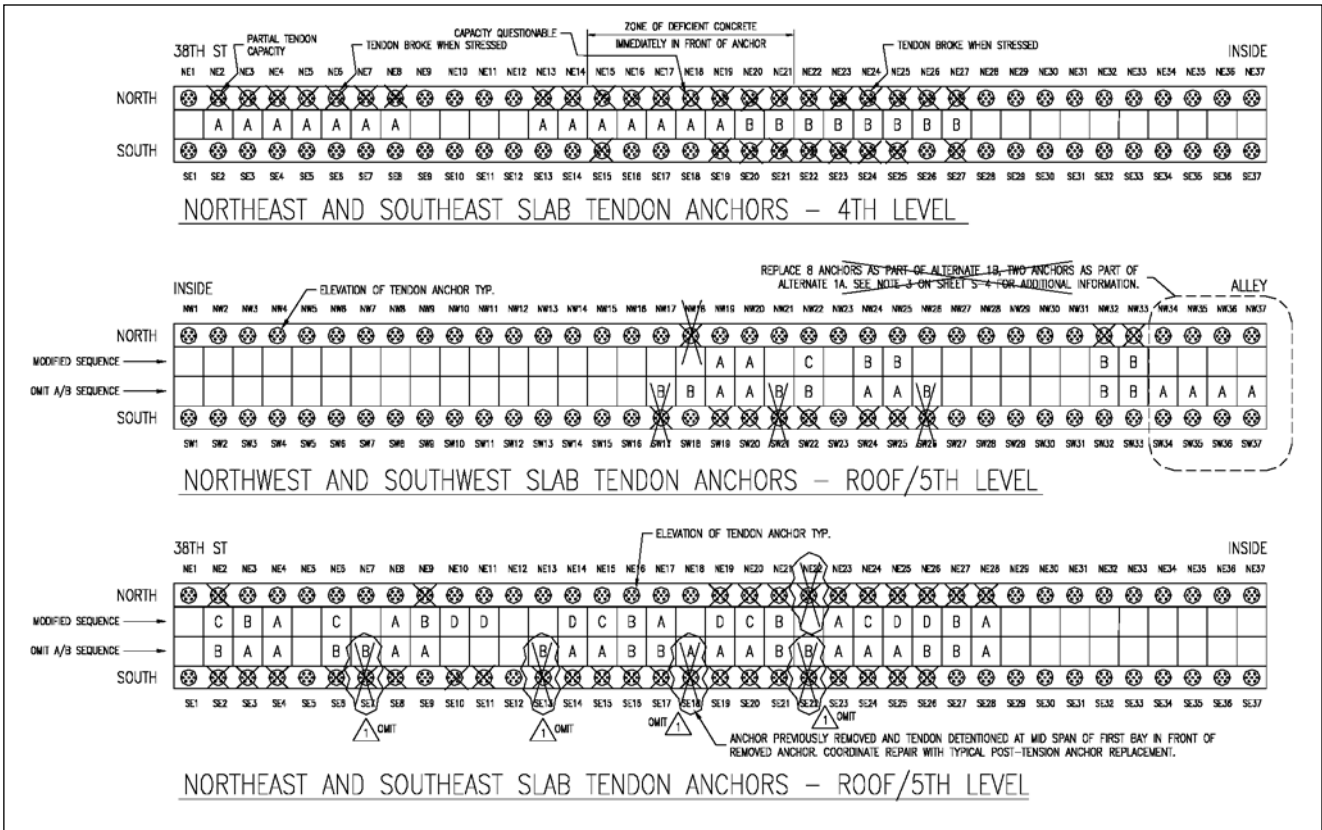
Fig. 5: Typical tendon sequencing diagram. Note that 4th floor had fewer sequences, but higher number of tendons per sequence; 5th floor sequence was modified after anchor inspection

Bid documents established an exact number and location of tendons to be replaced along with a recommended sequence (Fig. 5). Repairs began with careful removal of the concrete encasing the anchors. Physical inspection of the button-headed tendon anchors then confirmed the final number and sequence of replacement. Shoring was installed at the same time that anchor inspection was occurring, to permit the initial round of anchor replacement to occur within 2 weeks of starting on-site work. A 5- to 7-day cycle was established for each sequence, beginning with tendon cutting, then completion of concrete excavation inboard of the EJ line, where splicing and stressing would occur. Concrete placement occurred in two stages, with the initial placement encasing the new anchors. Fast-setting mixtures were used so that the tendons could be restressed in 2 to 3 days.

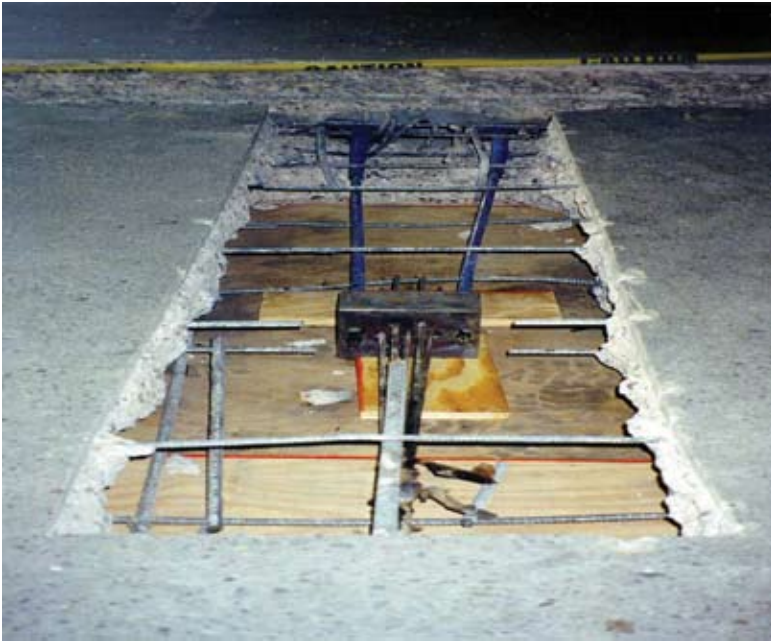
Fig. 6: Typical splice arrangement between single button-headed tendon and two monostrand tendons. Photo depicts arrangement at non-stressing end

The technology used by the successful contractor involved a unique splice block that employed wedges to anchor the button-headed tendon wires individually, while also accommodating two single strand anchors with standard wedges (Fig. 6 and 7). This arrangement proved very successful, despite the number of small wedges that needed to be set very carefully. In only one case did tendon slippage occur during restressing, requiring excavation, disassembly, and resetting of the splice assembly.

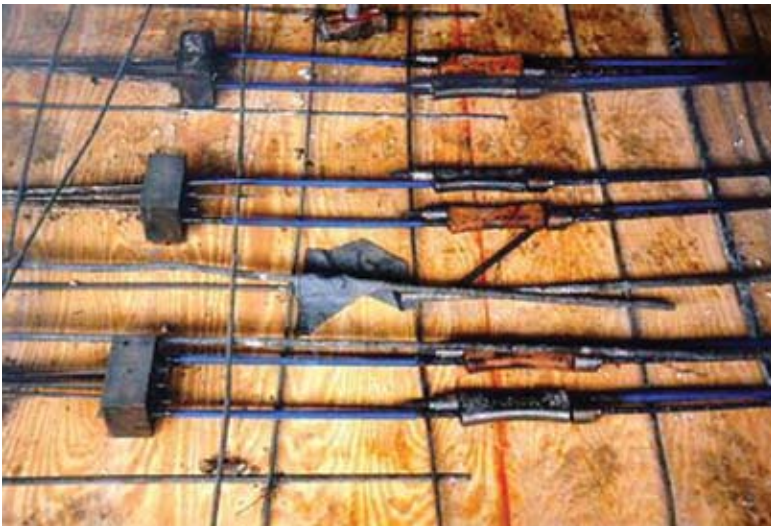
Fig. 7: Tendon splice arrangement with multiple adjacent tendons. Note splice transition block between single B/H tendon and two monostrand tendons, as well as dogbone stressing anchors
