Manhattan Repair Project Proves Challenging

by Gerald Valente

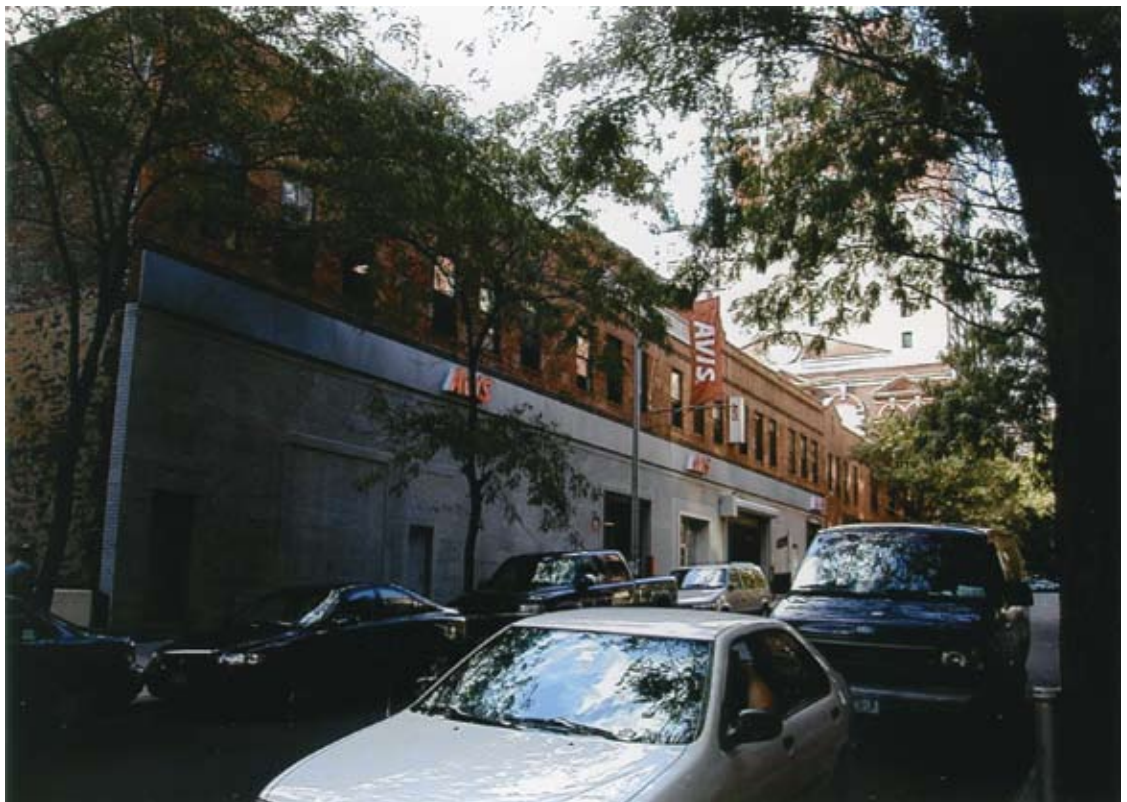
The second floor concrete slab was originally cast level, with no drainage, and was of a low-strength psi cinder-type concrete, 6 in. (150 mm) thick. The slab concrete tested at 700 to 800 psi (4.8 to 5.5 MPa) compressive strength and, over decades, had been built up with several layers of similar material 12 to 13 in. (30 to 33 cm) thick. The slab design was with a “draped mesh” that depended heavily on the steel reinforcement and concrete encasement, and not the cinder concrete. This design consisted of a heavy wire mesh placed

A protective membrane or structural design for vehicle traffic was not considered in the era the structure was built. After many years of vehicle use, the second floor slab began to deteriorate. The deterioration was hidden by the many levels of toppings and concrete encasements; it went unnoticed for years until delaminated concrete began falling from the ceiling to the level below. The owner immediately commissioned an engineering assessment. A survey was performed on the underside of the slab and probes were cut into the top slab and encasement. The assessment discovered heavily corroded slab reinforcement and steel beam flange and web corrosion. The girders and columns were found to be in relatively good condition.
