# Evaluation of Runway Distress and Repair Strategy at Hobby Airport, Houston, Texas

By Shondeep L. Sarkar, Dallas N. Little, Adil Godiwalla, and Gary G. Harvey

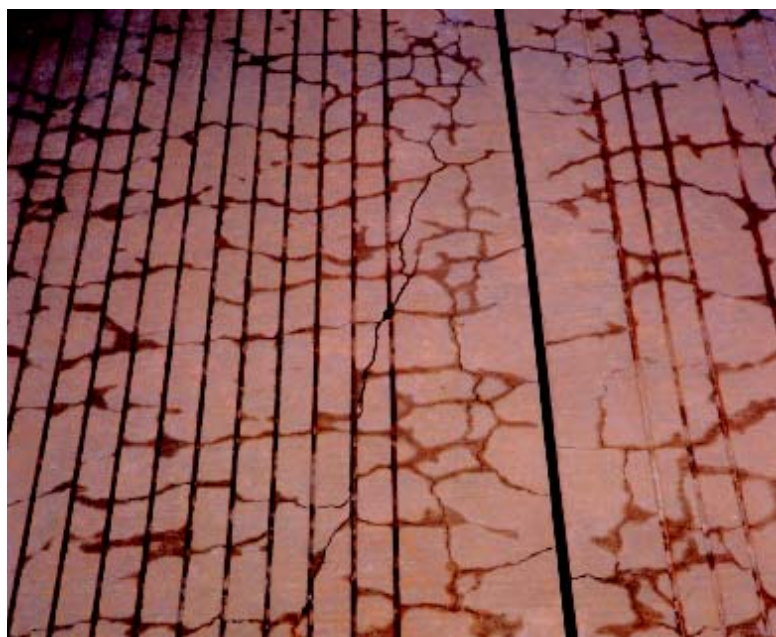
Fig. 1: Profuse map cracking on the concrete surface of Runway 4-22

Figure 1 illustrates the map cracking that had developed on the concrete surface of Runway 4-22. The asphalt distortion at the intersection on Runway 12R-30L is shown in Figure 2, and Figure 3 illustrates one of the affected light bases in the runway in which the Touchdown Zone Light circuit cable had severed.

From microstructural analysis, DEF was diagnosed as the primary cause of the distress in the intersection pavements. The high cement content used to achieve high early strength in concrete is likely to have generated excess heat, which is considered an essential condition for DEF. The most plausible source of the other prerequisites (sulfate and aluminum ions) for DEF to occur is the cement. As a Type III cement was used, its  $C_3A$  content could be expected to be much higher than in a Type I cement. The high heat caused thermal cracks to appear in the concrete earlier and more densely than usual, then these cracks increased both in frequency and dimensions as DEF progressed. Finally, as the concrete surface is horizontal, penetration of water through the microcracks occurred with relative ease. The net result was expansion of

The first recommendation made for repair is to seal the fine cracks that exist in the surface of the intersection, using a low-viscosity polymer grout injection. These materials are capable of flowing/seeping into the tortuous cracks and effectively sealing them as they form a solid matrix after injection. The most effective way to protect the slab from significant further damage is to prevent the ingress of water, especially through the surficial cracks.

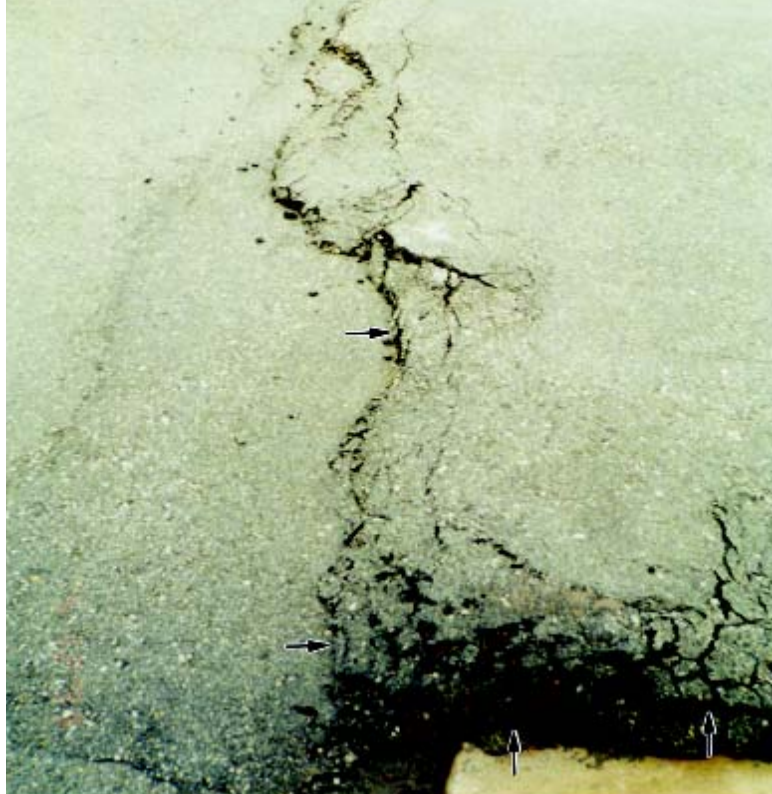
sides of the intersection of Runway 12R-30L at the joint between the concrete in the intersection and the asphalt pavement on the remainder of the runway, there was severe cracking and heaving of the asphalt comprising the shoulders in all four “corners” of the intersection, and significant spalling had occurred at the joint between the intersection concrete and the CRCP of Runway 4-22.

Fig. 2: Asphalt distortion at Runway 12R-30L

Additionally, a joint repair scheme that provides new expansion joints on each side of the concrete intersection between the asphalt pavement and the intersection concrete pavement has been recommended. These joints provide for an additional 12 cm (5 inches) of expansion, which is anticipated to be adequate for the remaining 15 years of the present design life. Also recommended is the installation of a set of full-depth (of the “new concrete”) expansion joints on Runway 4-22 on each side of the intersection at the joint with the existing continuously reinforced concrete pavement. It has been further proposed that the added expansion joint capacity should be 10 to 12 cm (4.5 to 5 inches), and should be sawn when the air temperature is approximately 70° F.

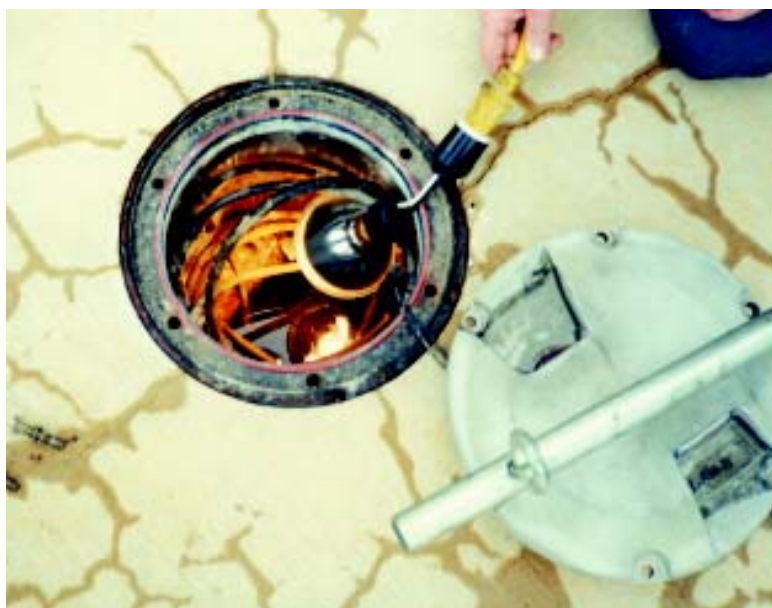
Fig. 3: An affected light base in the runway in which the Touchdown Zone Light circuit cable had severed

Out of the three options initially proposed for the light base repair, only recoring of the distressed base holes to a depth of the 42 cm (17-inch) pavement has been recommended. The 15 cm (6-inch) thick concrete pavement that pre-existed the 42 cm (17-inch) overlay will not be penetrated in this option. This option is recommended because additional differential movement between the two concrete slabs may occur, and the light base can move with the surface layer without damage due to that movement. A bond breaker should be placed between the bottom of each light base and the pre-existing 15 cm (6-inch) concrete slab at a depth of approximately 42 cm (17 inches). This bond breaker should consist of a 1.25 cm (½-inch) layer of a mixture of AC-5 grade asphalt cement and TxDOT Grade 4 aggregate.

Coring out the damaged light bases to the depth necessary to install a new "medium-depth" standard light base in the same surface locations has been recommended. In no case should the coring penetrate the "old" concrete which pre-existed the "new" concrete [that is, maximum depth of approximately 42 cm (17 inches)]. This option is anticipated to eliminate problems associated with differential movement between the "old" and "new" slabs.

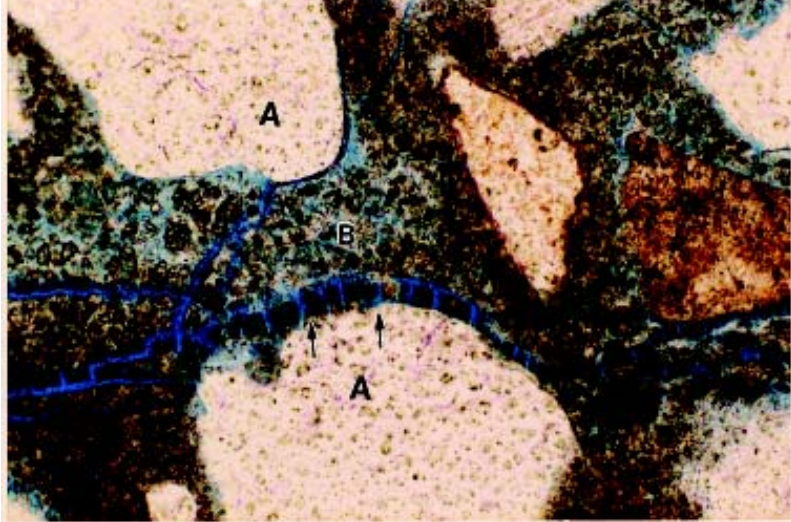
Figure 4 is an optical micrograph of the damaged concrete showing a multitude of microcracks in the paste. Furthermore, these microcracks are filled with a foreign mineral. Though microcracking of concrete is a rule rather than an exception, the frequency and width of microcracks, in this particular instance, were exceptionally high and suggest damage due to some secondary chemical reaction that must have occurred later in the service life of the concrete than its curing period. A significant amount of this foreign mineral is also present at the paste-aggregate interface, normally occupied by hydrated lime or  $\text{Ca}(\text{OH})_2$ . Figure 5 is a scanning electron micrograph illustrating profusion of needle-like crystal growth around an aggregate particle. Its EDX spectrum (Figure 6) typically displays a peak ratio of  $\text{Ca}:\text{S}:\text{Al} = 3:2:1$ , confirming the foreign mineral to be ettringite.

Fig. 4: An optical micrograph of the damaged concrete showing a multitude of microcracks filled with a foreign mineral in the paste

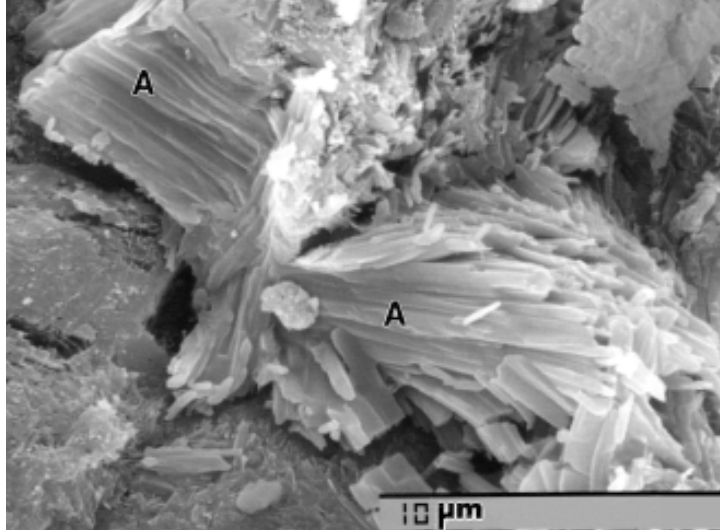
Fig. 5: A scanning electron micrograph illustrating profusion of needle-like crystal growth around an aggregate particle

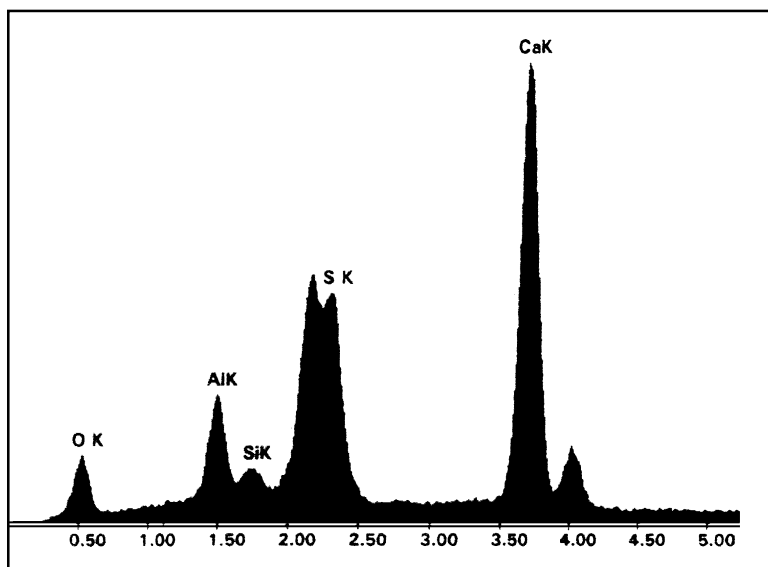
Fig. 6: Its EDX spectrum consisting mainly of Ca, Al, and S peaks confirms the foreign mineral to be ettringite
