Evaluation and Repair of a Liquid Sulphur Holding Tank

By Nick Trovato, MEng, PEng

The following case study presents the results of Read Jones Christoffersen Ltd.'s evaluations and repairs of a particular sulphur tank located in a gas plant in central Alberta. The tank was constructed in 1978 and we have been monitoring the condition of the structure since 1993. We undertook repairs in 1993 and are presenting our findings with respect to the ongoing deterioration of the structure and the performance of the repairs.

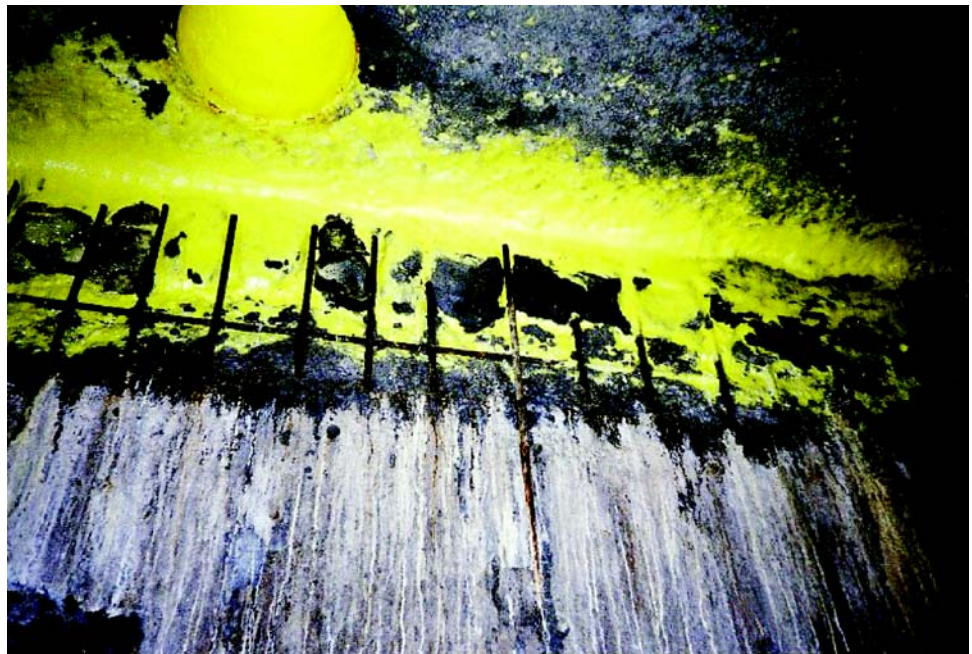
An internal inspection of the tank uncovered considerable corrosion and concrete spalling of the upper portions of the wall and areas on the underside of the roof slab (Fig. 1). This corresponded with the region within the vapor space, where sulphur vapors and moisture combine to form a highly acidic environment. Approximately 10% of the roof slab and 40% of the wall surfaces had signs of deterioration. The shotcrete repairs performed in 1990 had totally failed. The condition of the exposed reinforcing bars was variable. In some areas, the reinforcing bars were corroded through the entire cross section, while in other areas, the exposed reinforcing bars were in excellent condition, with no loss of cross section.

Selective removal of the concrete around the protected reinforcing bars determined that the concrete cover varied from 20 to 40 mm (0.8 to 1.6 in.) and that the bars were typically in good condition.

Figure 1: Exposed and corroded reinforcing steel in upper portion of wall

The 1993 repair program consisted of partial and total replacement of the concrete members where structural damage was noted. Areas of exposed aggregate were not repaired during this program, as the deterioration evident had not affected the load-carrying capacity of the structure.

In the partial repair areas, the concrete was removed beyond the inner layer of reinforcing steel and to a sound concrete substrate (Fig. 3). The existing, exposed steel was replaced with new steel where possible. The remaining reinforcing steel was sandblasted clean of any cement and corrosion product. The exposed concrete surfaces in the repair area were thoroughly cleaned of loose materials and contaminants to provide a suitable surface for bond with the new repair materials.

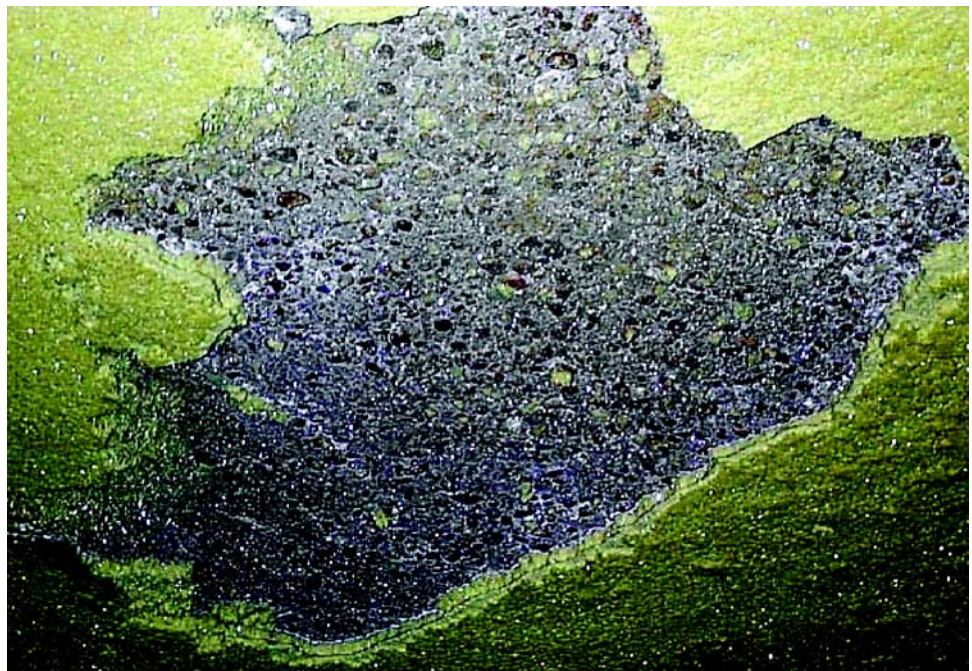
There was a loss of cement paste and exposed aggregate in the underside of the roof and portions of the wall (Fig. 2). This was relatively uniform and we did not observe any exposed reinforcing steel in these areas.

Figure 2: Exposed aggregate at underside of roof

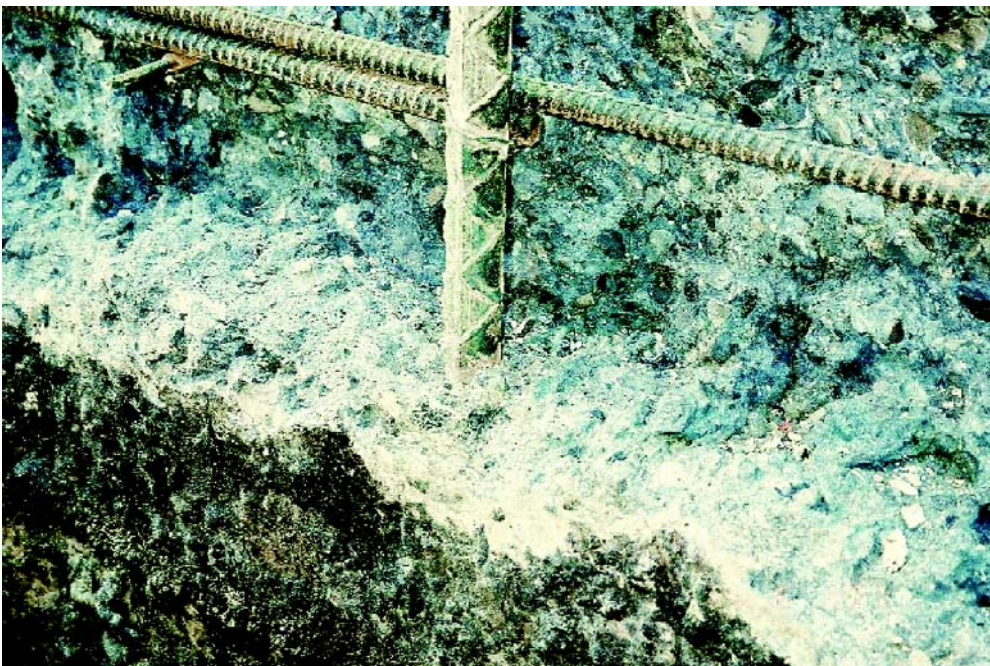
Figure 3: Patch preparation showing extent of concrete removal

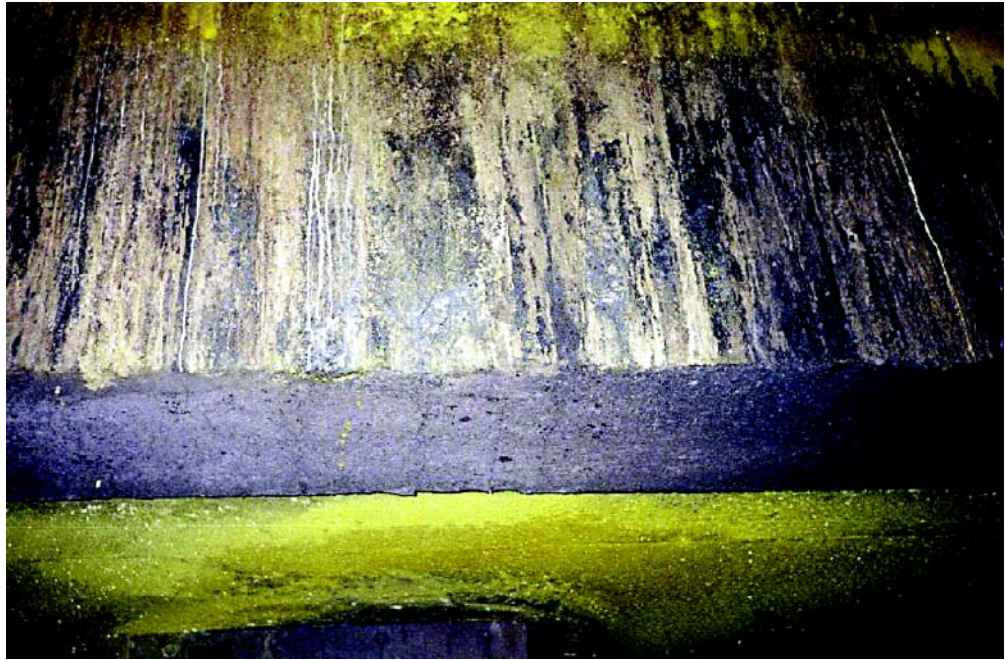
- In the repair areas, the concrete surface was in excellent condition with only localized areas where minimal loss of surface paste was observed (Fig. 4);

- Some fine cracks were noted in the repair areas. These appeared to be due to restrained shrinkage and thermal stress in the structure. The repair areas were sound and performing as intended;

Figure 4: Area of repair in excellent condition after seven years of service
