# REHABILITATION OF WET WELL AREAS OF THE PUMP STATIONS

BY HEMANT S. LIMAYE, ASHOK M. KAKADE, AND TOM KOURETAS

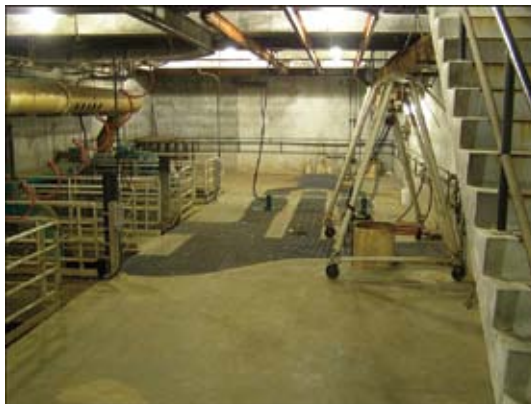
Figure 3 shows the overall view of the wet well area facing the north wall. At the time of the visit, the corroded sluice gate was removed from the influent channel. The top of the channel is covered with a grate. The north wall concrete above and near the gate area had eroded severely, exposing large aggregate. Figures 4 and 5 show a close-up view of the distressed concrete. At one of the stations, the same area showed severe concrete erosion with exposed, corroded reinforcing steel both in the wall and the slab. Assuming that there was a 2 in. (50 mm) concrete cover over the vertical reinforcing steel, total erosion of the concrete was at least 5 in. (127 mm) in the wall. The exposed reinforcing steel in the wall was not only corroded but also experienced significant section loss. Observations did not indicate significant cracks in the wall or the concrete slab.

Fig. 3: Overall view of the wet well area

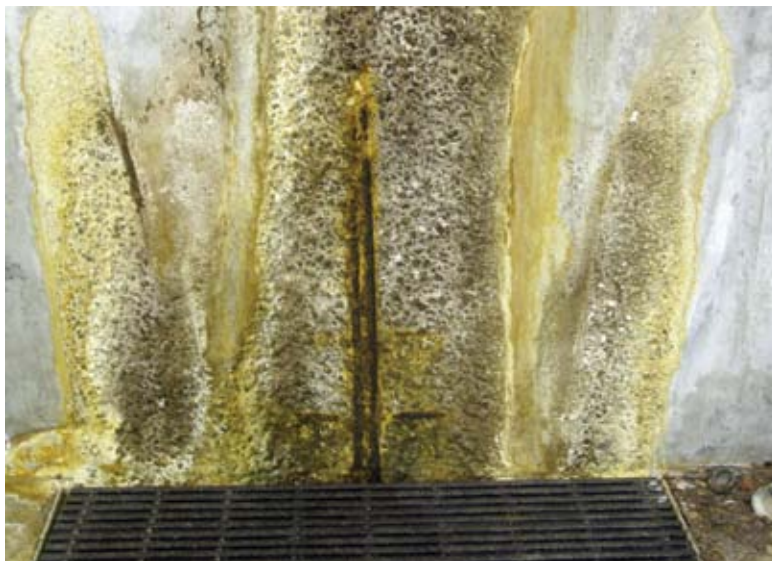
Fig. 4: Deteriorated area showing the exposed corroded steel above the wet well channel

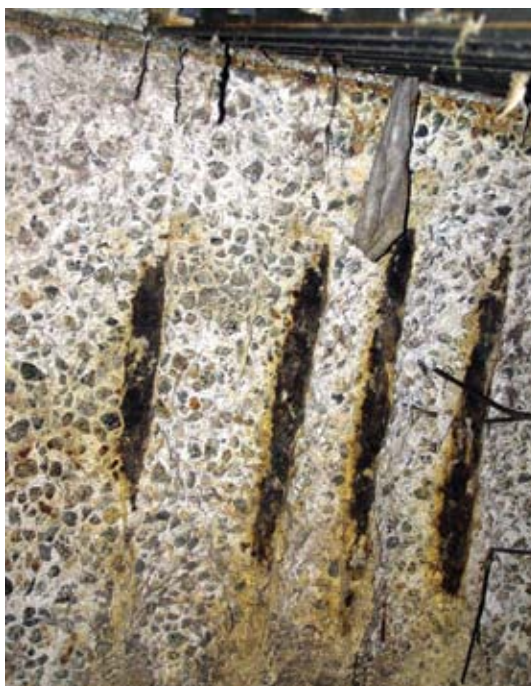
Fig. 5: Close-up view of concrete erosion and corroded reinforcing steel

Concrete at the influent pipe entry area near the wall and the vertical walls of the influent channel were severely deteriorated at both the pump stations. The concrete was eroded away mainly by the sulfuric acid generated by the hydrogen sulfide gas. The chemical attack would continue to degrade the concrete further until a remedial action was taken.

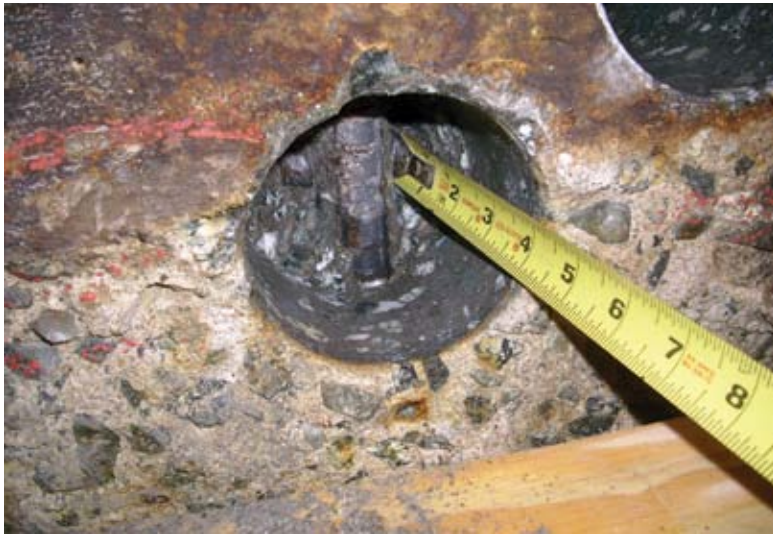
Reinforcing steel in the wall was located using an electronic detector. In areas of exposed steel, there was no need to use the electronic detector. Information obtained from locating the reinforcing steel was used to map out the core locations. Embedded steel was in good condition with an absence of corrosion stains. Average spacing in the wall was approximately 12 in. (305 mm) on-center in both directions. The vertical and horizontal bars were 3 and 4 in. (76 and 102 mm) from the surface, respectively.

Fig. 6: Partial-depth core showing interior reinforcing steel with minimal corrosion stains

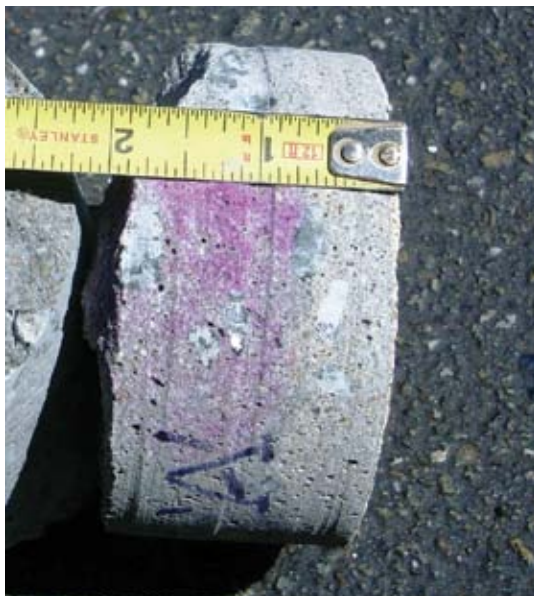
Fig. 7: Concrete carbonation depth of 0.75 in. (19 mm)

Carbonation is a reaction of the concrete with the carbon dioxide. Carbonation lowers the pH of the concrete, resulting in less protection in preventing the corrosion of the reinforcing steel. Carbonation depth on the concrete cores was measured using a phenolphthalein solution. The bright pink color indicates areas with no carbonation; no color indicates areas with carbonation. The depth of carbonation was found to be variable between 0.25 and 1 in. (6 and 25 mm) on the exterior portion of the cores (refer to Fig. 7).

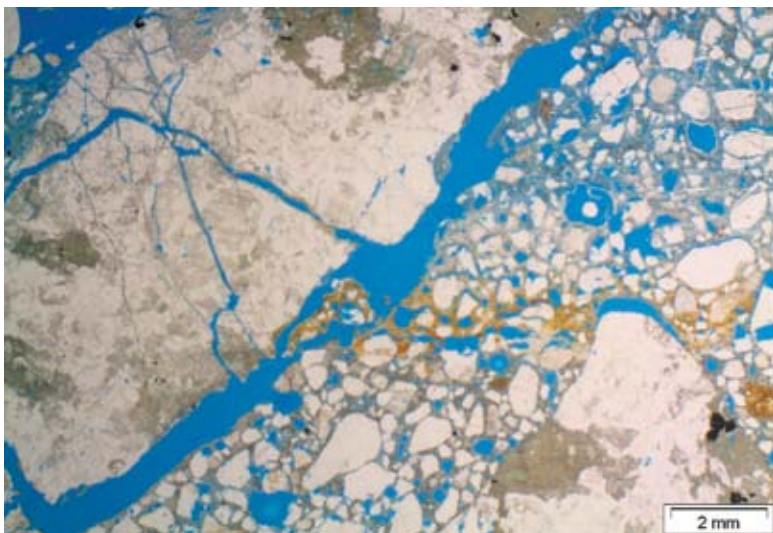
Fig. 8: Thin section of the deteriorated portion showing cracking and porous nature of concrete as indicated by the blue dye-mixed impregnated epoxy

The exterior surfaces of the cores showed light brown discoloration with severe alterations and decomposition and erosion. The broken ends (interior concrete) of the cores showed sound concrete. The paste was soft and severely altered in the deteriorated section (top 0.75 in. [19 mm]), but it was dense and hard in the sound concrete. The depth of carbonation had extended up to 2.25 in. (57 mm) from the surface. The cores from different pump stations showed similar severe deterioration of concrete due to chemical attack by the sulfuric acid generated by the hydrogen sulfide gas. The attack has resulted in softening of the concrete with increased porosity and microcracking (refer to Fig. 8). The chemical attack extended 0.75 in. (19 mm) deep from the exposed end, with a complete loss of calcium hydroxide component of the cement paste. The deteriorated portion of the concrete also showed severe microcracking. Figure 9(a) and (b) shows X-ray diffraction analysis graphs for the good and deteriorated portions of the concrete, respectively. Chemical reactions generated abundant deposits of secondary gypsum in the deteriorated portion.

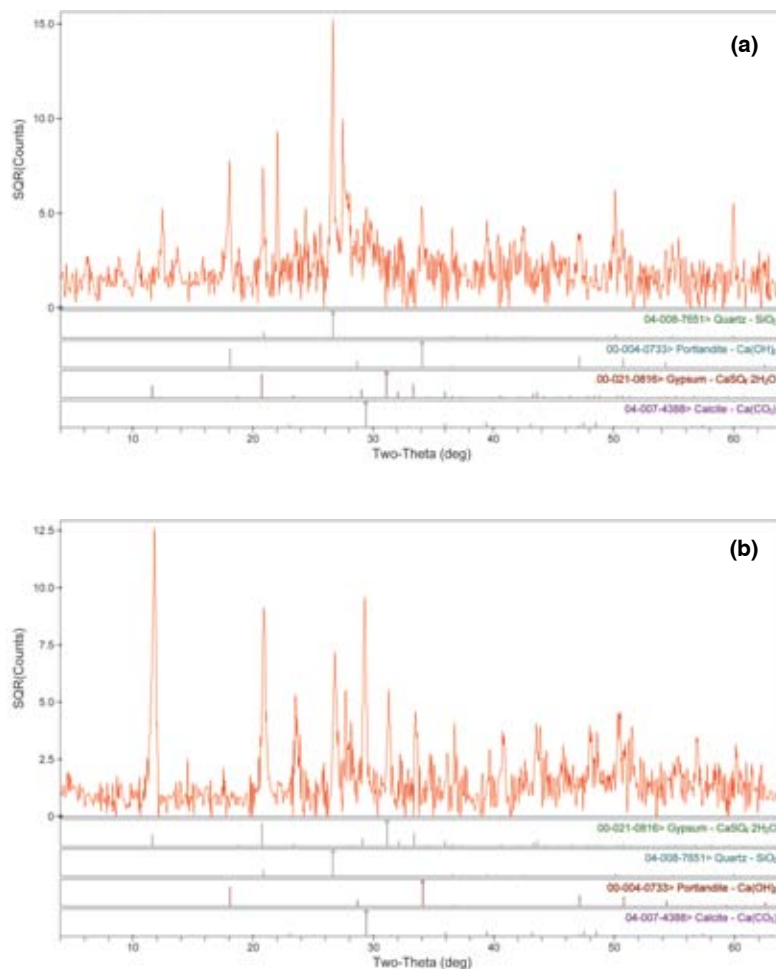
Fig. 9: (a) X-ray diffraction pattern of good portions of the concrete—absence of gypsum deposits; and (b) X-ray diffraction pattern of deteriorated portions of the concrete—abundance of gypsum deposits

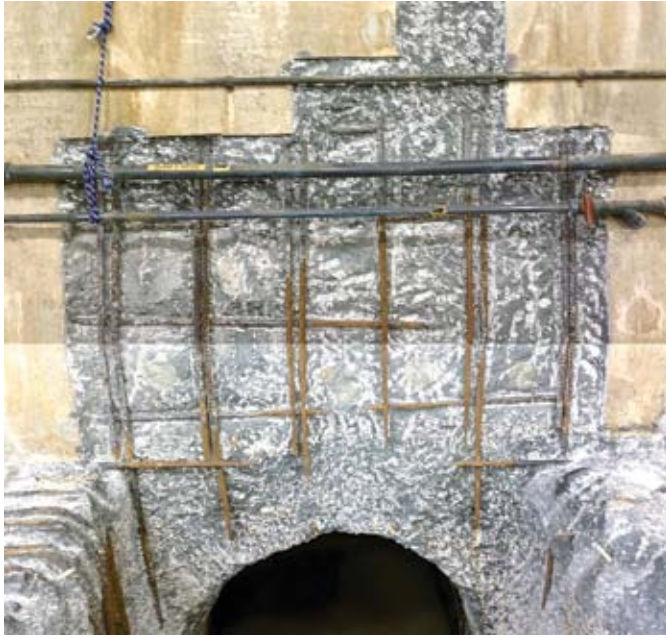
Fig. 10: Corroded reinforcing steel

- Extra manpower was required to carefully monitor the pump station operations.
- Difficulties were encountered when applying the protective coating. Once deteriorated concrete was removed, corroded reinforcing steel in the wall needed to be replaced (refer to Fig. 10 and 11). It was difficult to properly apply the protective coating. Heated air blowers had to be used to dry the moist substrate. Many times, after the initial application of the protective coating, several blisters appeared on the surface (refer to Fig. 12), and the contractor needed to remove and reapply the coating. Spark testing showed several pin holes that required localized repair of the coating material. Once the protective coating passed the spark testing, however, adhesion testing showed more than 200 psi (1.4 MPa) bond strength. Although the rehabilitation took longer than estimated, the quality control and assurance procedures that followed resulted in a satisfactory repair. Figure 13 shows the repaired area with the sluice gate installed at one of the stations.

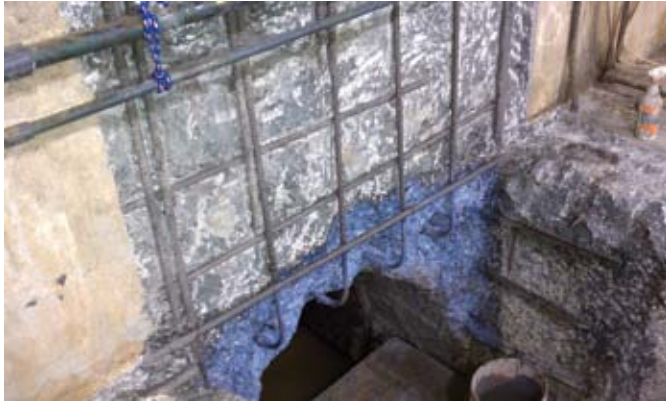
Fig. 11: Replaced reinforcing steel

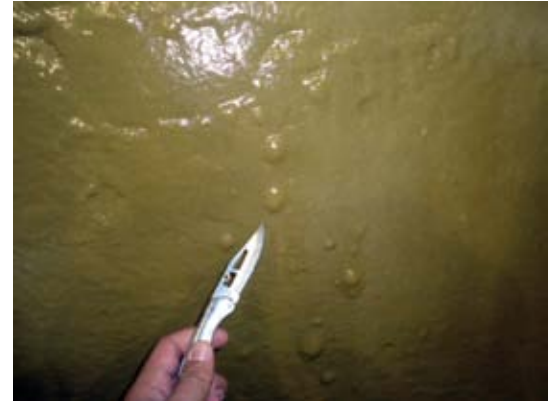
Fig. 12: Blisters in the protective coating

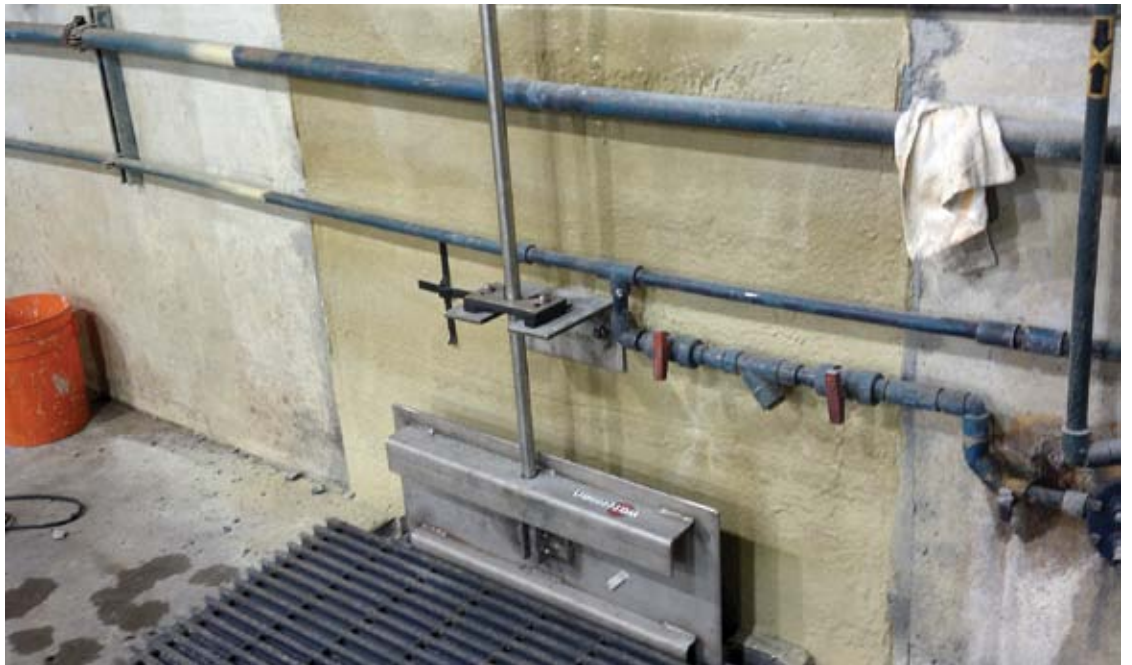
Fig. 13: Completed repaired area with the sluice gate in place
