RESTORATION OF PARKING GARAGES AT PHILADELPHIA INTERNATIONAL AIRPORT

BY THOMAS J. DONNELLY JR.

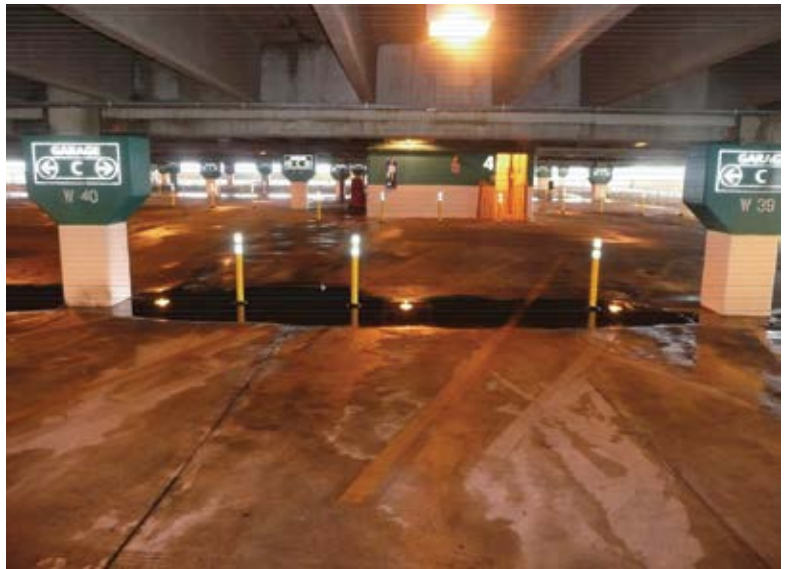
The existing conditions requiring repair included excessive ponding of water (Fig. 3) and drainage issues; vertical and overhead concrete deterioration to columns (Fig. 4 and 5), beams, and precast tee beams; horizontal concrete deterioration in the cast-in-place concrete and precast tee beams; structural connection repairs due to moisture-related corrosion; expansion joint system failures; and control and construction joint replacement. Miscellaneous repair items included painting of structural steel, the installation of new traffic markings, and upgrades to stair/elevator towers.

Fig. 3: Existing condition—ponding of water

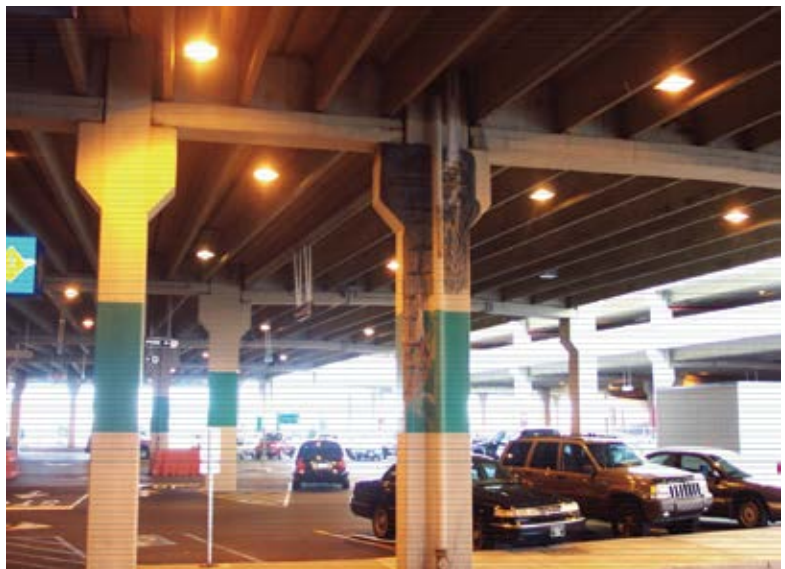
Fig. 4: Existing condition—vertical concrete column deterioration

- Removal and replacement of delaminated concrete from support beams and columns; the underside of precast tee beams; and shallow and full-depth deck repair areas through the installation of conventional concrete, prepackaged repair materials and shotcrete with each item bid on a unit price work item basis, as follows:

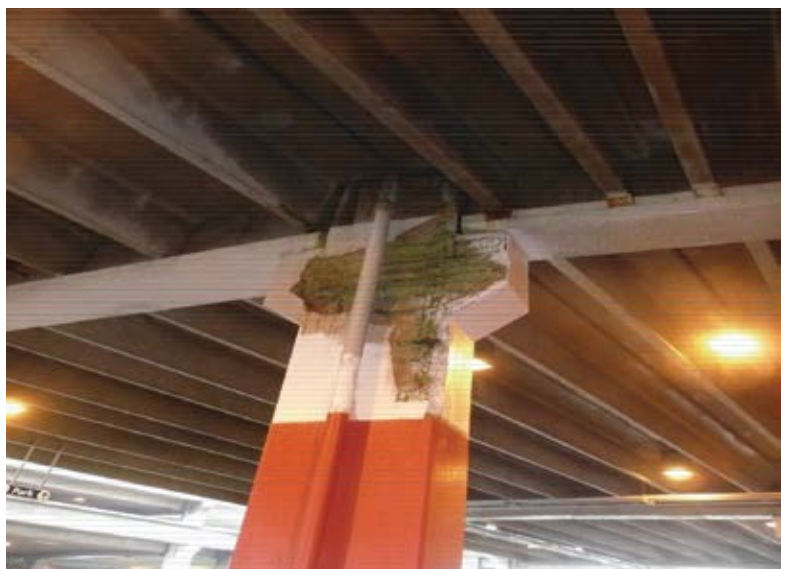
Fig. 5: Existing condition—vertical concrete column deterioration

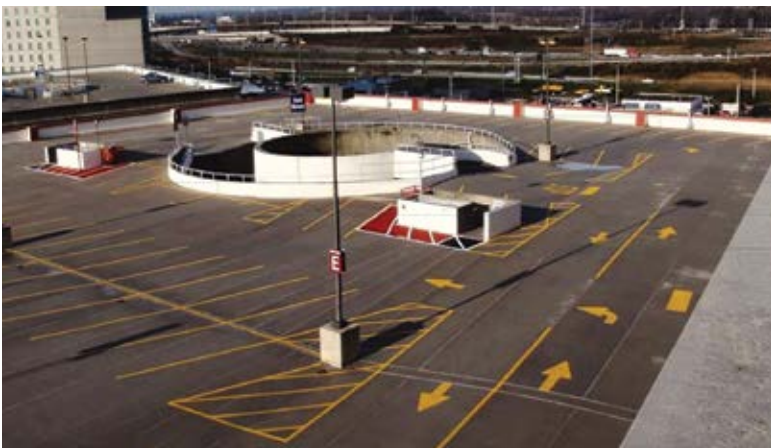
Fig. 6: Completed view of “D” garage

- Installation of an epoxy broadcast traffic deck coating system on the roof level of the “C” and “D” garages, including surface preparation by shotblasting, bid as a lump-sum work item, for approximately 280,000 ft² (26,010 m²);

Horizontal concrete placement used a combination of ready mixed concrete delivered to the site and placed with concrete buggies, or approved concrete prepackaged bag materials, which were mixed on site and placed. Vertical and overhead concrete placement was performed with a combination of prepackaged hand- and trowel-applied materials, or a prepackaged shotcrete material. Joint sealant replacement was with a two-component urethane sealant and primer, and they were installed with bulk guns. The concrete sealer was installed with air-powered spray equipment, and the roof-level traffic deck coating system included two lifts of epoxy, each installed with squeegees and sand loaded to refusal, and then back-rolled (Fig. 6).
