CONCRETE REPAIR AND PROTECTION AT HIGH ALTITUDE

SKI AND RACQUET CLUB CONDOMINIUMS

Ski and Racquet Club Condominiums

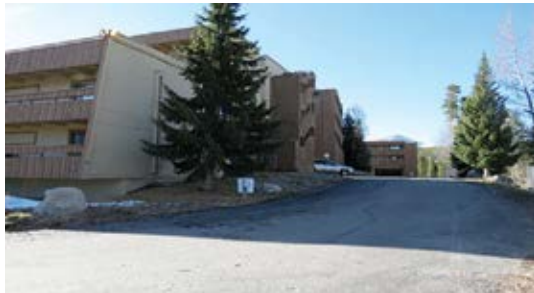
Fig. 1

In 2008, the Owners' Board at Ski and Racquet Club condominiums (Fig. 1) determined that the 40-year old precast triple-tee beam concrete structure needed a new facelift. The Board contracted an architect in Breckenridge, CO, to review the structure and design a new building envelope system. Upon the initial investigation of the structure, the architect found several areas of concrete that looked suspect and determined that a structural

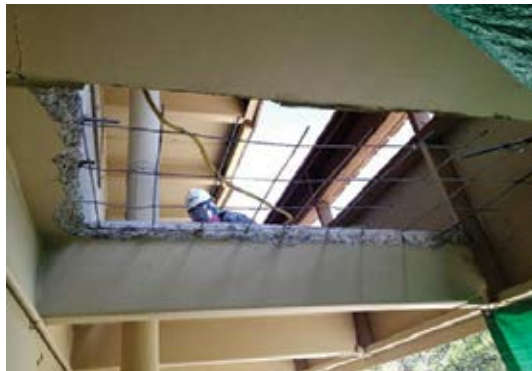
Fig. 3

A similar concrete review program took place on all walking surfaces. The contractor performed the review on the horizontal walkways, marked the areas that sounded hollow, and proceeded with the concrete demolition process (Fig. 3). The existing welded wire mesh was cleaned of corrosion, and in areas where it was significantly damaged, the mesh was replaced. Concrete deck spalls were also repaired using a polymer-modified concrete repair material. A form-and-pour method for the large spalls (Fig. 4) and a trowel-applied method for the smaller spalls were used to assist production.

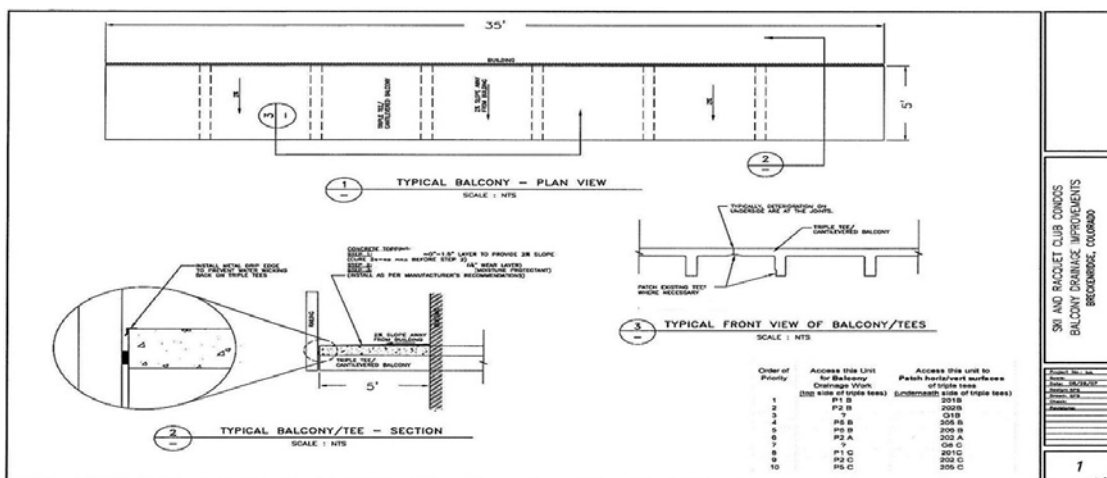
Fig. 5

During the initial review, the structural engineer determined that the exterior walkways exhibited neutral or negative slope. Accordingly, they developed a topping design that would allow for positive drainage from the building to the drip edge of the existing walkways. However, because of the new railing and hanger system at the walkway edge, along with the flush-mounted existing doors, this topping system installation took a lot of preplanning. The doors were the largest issue to overcome. The doors had to be removed, reframed, and cut to fit a new opening that was 2 in. (50 mm) smaller. Because the door thresholds had to be installed and waterproofed first, the contractor developed a system of blockout forms that would provide a curb for the thresholds to sit on. This allowed the door to be

profile was achieved prior to placing the concrete overlay. The existing walkways (balconies) at the complex were typically at 262 x 5 ft (80 x 1.5 m), for over 12,000 ft² (1115 m²) that needed to be resloped (Fig. 5). Once the carpet was removed, the concrete was ground to remove as much of the old glue as possible. The final step of the surface preparation was to use a concrete scabber to achieve the desired concrete surface profile. As with all concrete repair applications, achieving the proper saturated surface-dry (SSD) condition of the prepared surface prior to concrete placement is critical. As such, the contractor sectioned off the deck into workable sections each day and allowed a soaker hose to keep the deck wet for several hours prior to installing the concrete topping. The second critical step in the overlay process was to make sure a scrub coat of the polymer-modified overlay material (Fig. 6) was used to ensure a good bond. Immediately after the scrub coat was applied, the polymer-modified sloping material was installed by pouring the mortar onto the deck and screeding the material into place between the forms. A light broom finish was applied to the new overlay and cured.
