# Fountain View on the Plaza Parking Garages' Structural Strengthening and Concrete Repair and Protection

## Fountain View on the Plaza Parking Garage

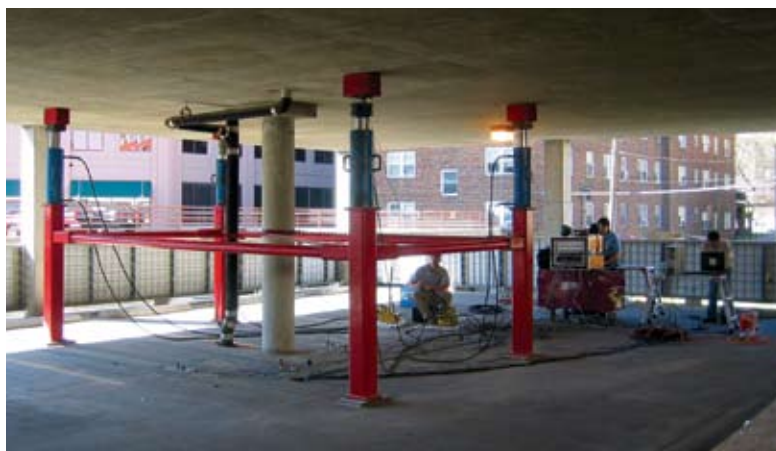
*Fig. 1: Load testing of slab using hydraulic jacks and steel frame to apply the loads. Note the computers acquiring data*

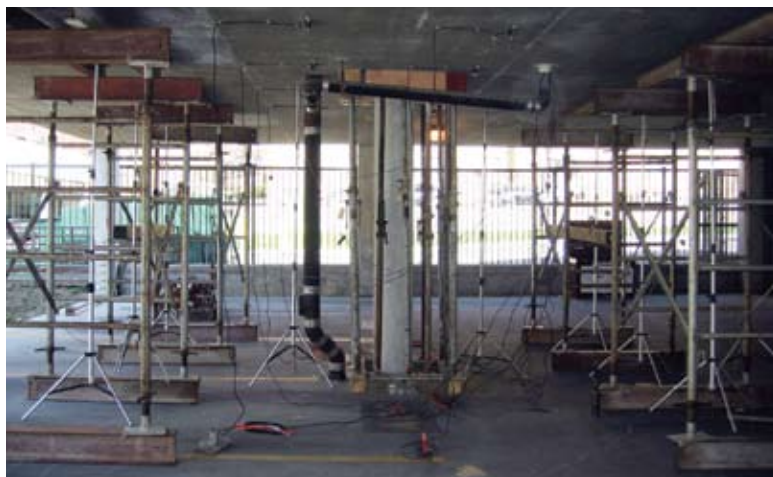
The load test objective was to demonstrate the feasibility of Option 1 to effectively increase the structural capacity of the slabs. A garage area showing typical overstresses (25% for flexural capacity and 30% for punching shear capacity) was selected to test both options. The load test was designed to simulate the stress condition caused by the uniformly distributed self weight and vehicular traffic load. The test loads were generated by four hydraulic jacks controlled by manual pumps, which applied the load to the slab through a steel frame (Fig. 1) and reacted against the floors above. Several sensors were connected to a computer and installed under the slab to monitor displacements and deformations of the slab during the load tests (Fig. 2).

Load testing of Option 2 was conducted first. The test simulated the presence of a shear collar using shoring posts. The load test of Option 1 occurred after installing CFRP laminates in the mock-up area. The test results demonstrated the effectiveness of Option 1. Therefore, this option was selected to strengthen areas with typical overstresses. For areas with larger overstresses,

*Fig. 2: Underside of test slab showing sensors during load test of Option 2. Shoring was used as a safety measure (it was not in contact with the slab bottom)*

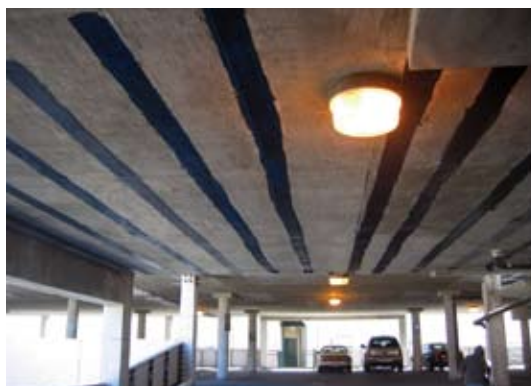
*Fig. 3: Slab underside strengthened with CFRP laminates*

Flexural strengthening of positive moment regions (slab underside) was also undertaken where the slab strength was inadequate due to the incorrect placement of the tendons. This strengthening was accomplished with a CFRP laminate system placed on the bottom of the slab (Fig. 3).

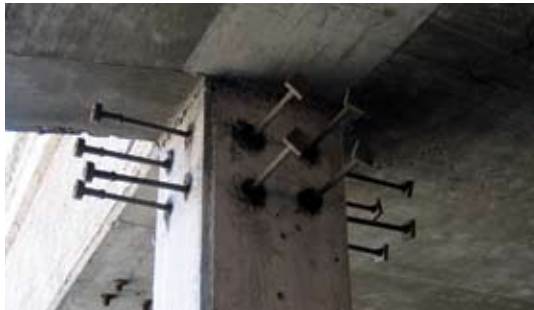
*Fig. 4: Headed bars used in the construction of external shear collars*

There was also a need for punching shear strengthening of slab/column intersections. At interior columns, this strengthening was accomplished by installing shear collars. Shear collars strengthened the exterior/ramp edge columns with three-sided corbels doweled into the column faces (Fig. 4) or with new spandrel beams connected to the existing columns.

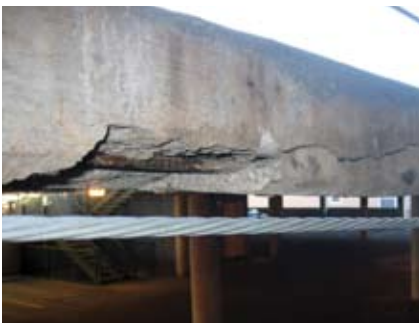
*Fig. 5: Cracking on slab edge shown before and after repair*

2. Repairing hollow-sounding areas of concrete and previous repairs on the underside of the slab below the banded tendons where the concrete/repairs were cracked;
3. Repairing areas of slab with horizontal cracks on the exposed slab edge (Fig. 5);
4. Repairing stressing pockets where the grout-fill had gaps and/or showed signs of leakage, and filling grout pockets that were ungrouted;
5. Injecting epoxy into column cracks resulting from the restraint of slab post-tensioning and other volume changes;
6. Repairing spalled column tops;
7. Routing and filling cracks in the topside of the slab with methacrylate resin;
8. Applying vehicular traffic-bearing waterproofing on the elevated slabs. The waterproofing was extended down the vertical faces of the exposed slab edges to provide additional protection to the ends of the tendons; and
9. Applying penetrating sealer to all the slabs-on-ground.
