# ST. ALPHONSUS CHURCH: REPAIR AND SPIRE INSTALLATION

BY CHRISTIAN HILL AND MARK K. HOWELL

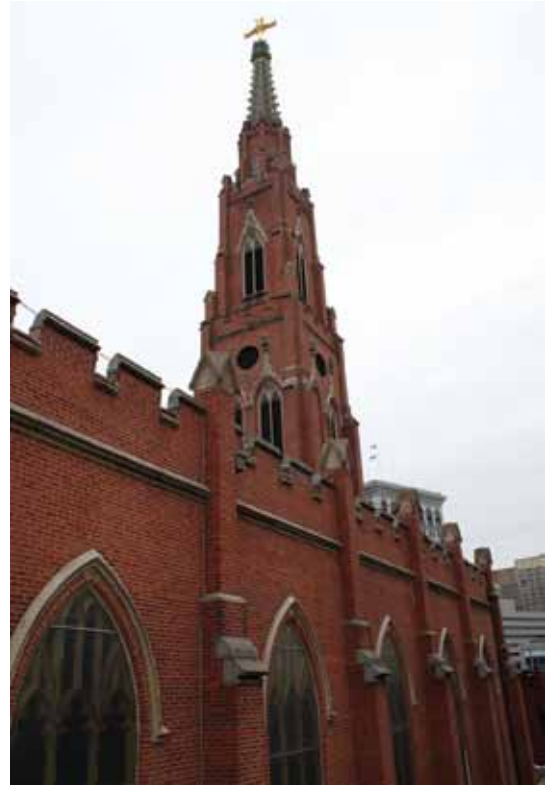
*In the early 1900s, the church's signature spires were deteriorated to the point that they were a safety concern for pedestrians. They were removed, but never replaced*

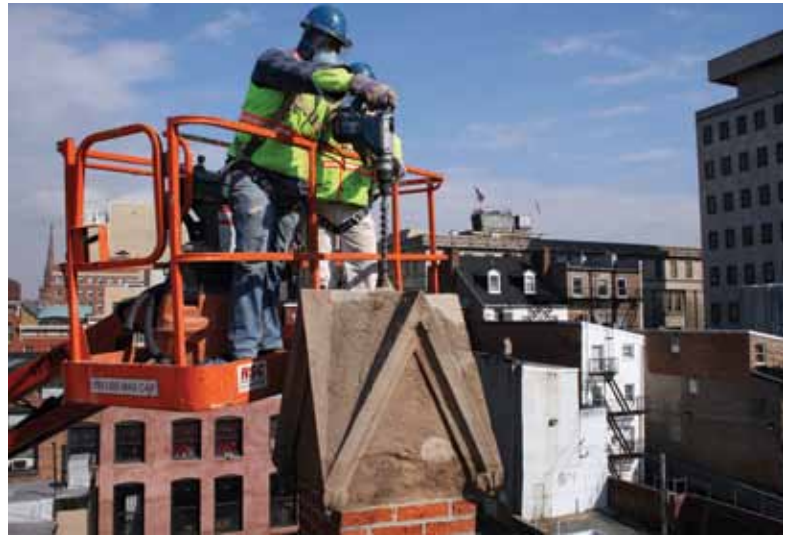
A cruciform bit was used to drill through limestone into masonry columns

The installation of the spires began by evaluating a number of drilling methods. Holes, 42 in. (1067 mm) deep and 1.5 in. (38 mm) in diameter, had to be drilled through the pier caps and into the brick piers. Ideally, the repair contractor did not want to use typical hole-boring equipment because most use water to lubricate the drive through the substrate. Water, if combined with the dust from the drilling, posed a serious problem as cementitious slurry would result. The paste could run down the pier, potentially staining the historic brick. Instead, the contractor used a waterless drilling mechanism. A special drill bit and an extension rod were purchased to allow for dry drilling. In the few areas where a wet boring was needed in order to avoid splitting a pier, a small containment reservoir was built on the cap and continuously vacuumed to control the slurry.

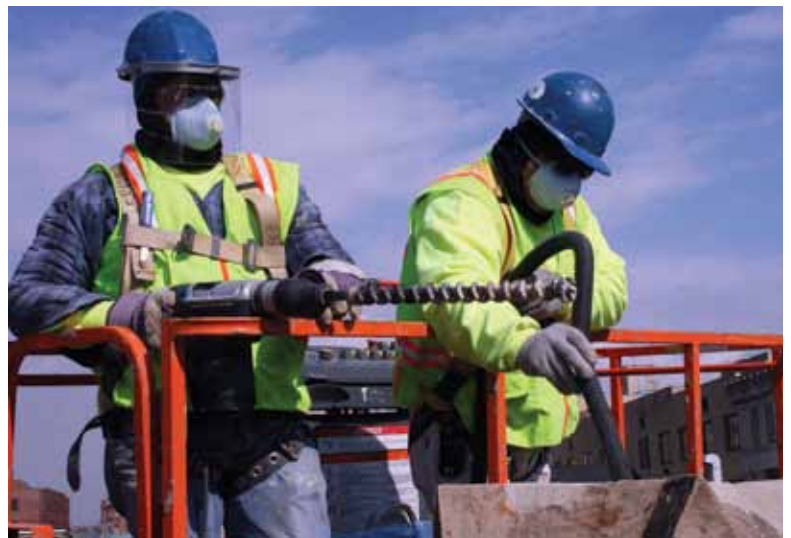
Anchorage holes were vacuumed after drilling to ensure they were clean so a proper bond could be formed with the anchor

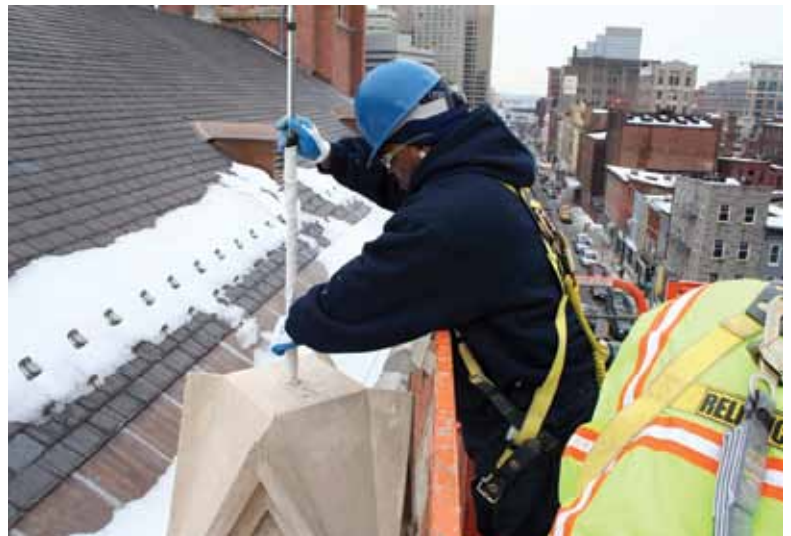
The 48 in. (1219 mm) long specialty anchor, covered in a long cotton sock to promote a good bond when the grout is pumped, is lowered into the anchor hole

masonry and their ability to flex with the structure. They work by inserting a 48 in. (1219 mm) long piece of 0.75 in. (19 mm) stainless steel all-thread into the hole. A cotton sock with a plastic hose running to its bottom was wrapped around the bottom of the all-thread. A highly fluid cementitious grout was pumped into the hose until the sock was completely full and expanded to hold the entire piece in place against the substrate. Next, a 1 in. (25 mm) thick grout bed was poured to bond the pier cap and receiver plate together. An 8 x 8 in. (200 x 200 mm) stainless steel receiver plate was placed on top of the grout, and once everything had set and cured, the spires were attached to the plate by bolting the entire unit to the receiver plate.

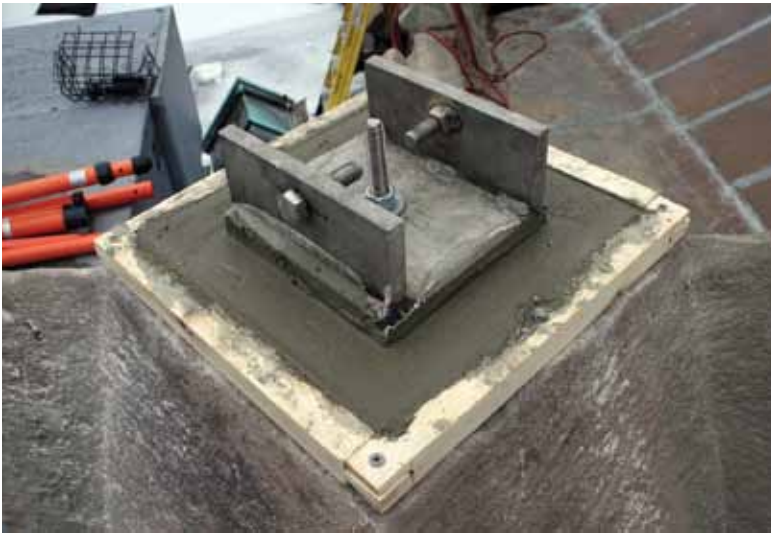
*Nonshrink grout placement below the receiver plate*

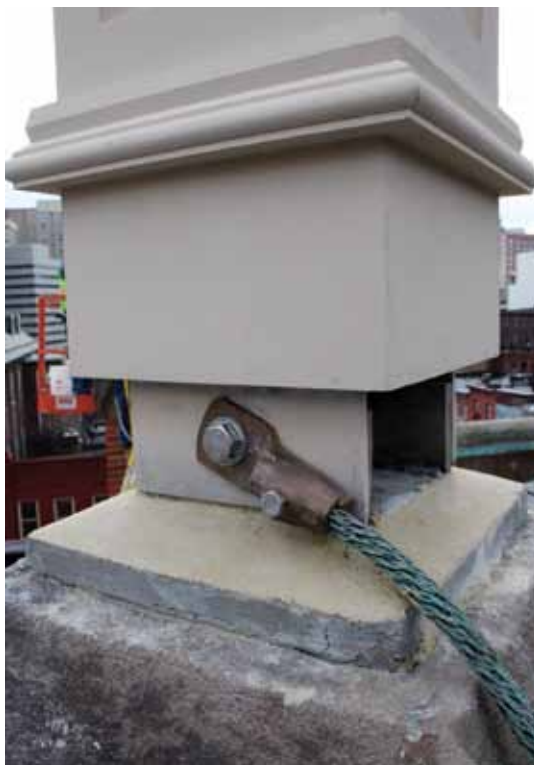
*Lightning arrestor system attached to the stainless steel skeleton*

As part of the repair process, the team also installed a lightning arrestor system. The wiring for the system was attached to the spire base and the actual lightning rod was screwed into the tip of the spire. The connection between these components was completed with a stainless steel rod running through the body of the spire.

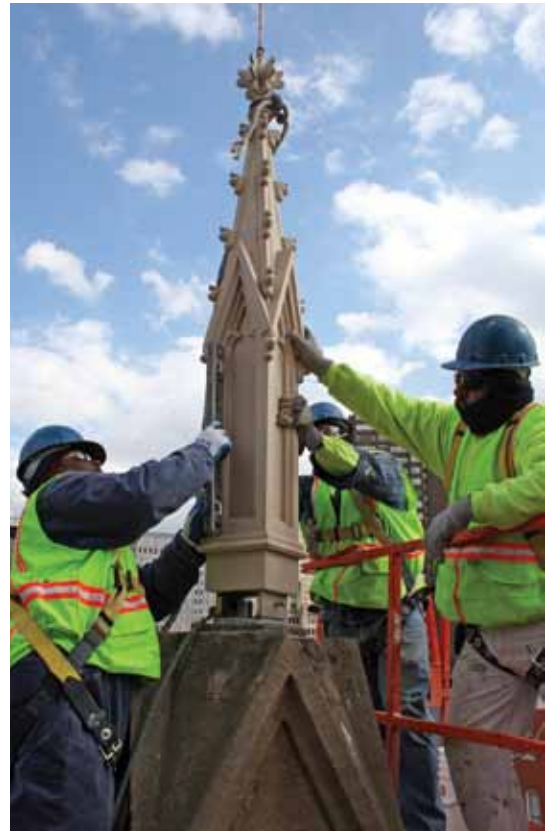
*Alignment of spire in preparation for tack welding*

The repair contractor was also cognizant of the fact that the piers were not supported in a vertical fashion, which would result in the spires appearing out-of-line when placed vertically into the holes. In response to this challenge, the repair contractor suggested shimming the brick piers, allowing for easy straightening as needed. Because many of the original capitals were not completely plumb, the stainless steel receiver plates were shimmed up to level, and then a nonshrink grout bed was poured in under the base plates. The PVC base molding that was added not only served to increase the base footprint, but also covered the stainless steel receiver plates and lightning arrestor system connection.

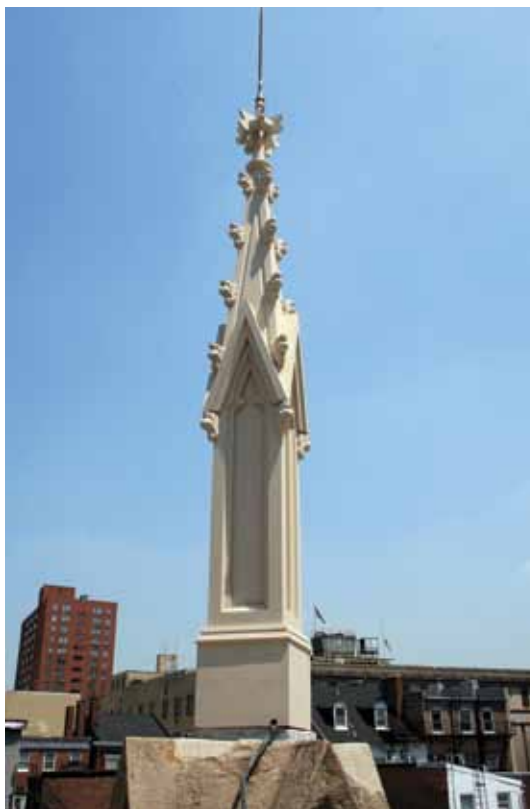
*After 100 years, the original gothic element is restored*
