Strengthening Category

# Seismic Retrofit of McKinley Tower

Anchorage, Alaska

Submitted by QuakeWrap, Inc.

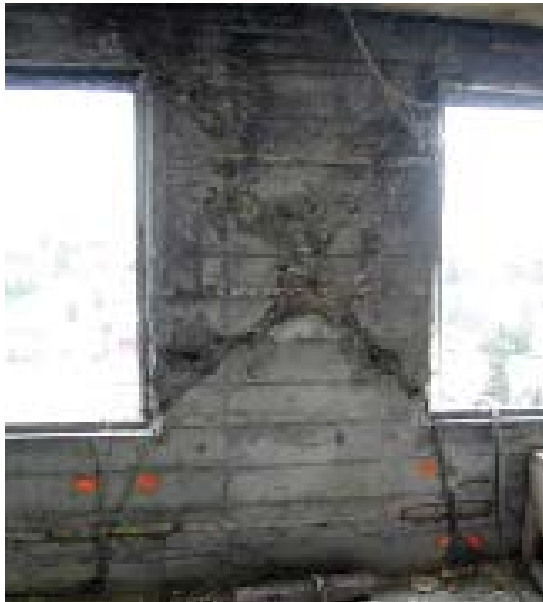
Fig. 1: Damage to walls caused by the earthquake

The building survived the 1964 “Good Friday” Alaska Earthquake, which had a Richter scale magnitude of 9.2, making it the strongest earthquake in North America to date. Damage to the building consisted of shear failure of exterior spandrel beams and extensive diagonal cracking of exterior walls (Fig. 1). The east vertical pier on the north-end wall failed up to the third floor at a construction joint and similar failure was observed on the south-end wall. The walls around the building’s core suffered light diagonal and horizontal cracks at construction joints, with damage being more severe from the third to sixth floors.

After the earthquake, the building was vacated and put up for auction. In 1965, some repair work was done, consisting of patching exterior cracks, replacing damaged reinforcement of ornamental spandrel beams, removing loose material, and fixing spalled areas in the stairwell and elevator core.
