Historic Category

Bok Tower Restoration

Lake Wales, Florida

Submitted by Sika Corporation

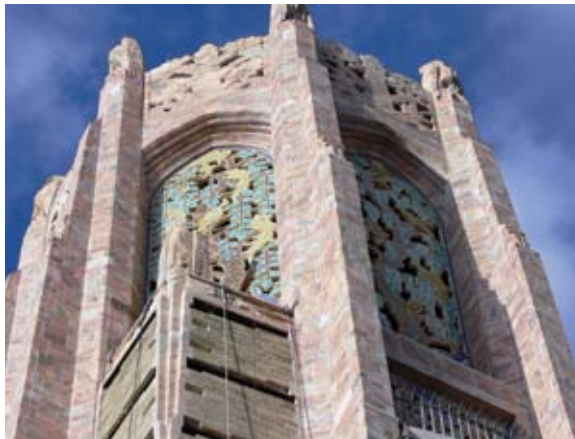
Close-up of beautiful coquina brick on Bok Tower

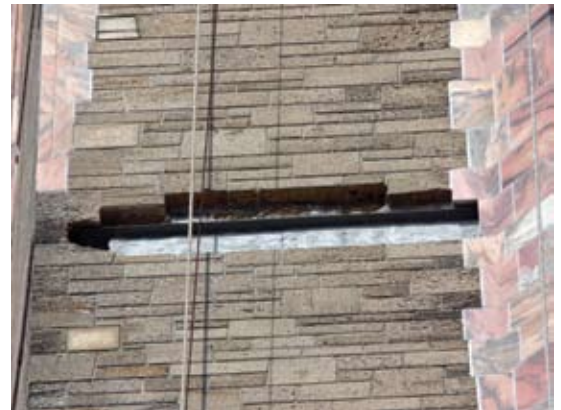
Coquina brick and underlying masonry had separated from tower

Coquina brick is porous brick made of crushed seashells and similar material. Corrosion of horizontal structural steel members caused the coquina brick and underlying masonry to separate from the tower. The root cause of the corrosion was found to be ingress of moisture through the porous coquina brick and from openings in the top of the tower. In addition, there were cavities present, some of which were created by plastic sheeting that was installed behind the coquina brick during repairs completed in the 1970s. The cavities served as the primary sites for accelerated corrosion.

1. Remove the coquina brick and underlying masonry from in front of the horizontal beams and top plate;
2. Clean the structural steel surfaces, coat with a cementitious coating, and encase with brick mortar;
3. Reinstall new coquina brick; and
4. Encase the areas behind the coquina brick at the corners of the towers with Type K mortar.

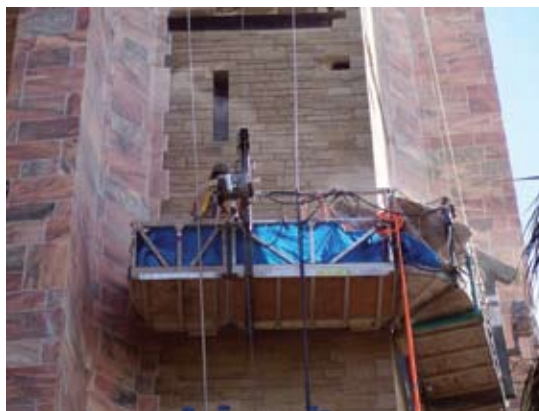
Coquina brick replacement

Areas behind the coquina brick at the corners of the tower and behind the columns were completely encased with a Type K mortar. The stone above and below the steel members was set in a full bed of mortar on the sides and back. The replacement stone was also reinstalled in this manner. For the 12 in. (305 mm) band within the flanges of the structural steel beams, the stone was completely filled with mortar and masonry. After the bed mortar set, the outer 3/4 in. (19 mm) of the stone work was pointed with a low-compressive-strength mortar matching the color of the existing pointing mortar.

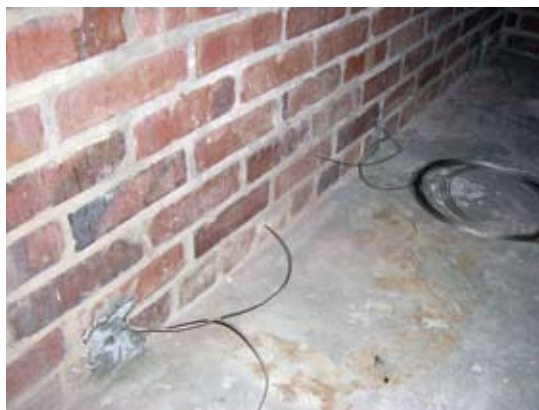
Inserted anodes

Because of the geometry of the tower and need to preserve the appearance of the exterior, a discrete anode system was chosen for the ICCP system. The discrete anode system allows for installation of the anodes from inside the tower, resulting in an easier installation and preservation of the decorative brick and marble exterior.

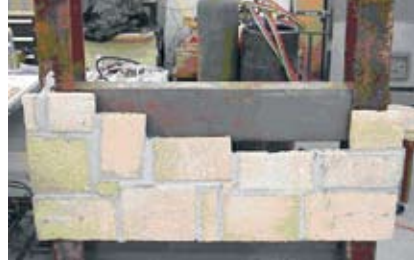
Once it was determined that the structure was fit for application of ICCP, a mockup tower section was constructed to help identify design specifics. The wall was broken up into a grid pattern, five columns across and five rows down. A number of potential measurements were taken at each section (A1, A2, etc.) of the wall while it was dry and again after being saturated

with water. Testing and theoretical considerations revealed that the anodes needed to be applied above and below each horizontal beam to apply an adequate current on all exposed surfaces.

Mockup tower section

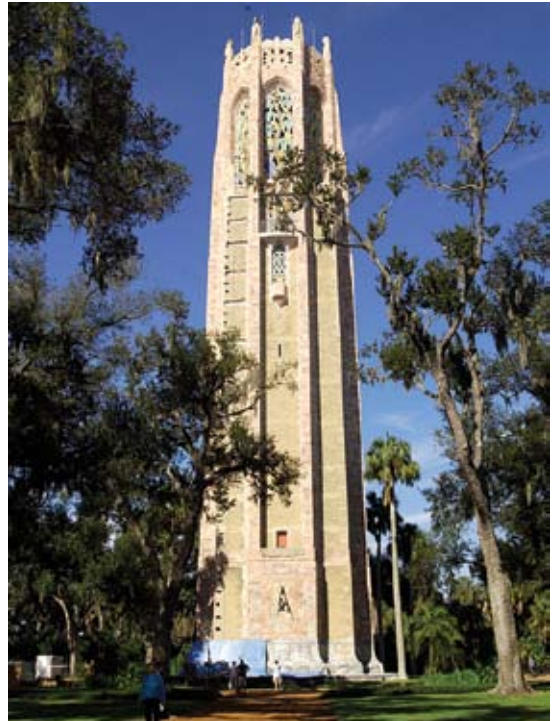
Fully repaired Bok Tower
