# Historic Preservation of Hoare's Bank

London, England

Submitted by C-Probe Systems, Ltd.

2007 Award of Excellence

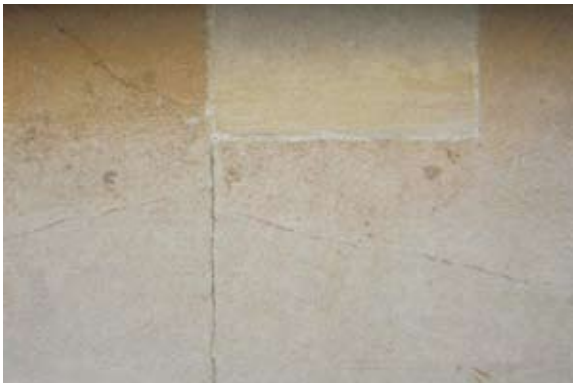
*Aesthetic deterioration caused by the unsightliness of cracking of the stonework. Note the crack developing from a previous repair where the iron was not removed*

The building is a sandstone construction of load-bearing masonry whose blockwork was interconnected by wrought iron cramps and pins used to prevent movement of the stone during construction. These metal fixtures remain in position approximately 4 in. (100 mm) deep within the stone, but (like all iron-based components) are prone to corrosion. Deeper components have been identified that were

Over the past 20 years, the building has been the subject of localized repairs where the iron component is often (but not always) removed and a stone patch replaces the breakout area that was necessary to remove the ironwork.

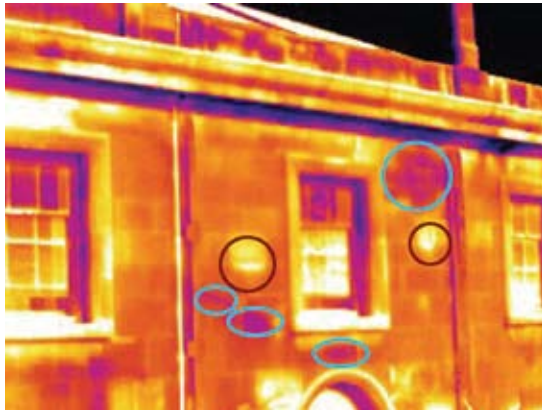
*Thermography output showing areas of moisture retention within the stone and heat loss around the windows as well as locations of previous repairs*

Infrared thermography was chosen to assess the retained moisture profile of the façade, as this is inextricably linked to the vulnerability pattern of the iron within the stone. Where moisture is retained, it is likely that the ironwork in that location would be prone to corrosion.

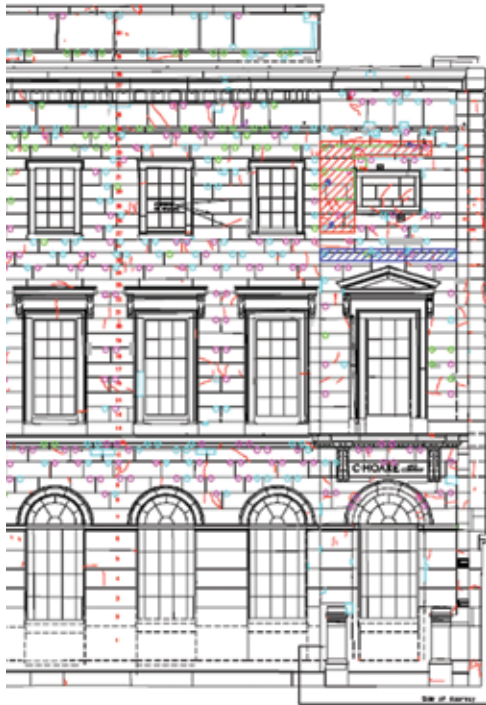
*CAD representation of iron component positions including color-coding of corrosion risk assessment. Note that the red-shaded area was the location chosen for the ICCP preview study. The blue-shaded area was to test surface-applied corrosion inhibitors that did not take place*

Iron components were graded as low, medium, and high risk, depending on the combined results of the survey techniques and a produced CAD drawing that showed the precise locations of all detectable iron components.

Facing these barriers, a preview (mockup) study of the proposed ICCP installation was developed and temporarily powered-up to ensure correct operation. This stage would also be used to convince the City's conservation specialists that a full-scale scheme could be employed.

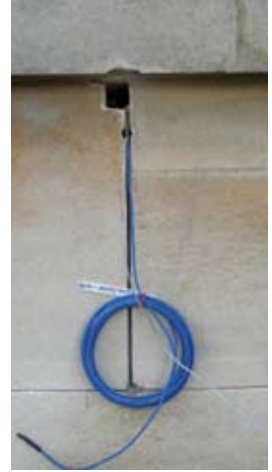
*Position showing discrete breakout for drill and tap steel connections and reference electrode monitoring installation*

The cathode interconnections were made using 0.05 in. (1.2 mm) steel wire and formed in joints on the opposite side (where possible) to the anode wire. Where crossover was a problem, the titanium anode wire was sleeved with a small-diameter tubing to insulate the two wires.

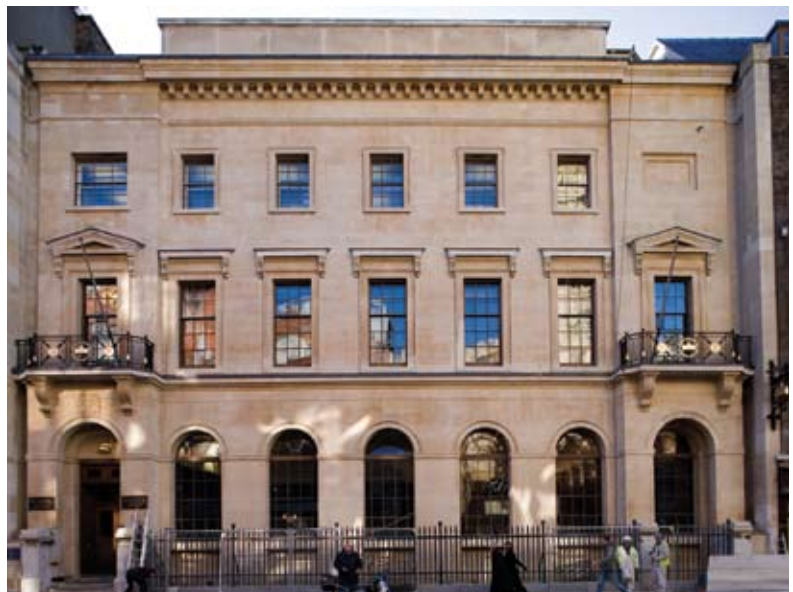
*A view of Hoare's Bank after the work was completed*

The end product for the owner is a repaired building that has, on the face of it, remained unchanged from the first reconstruction of the building in 1827, but with a new lease of life that is protected and controlled for the foreseeable future.
