# Montgomery County Underground Garage Restoration

Dayton, Ohio

Submitted by Carl Walker, Inc.

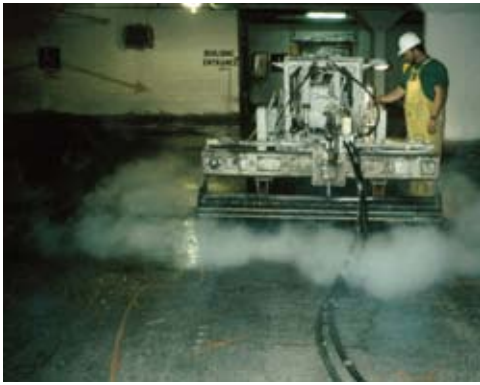
*Hydrodemolition removal of deteriorated concrete*

Hydrodemolition was used extensively as the demolition method on this project. The hydrodemolition not only removed all concrete at delaminated areas but also removed approximately 1 in. (25 mm) of concrete before to the concrete overlay. As the cathodic protection system would arrest

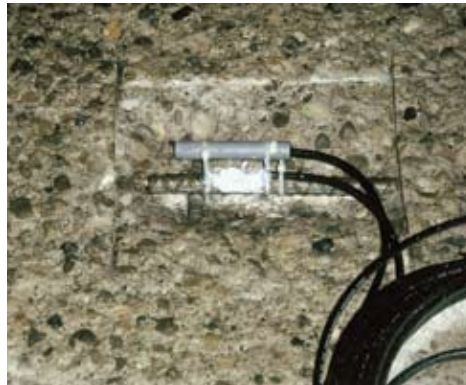
*Cathodic protection reference electrode installation*

After the hydrodemolition removed the concrete delaminations, larger areas of existing reinforcing steel was exposed. Wiring and monitoring systems were installed on the reinforcing steel before patching. The deep repair areas were patched first, followed by the installation of the titanium mesh anode and concrete overlay. Silver-Silver reference electrodes were installed in each zone to monitor the performance of the cathodic protection system over time.

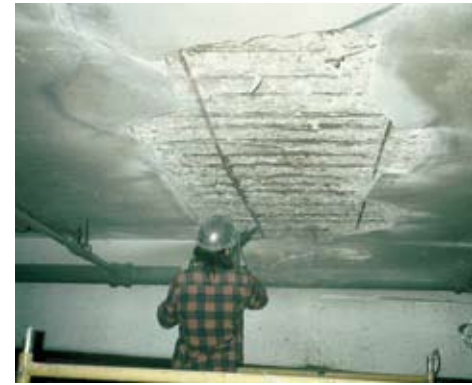
*Concrete ceiling repair demolition*

For the columns and ceilings, delaminated, spalled, and unsound concrete had their marked boundaries saw-cut or vertically chipped in columns and ceilings to a depth of 1/2 in. (13 mm) into the existing concrete, measured from the original surface. All concrete was removed from within the marked boundary to a minimum depth of 3/4 in. (19 mm) around existing reinforcing steel.

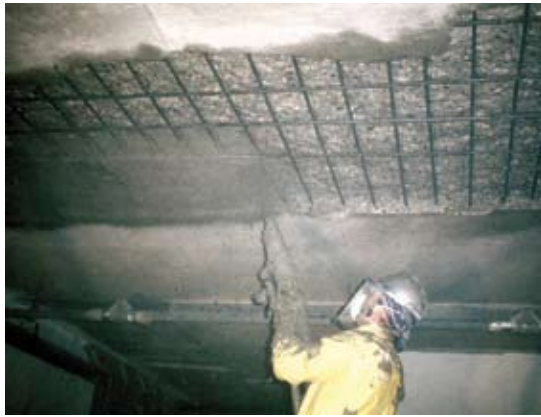
Ceiling shotcrete installation

The ceiling repair areas were patched with shotcrete.

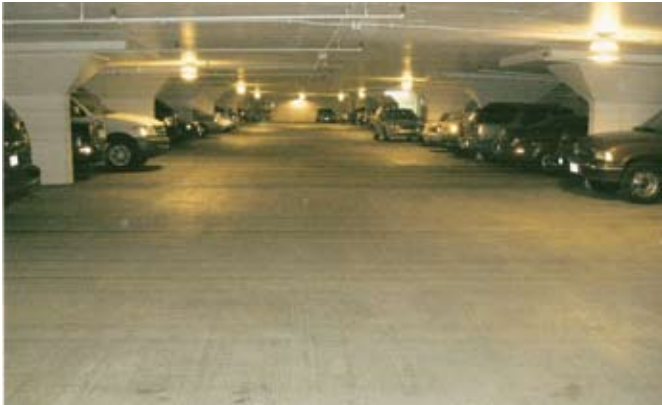
The successful repairs in April 2007
