Concrete Restoration of Three Underground Water Storage Tanks

Boston, Massachusetts

Submitted by Gale Associates, Inc.

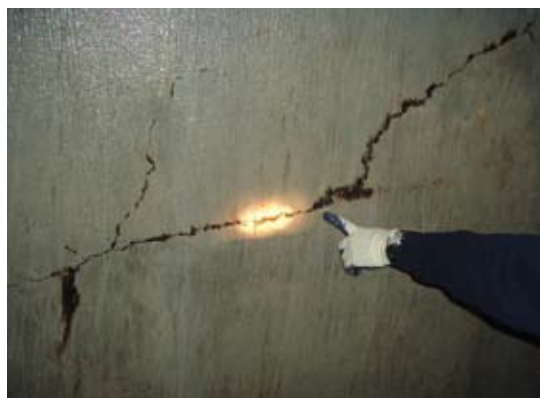
Historically, the tanks had been used to store clean water for use within the building's mechanical air-conditioning equipment. Each of the three tanks was leaking thousands of gallons each day, causing concern about the possible undermining of the structures, the potential to damage mechanical equipment, and the cost of replenishing the tanks on a daily basis. In the mid-1990s, attempts at repair using crystalline parge coat waterproofing were ineffective in stopping leakage.

Leaking water tank

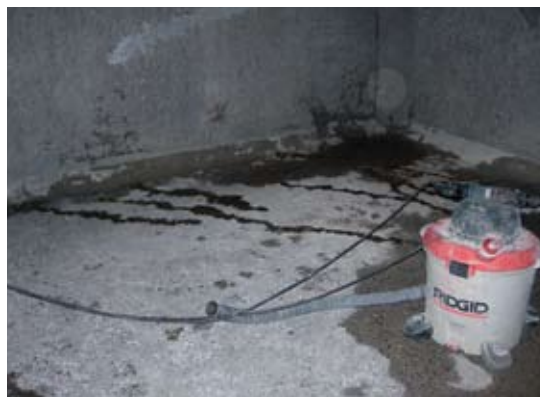
Front of tank showing major leaks

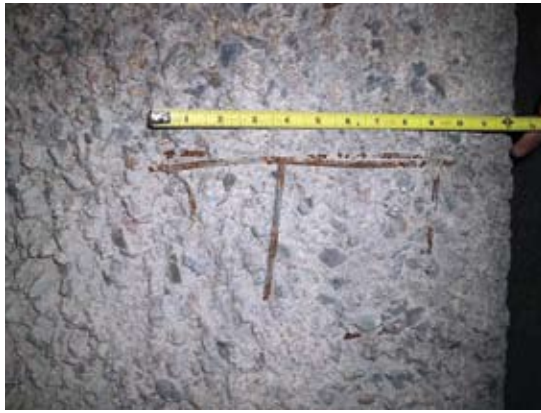
Corroded reinforcement showing through deteriorated concrete

Inadequate vibration and placement of the concrete, insufficient concrete coverage over reinforcing steel, inadequate waterproofing of the interiors of the tanks, and lack of maintenance over the years all contributed to accelerated deterioration of the concrete walls of the tanks.

- Perform hydrodemolition to interior surfaces of the tank walls, basin slab, and column encasements to remove existing waterproof coatings and the soft carbonated, micro-cracked layer of underlying concrete;
- Repair cracks via high-pressure epoxy injection and repair spalls with reinforced mortar patches; provide supplemental reinforcing steel as required;
- Apply a high-performance fiber-reinforced resurfacing mortar via the shotcrete method to replace the removed deficient layer of concrete;
- Apply a monolithic cycloaliphatic epoxy waterproof coating (reinforced with fiberglass fabric as required) to the interior of the tank; and
- Replace all internal piping and replace existing pipe hanger support components with new stainless steel components.

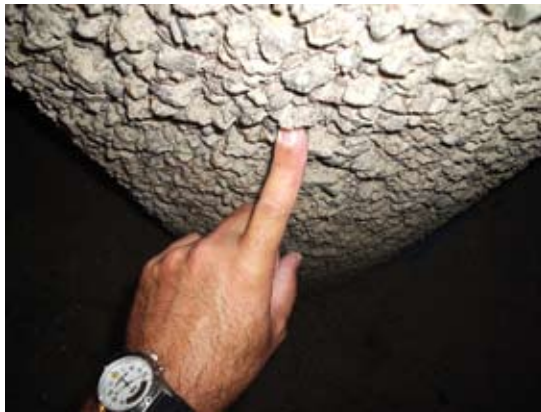
Close-up view of "soft" deteriorated concrete

The building envelope engineer used the claw of a small hammer to check concrete "softness" at spot locations. The hammer was also used to "sound" the concrete at suspect areas and surfaces directly adjacent to cracks, for audible detection of substrate delaminations and possible evidence of corroded reinforcing steel. An electric coring drill in combination with a small electric hammer drill was used to obtain concrete core samples.

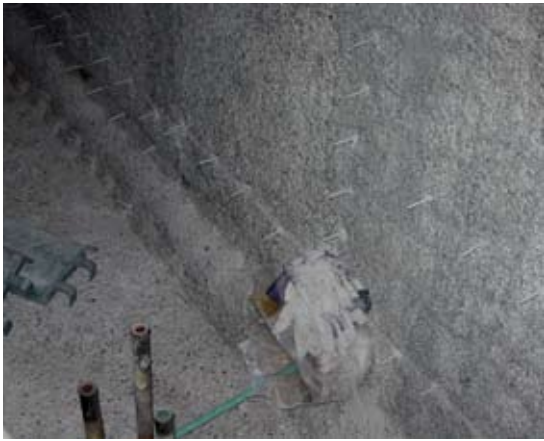
Concrete ready for epoxy injection

Surface preparation included initial removal of loose coatings, delaminated concrete, and corrosion using hydrodemolition. Prior to application of shotcrete, all cracks were repaired using high-pressure epoxy injection, concrete spall repairs, and installation of supplemental reinforcing steel.

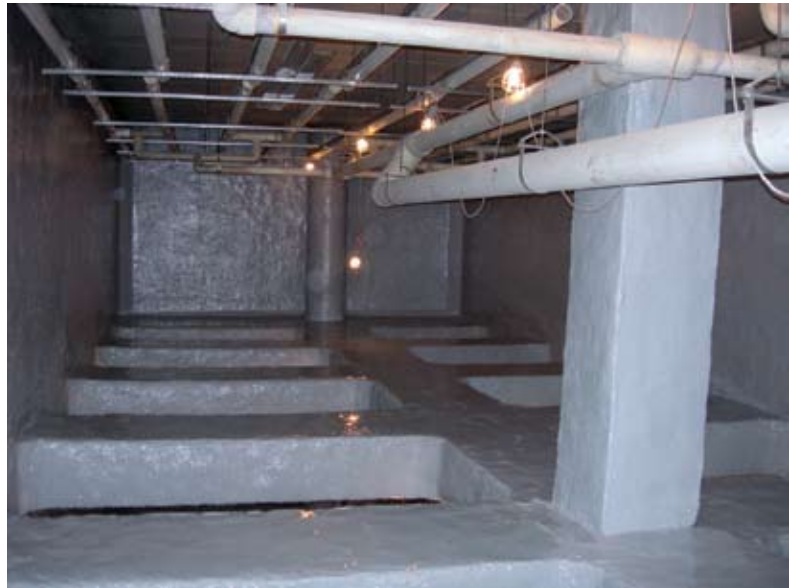
Finished repair

After surface preparation using hydrodemolition crack and spall repairs, a fiber-reinforced resurfacing mortar was applied using the shotcrete method over which a reinforced epoxy coating was applied.
