Longevity Category

2100 Towers Condominium Restoration

Cocoa Beach, FL

Submitted by Cathodic Protection Technology

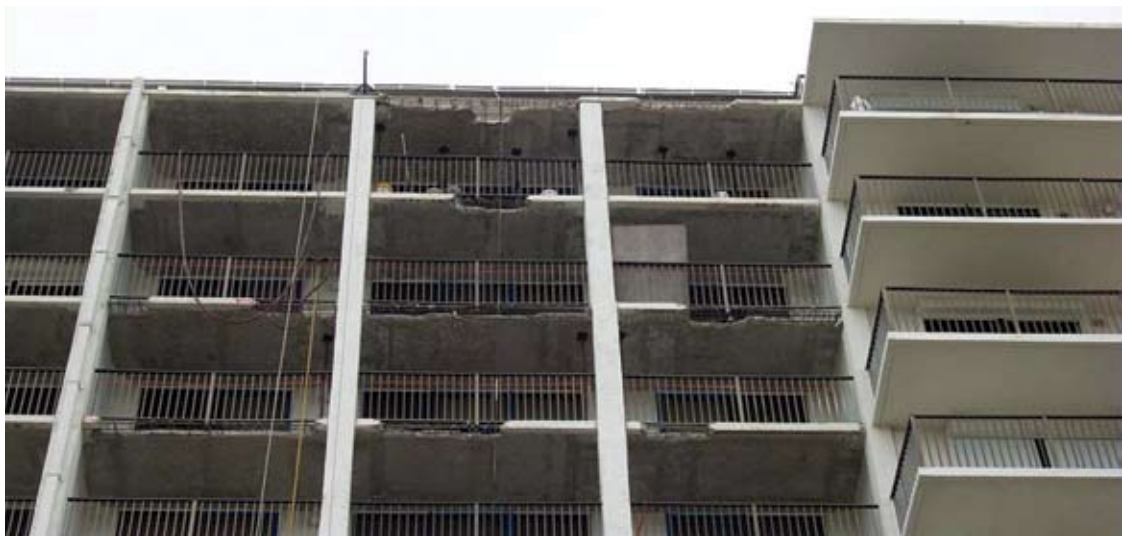
View of the stack and edge repair needed

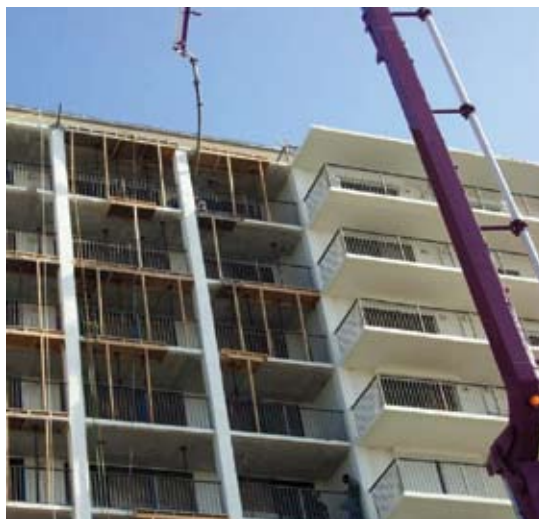
A view of the edges and balcony work

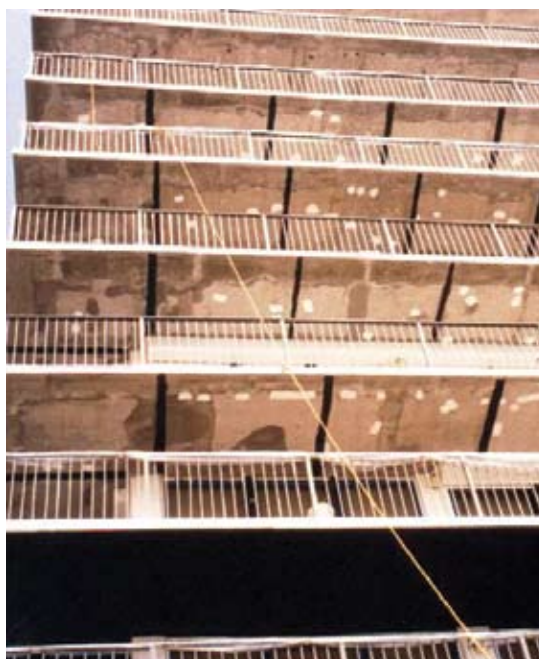
Anode installation on soffit side

After the concrete surface preparation is completed, the installation of the primary anode is conducted. Platinum anodes, with factory attached connections to the cable, are installed to the concrete surface by securing the anode to the surface and applying the conductive coating over the platinum anode. Then, once the anodes are installed and flush to the concrete surface, the entire surface is coated with two coats of the conductive coating. After the appropriate cure times, the conductive coating is covered with a cosmetic overcoat.

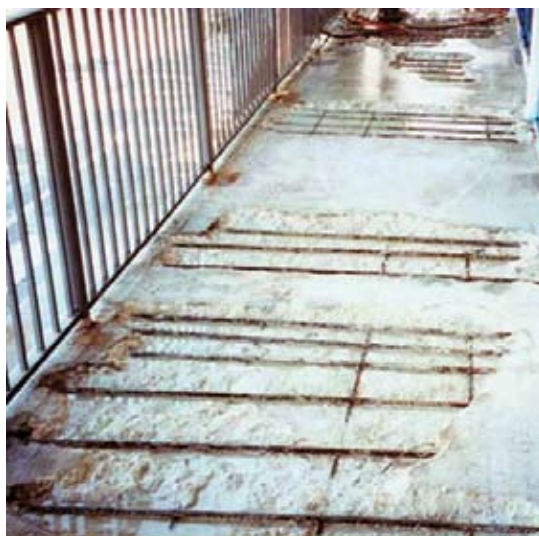
Typical balcony corrosion

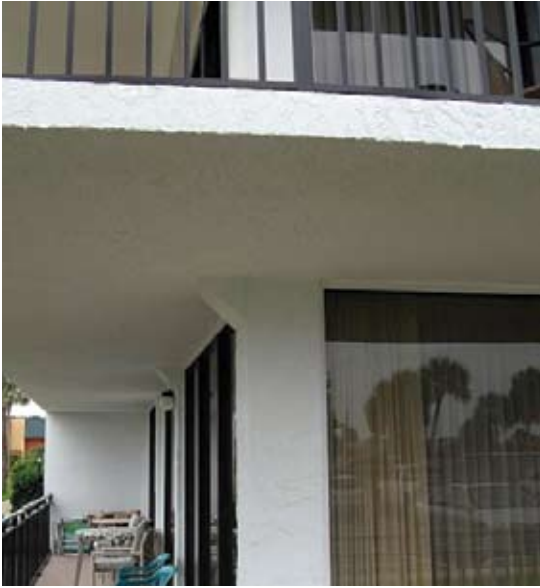
Close-up of balcony edge in 2008

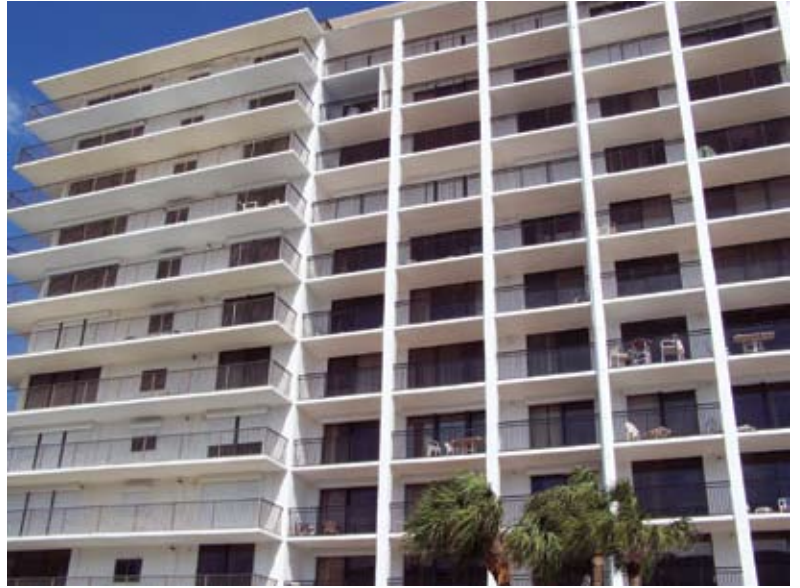
Complete building in 2008
