Chesapeake Bay Bridge-Tunnel Pile Repair and Protection

Cape Charles, VA

2008 Award of Excellence

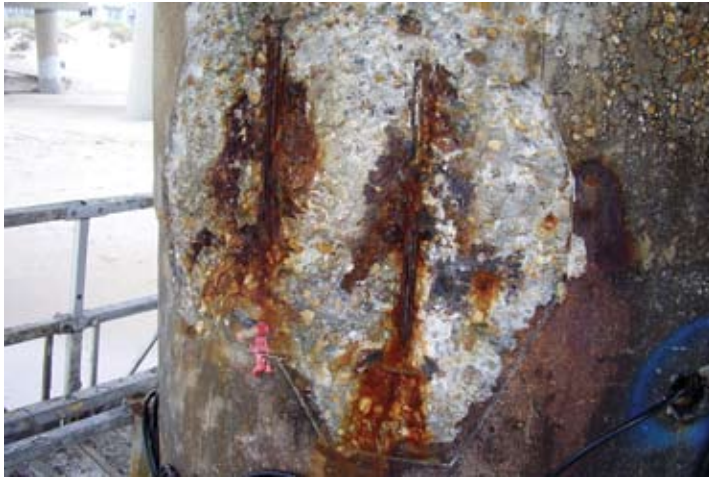
Corrosion of the reinforcing steel encased within the structure's support piles caused the concrete bridge piles to crack and spall. The cracks and spalls on the bridge's piles were patched and repaired, but the reinforcing steel in some of the bridge's oldest piles continued to corrode. Therefore, the Bridge and Tunnel District hired a concrete repair contractor to correct the problem and prevent further corrosion.

Inspections in 1989 revealed that the reinforcing steel in the piles with installation fractures was corroding and expanding, causing the concrete to crack and spall. Fracture repairs were made using epoxy crack injection. Although a standard material used to repair concrete at the time, the epoxy material did not adequately protect the steel reinforcements

Corrosion of vertical pressed steel

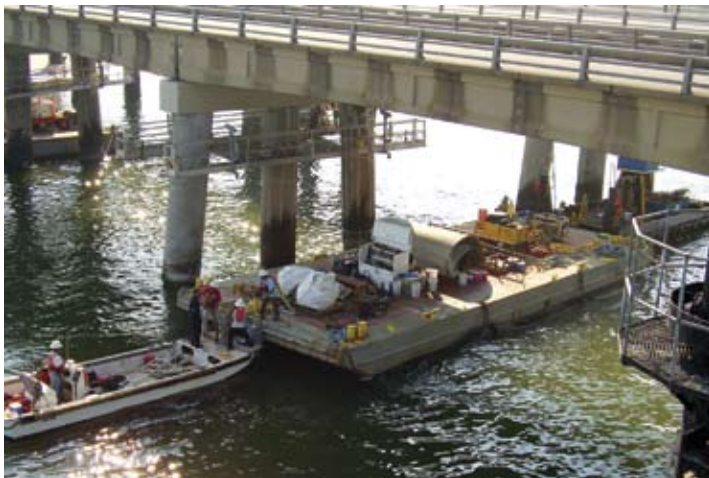
Work platforms and scaffolding under the bridge

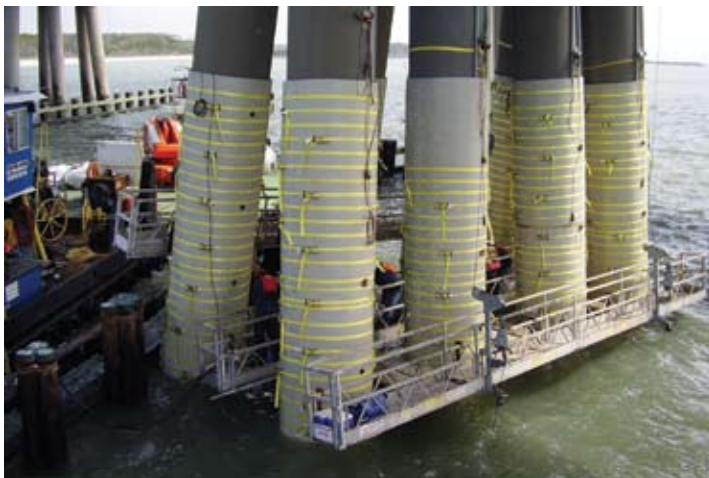
Jackets strapped into place to maintain uniform shape during grouting operations

Each fiberglass jacket was installed in four sections. Crew members pumped grout comprising portland

cement and sand from the bottom of the jacket to the top from alternate pumping ports to create a single monolithic fill approximately 2 in. (50 mm) thick.

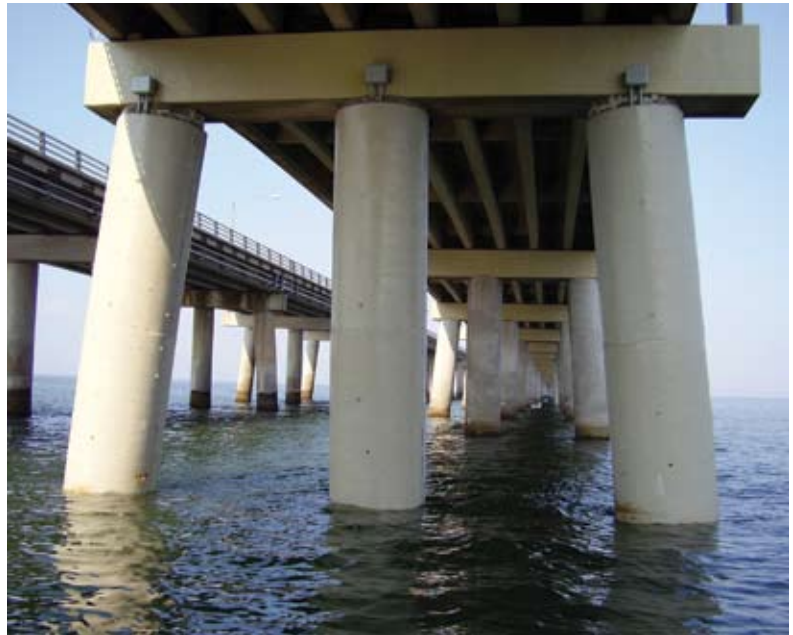
Completed installation
