Concrete Dock Repair: Removal and Replacement of Concrete Slab

Port Arthur, Texas

Submitted by Structural Preservation Systems

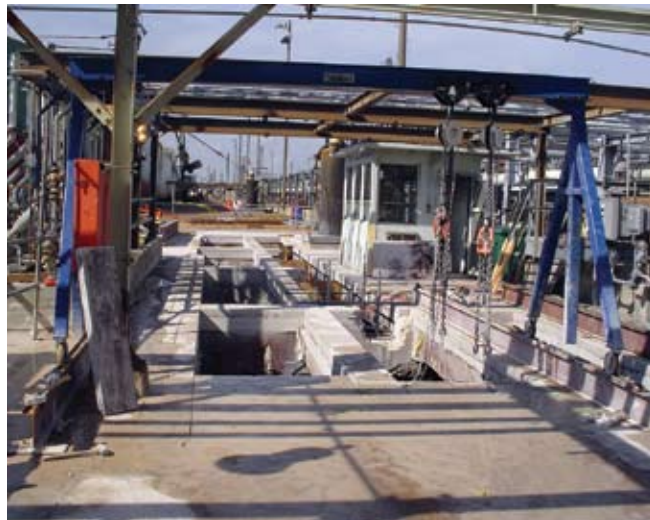
Concrete slab demolition; blue A-frame with chain hoist was used to lift out concrete blocks after they were saw cut

To remove the concrete, crews saw cut concrete to the full depth through the slab and hoisted it out. The team cut 4 x 6 ft (1.2 x 1.8 m) segments out of the concrete and connected the concrete segments to an A-frame for removal. The A-frame was rolled to hand truck dollies. The segments were then wheeled to the end of the dock where a small crane hoisted them into trucks to be hauled away from the site. The team had to chip out these damaged portions using pneumatic chipping hammers and remove all debris by hand. Crews worked on scaffolding to accomplish this task. After communicating with the owner, it was determined that slurry water from concrete saw cutting would not be contained, which was acceptable.

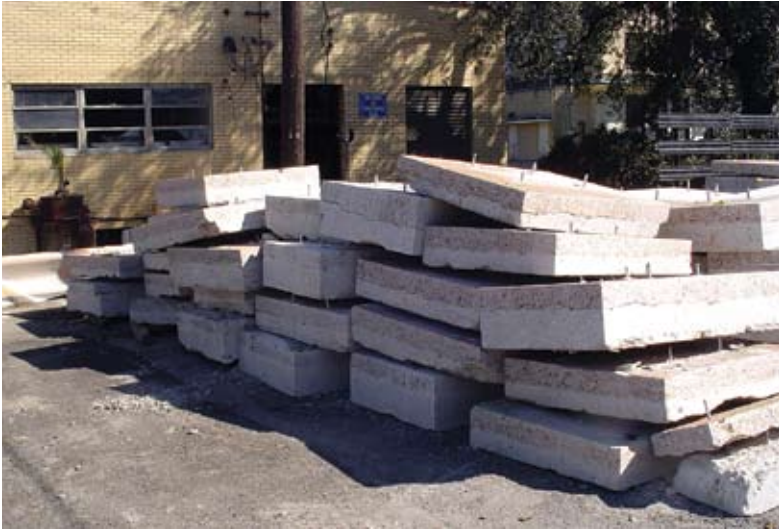
Concrete blocks stacked after being saw cut and removed from dock slab

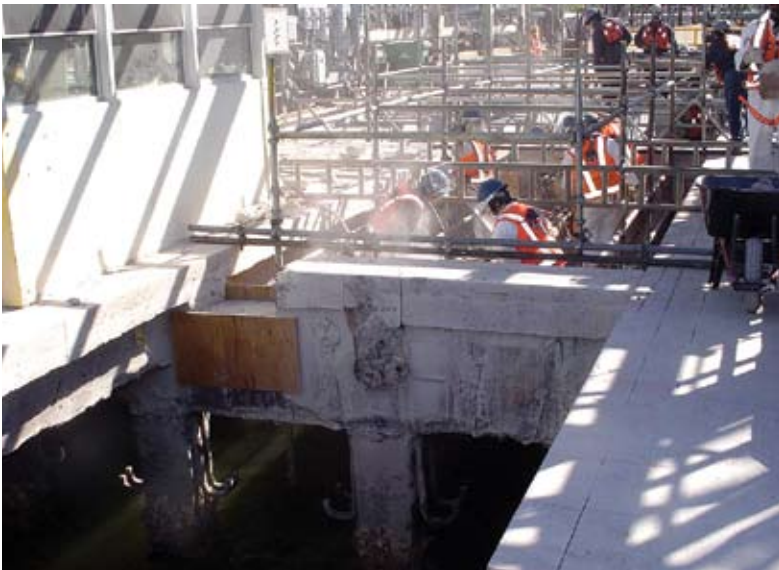
Crews removing intermediate beams using pneumatic chipping hammers; due to the thickness of the beams, they could not be safely removed by saw cutting

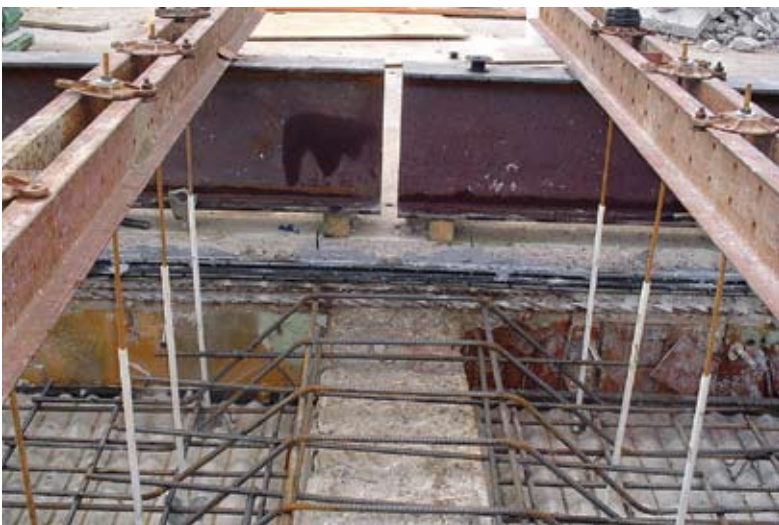
Reinforcing steel being installed; bottom layer of a double reinforced system

Once the concrete was removed, crews set and tied two layers of reinforcing. This new system used No. 6 bars and was designed to support the new slab. A waterproof barrier was installed to the remaining perimeter repair areas to mitigate water infiltration. Crews then fastened the remaining support rods through the deck and sealed the forms. Placement of the concrete was extremely challenging because a flood protection wall hindered access. A concrete boom truck was placed directly next to the wall at one end of the dock. Concrete had to be placed on the opposite end, which was 160 ft (49 m) away from the truck's location. The concrete that was poured back was 2.25 ft (0.69 m) thick.

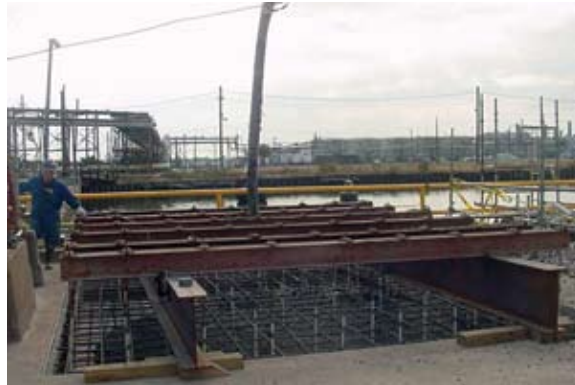
Lowering of concrete hose to place final section of dock

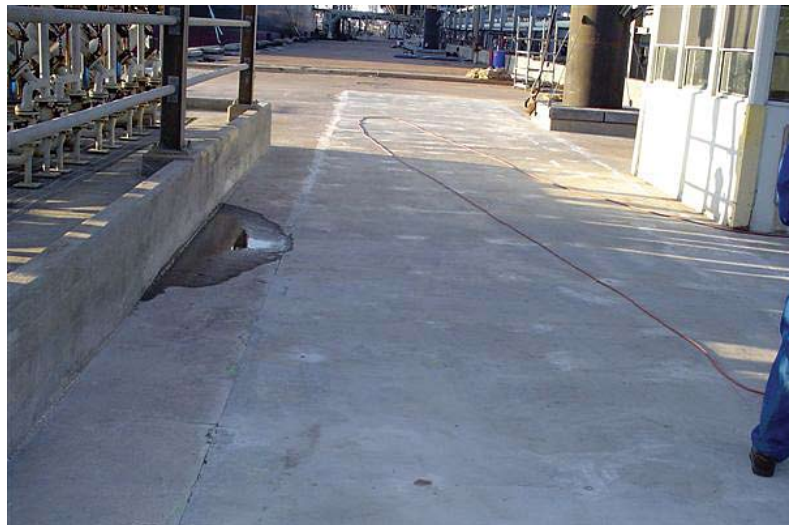
Finished shot after removing forms and filling PVC holes with grout

The concrete took 4 days to cure, achieving 4000 psi (27.6 MPa) during that time. Once the concrete had been cured, crews removed the coil rods that were sleeved with polyvinyl chloride (PVC) and filled the holes with cementitious grout.
