Hopkins House Concrete Repairs and Protection Systems Installation

Baltimore, Maryland

Submitted by Structural Preservation Systems

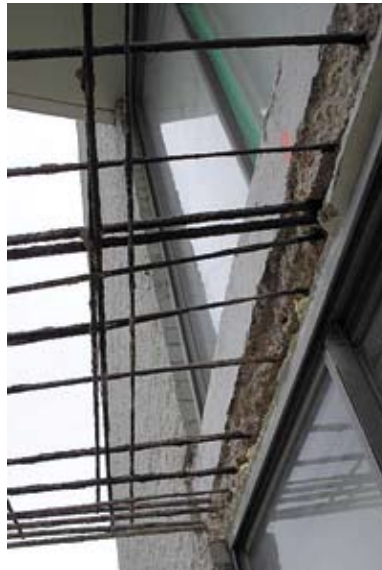
After the concrete was demolished in several balcony repair locations, significant reinforcing steel corrosion was visible. Many reinforcing steel bars within the cantilevered balcony slabs lost a significant amount of cross section due to rust. New reinforcing steel was spliced into the existing reinforcing steel layout

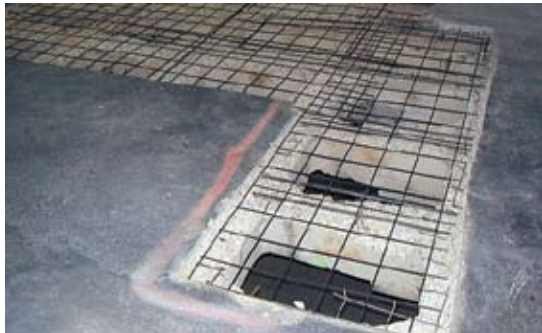
One of the parking garage full-depth slab repairs, prior to installation of zinc anodes for galvanized cathodic protection. At this phase in the repair, zinc anodes were attached to the reinforcing steel and wire mesh system along the perimeter of the repair area

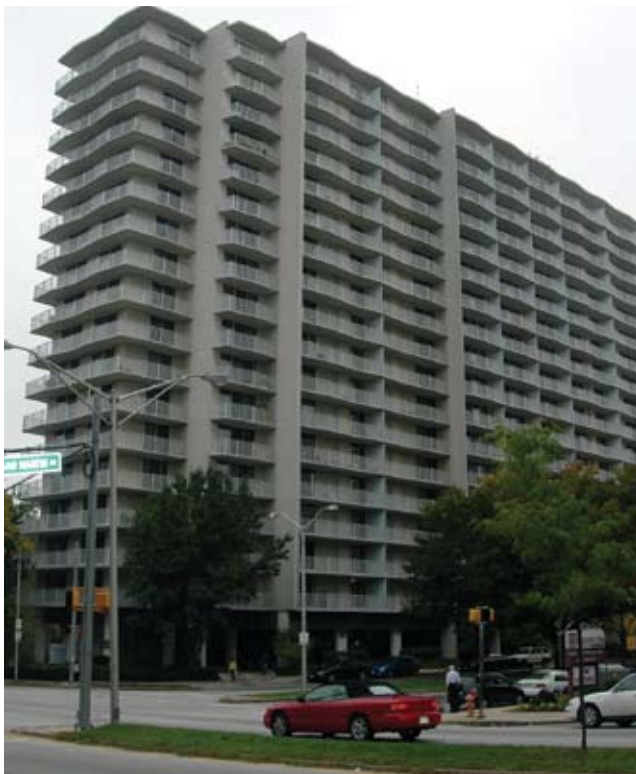
Concrete repairs, pedestrian duty coatings installations, masonry repairs, new handrail installations, and new window installations were all performed during this project

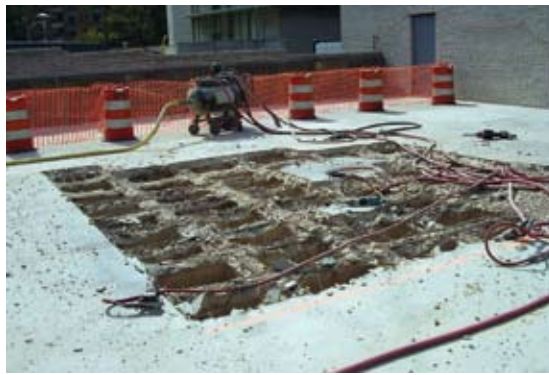
Another unforeseen challenge was that one level of the parking garage had significant water drainage problems, which led to the deterioration of a large portion of the slab. Over the years, a multitude of drains were installed as new areas collected water. The repair contractor corrected this issue by performing a large full-depth concrete repair at this parking level and then finished the concrete with a proper slope to the remaining drains.

A large portion of the top level of the parking garage experienced deterioration due to poor drainage. This slab was repaired in one large deck repair and was finished with the proper slope to permanent drains, which allowed the contractor to eliminate several of the existing drains and improve the drainage of the top level parking deck

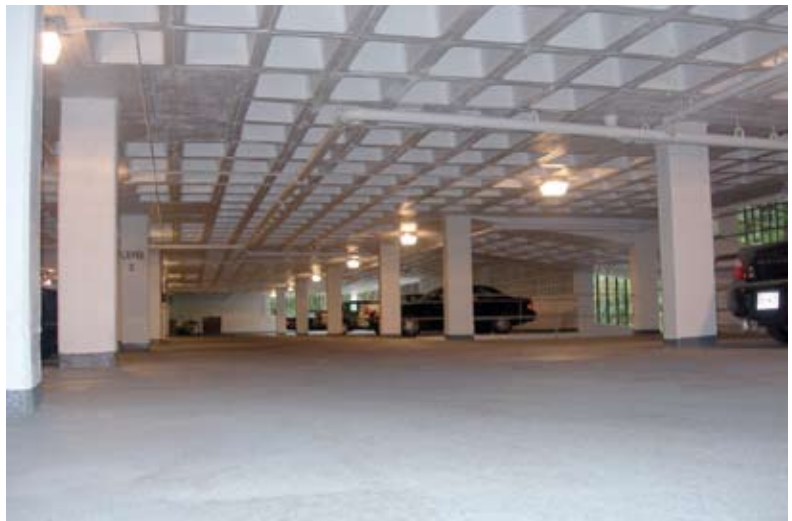
Concrete repairs using galvanized cathodic protection, protective traffic bearing coatings, and painting of columns, walls, and ceilings were performed in the five-level parking garage
