Historic Category

Ronald Reagan Washington National Airport Terminal: A Historic Concrete Façade Rehabilitation

Gravelly Point, Arlington, Virginia
Submitted by C.A. Lindman, Inc.

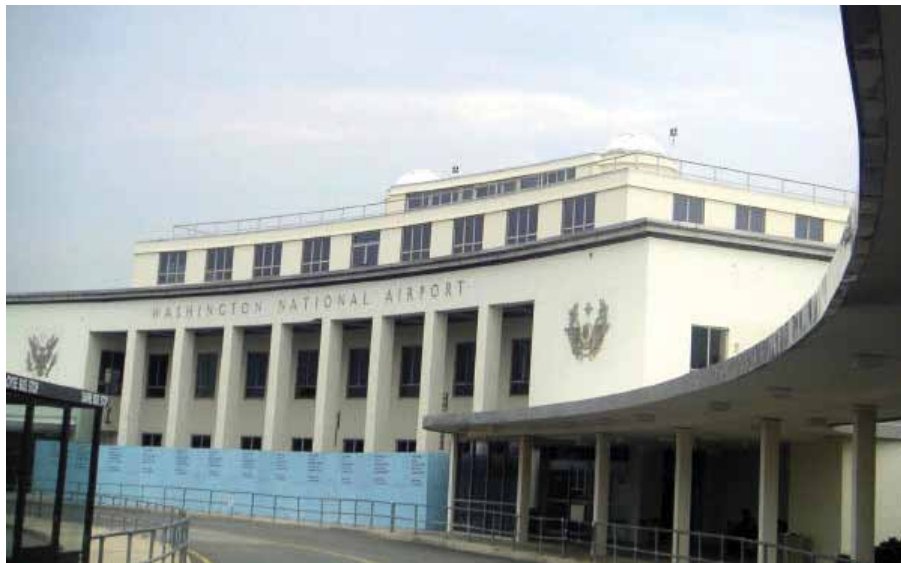
Before construction

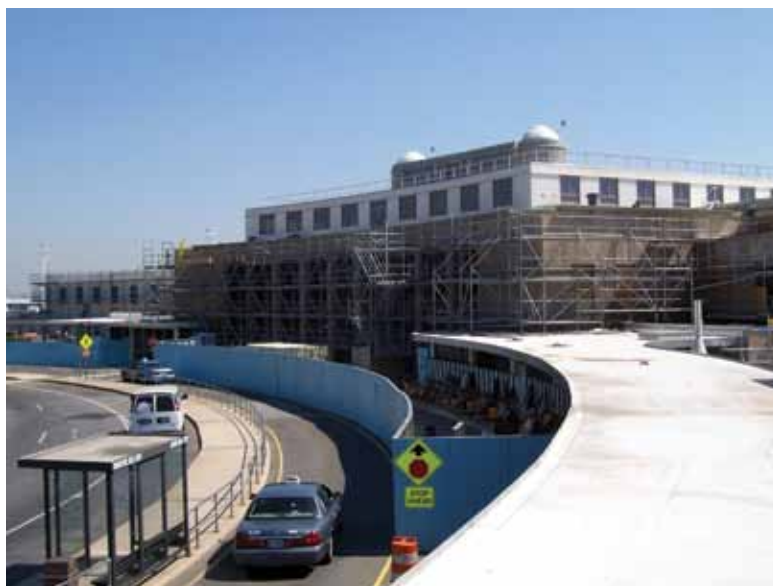
During construction

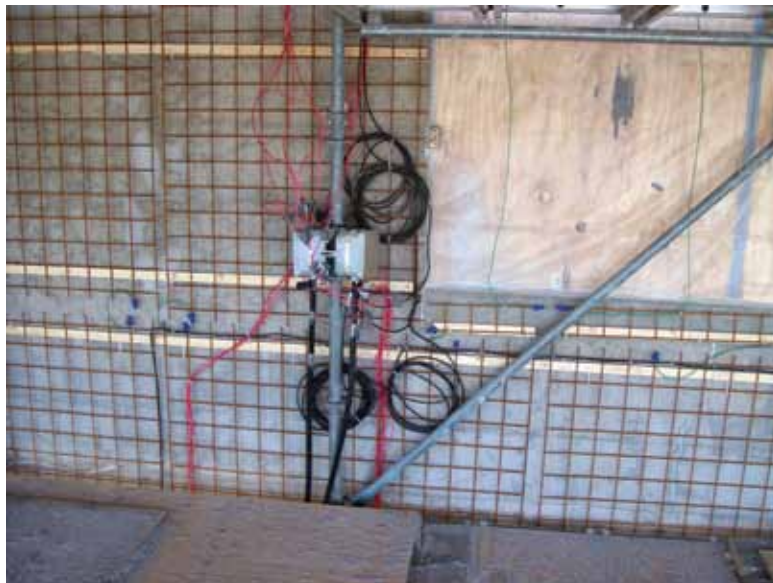
Setup for realkalization without absorbent media cover

The contractor and a designated subcontractor set up the processes for realkalization to 100% of the surface area, 22,000 ft² (2044 m²). A steel mesh electrode was attached to the structure. The electrode was embedded in a nontoxic biodegradable electrolytic media. Next, electric contacts were established between the attached electrode and the steel reinforcing inside the concrete. When an electric field is applied, chloride ions migrate away from the reinforcing steel toward the externally attached electrode, eventually ending up in the temporary electrolytic media, which is then discarded. Simultaneously, alkali ions migrate from the electrolyte into the concrete, raising its pH to the original levels. The passivating layer of the reinforcing steel is thus reestablished to protect them from corrosion. This system required 72-hour constant charge and monitoring.

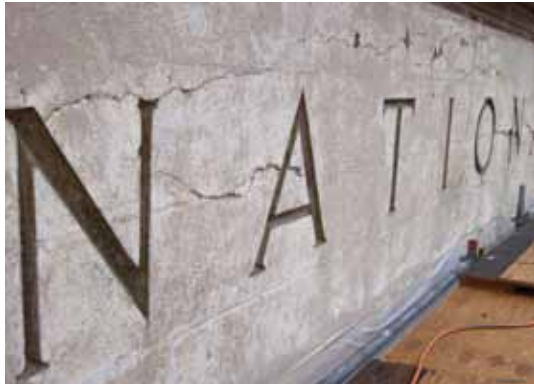
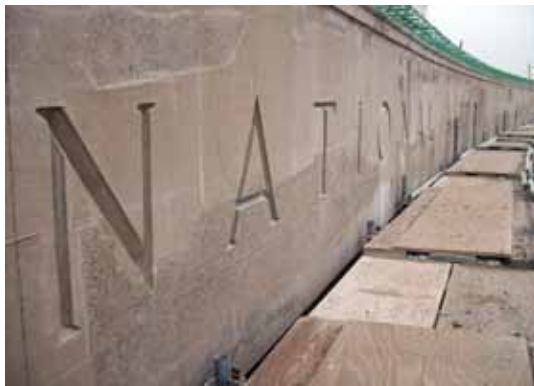
Large field carved lettering panel

The large field-carved name panel above the loggia was one of the most severely damaged areas, requiring not only expert masons but also carvers to return the lettering to its original state, which would later be gilded upon completion. Larger spalls, such as the 240 linear feet (73 m) radius cornice, were removed completely. New reinforcing steel was set and tied and special forms were created, set, and poured with the specified concrete mixture.

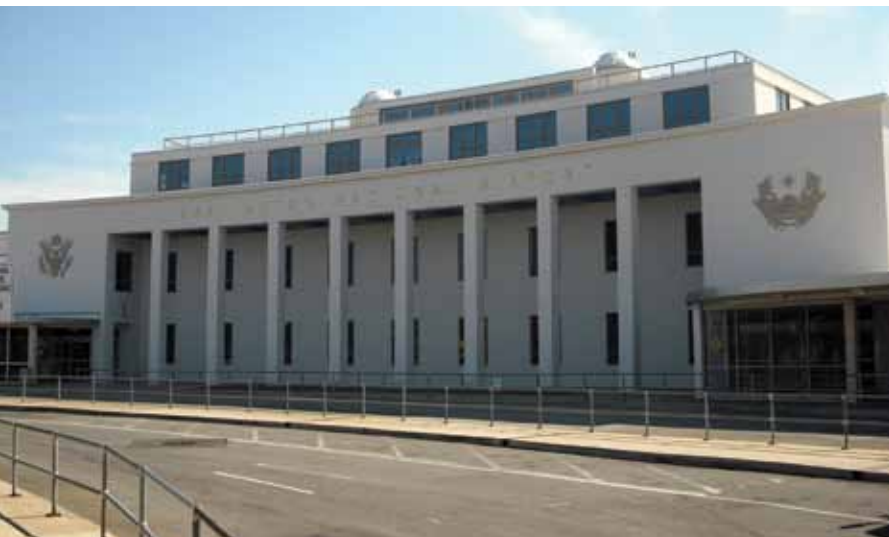
Completed façade

After allowance for proper curing of repair mortars, the contractor's forces began the massive effort of preparing the surfaces again and applying three and sometimes four coats of a potassium silicate mineral-based specialty coating system to all of the façade elevations, approximately 24,740 ft² (2298 m²). This material was chosen by the preservation architects to enhance and protect the Terminal A structure for a minimum of 25 years with proper maintenance. Windows, doors, eagle emblems, and signage received hand-applied paint systems as required, including gilding the incised lettering "Washington National Airport."
