Park Hudson Garage Restoration

North Bergen, NJ

Submitted by Structural Preservation Systems, LLC

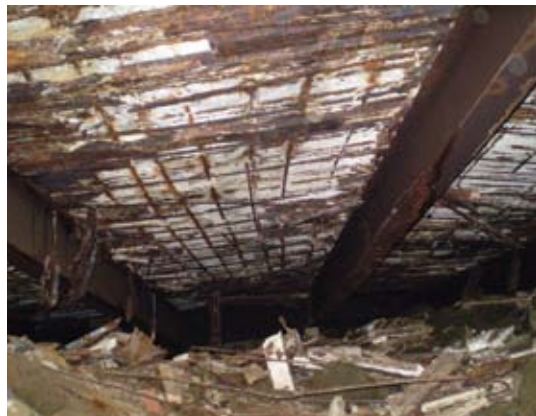
The underside of the existing ramp prior to repair

Severe corrosion and structural decay developed as a result of humidity from the nearby river, harsh weather, and chlorides from deicing salts.

Because most of the deck floor drains were clogged and the slab had little pitch to facilitate drainage, water would pool on the deck for long periods of time. The combination of pooling water and high chloride content from deicing salts contributed to the decay of concrete and structural steel. Finally, erosion of the steep hillside on the west side of the structure had buried several column bases and beams, causing the soil to hold moisture and cause decay.

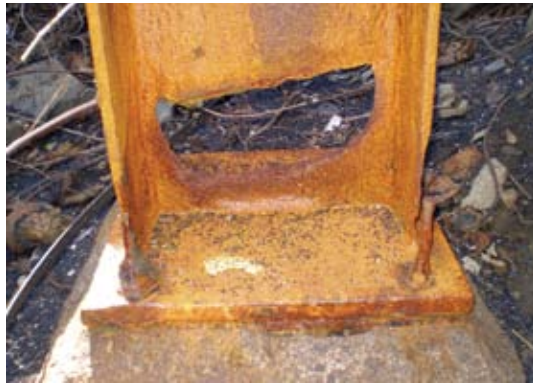
Erosion of the steep hillside on the west side of the structure had buried several column bases and beams, causing the soil to hold moisture and cause deterioration

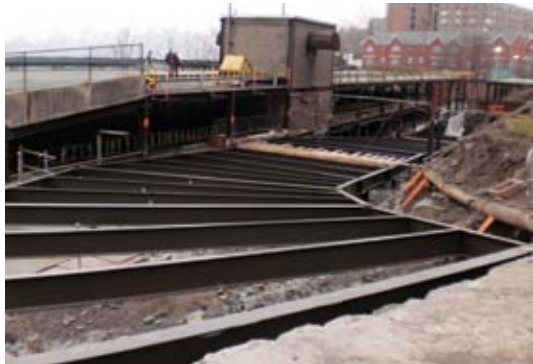
Looking down the ramp after new structural steel was placed

Several new and unexpected conditions were exposed throughout the project and resulted in numerous scope changes and additions, three of which were very significant. Changes involving the ramp included the complete replacement of the all-steel framing at the ramp, as well as the removal and replacement of the area at the west side in between the first and second floors. Additional steel work included supplementary details to address extensive corrosion at the base plates and almost 3000 linear ft (915 linear m) of structural steel to replace existing steel framing at the interior levels.

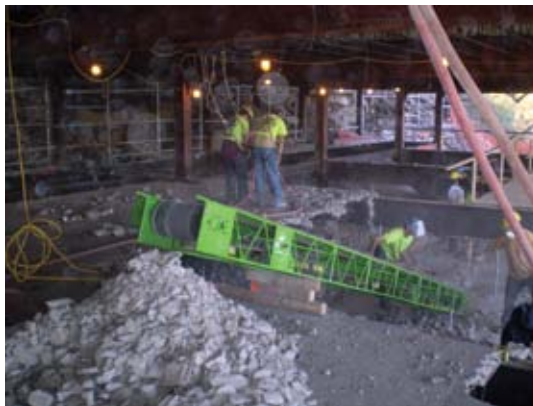
At the interior levels, debris was removed from the scaffold platform using conveyor belts and hauled to dumpsters using a small skid steer

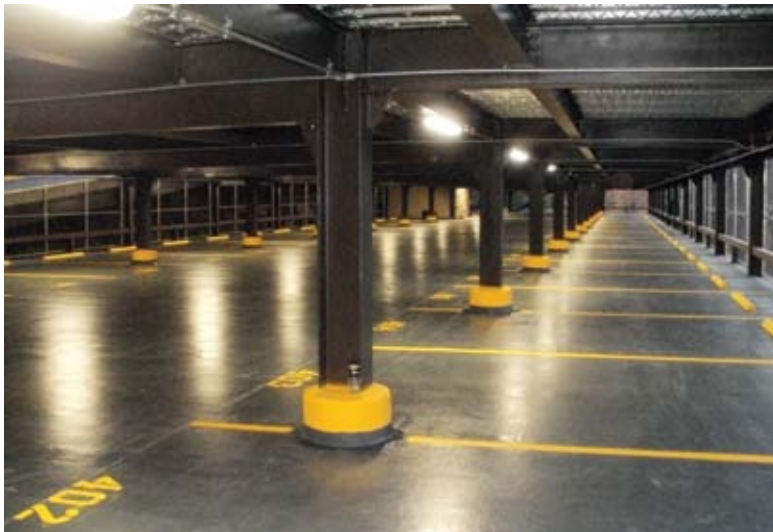
One of the completed interior levels

A traffic-bearing waterproof membrane was installed at the second, third, and fourth levels. At the first level and ramp, sheet membrane waterproofing and asphalt were installed. Drainage matting was placed between the membrane and asphalt and then asphalt were installed in three phases: one phase for the ramp and two phases for the first level.

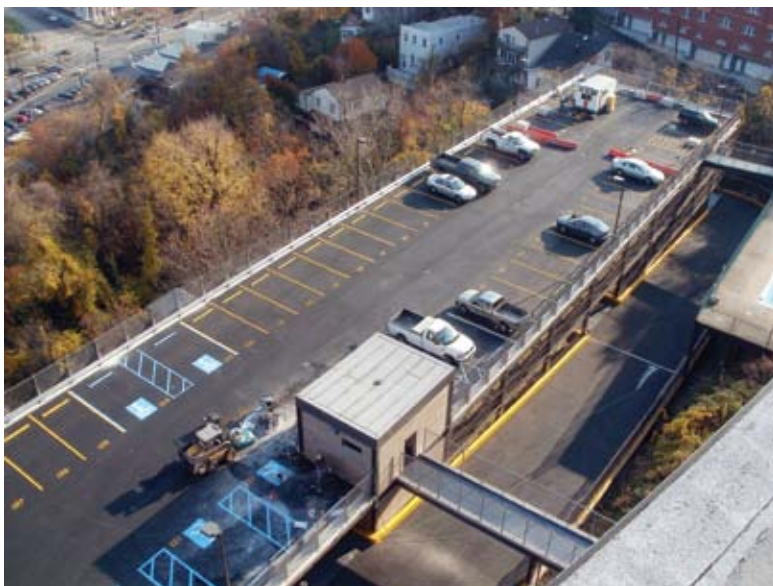
A view of the completely repaired/rebuilt garage from the top of the adjacent condominium complex
