The Todd Bolender Center for Dance and Creativity

Kansas City, MO

Submitted by Structural Engineering Associates, Inc.

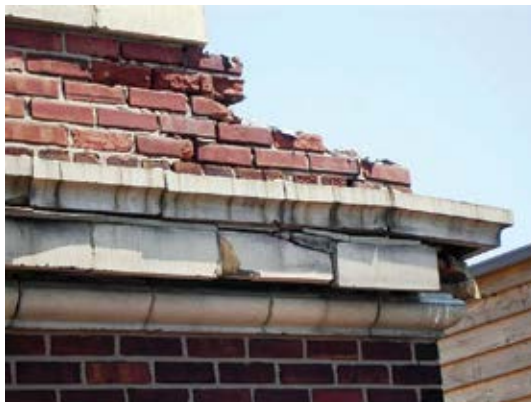
Typical deterioration of exterior brick and terra cotta cornices

The exterior brick façade, penthouse, and chimney base were to be 100% repointed (158,000 ft [48,158 m] of brick joints). In addition, much of the original architectural terra cotta had to be repaired or replaced. Nearly every cornice assembly needed to be re-anchored due to severe corrosion degradation of the existing anchor rods. During the masonry restoration of the structure, some 17,500 period bricks were removed and replaced (the project team was able to locate matching bricks from the original kiln in Oklahoma) along with 268 pieces of terra cotta (replaced with matching glass fiber-reinforced concrete sections). A total of over 134,000 ft² (12,449 m²) of brick and terra cotta was restoratively cleaned and sealed.

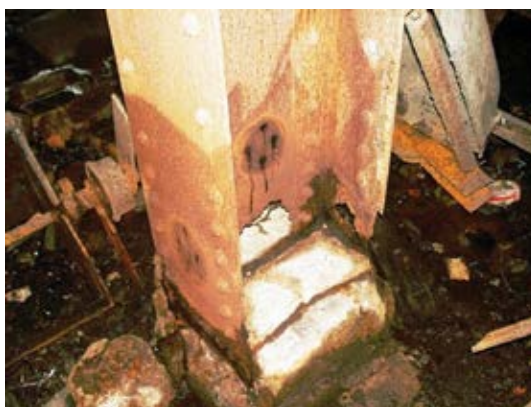
Deterioration of existing column section

Before any of the work in the badly deteriorated basement level could be started, 16 in. (406 mm) of standing water had to be pumped out. Many of the very large, heavily loaded steel basement columns had experienced severe corrosion and section loss of the bottom 2 ft (0.6 m) as the result of having been submerged in the equivalent of a wet-cell battery for over four decades. Severe corrosion delamination repairs on the concrete foundation walls and large tunnel connecting this site to the adjacent National Archives and Records Administration building were also required.

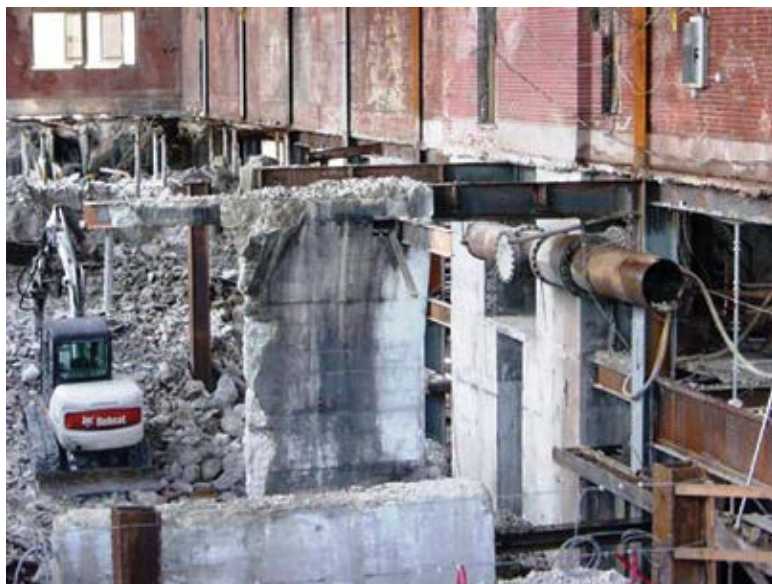
View of basement demolition

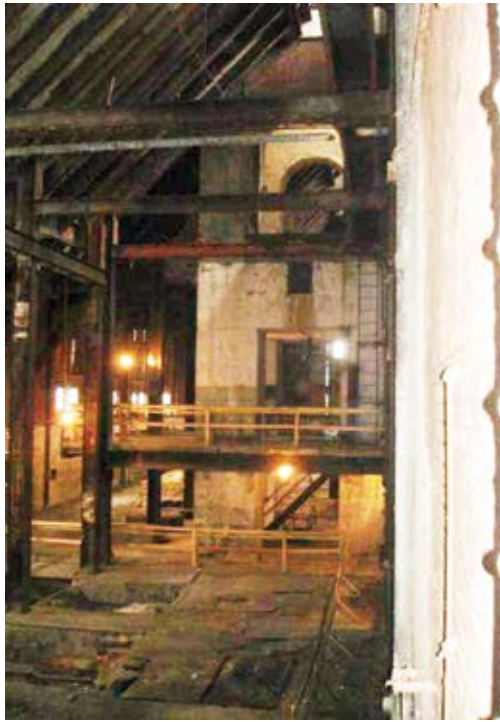
Interior after selective demolition

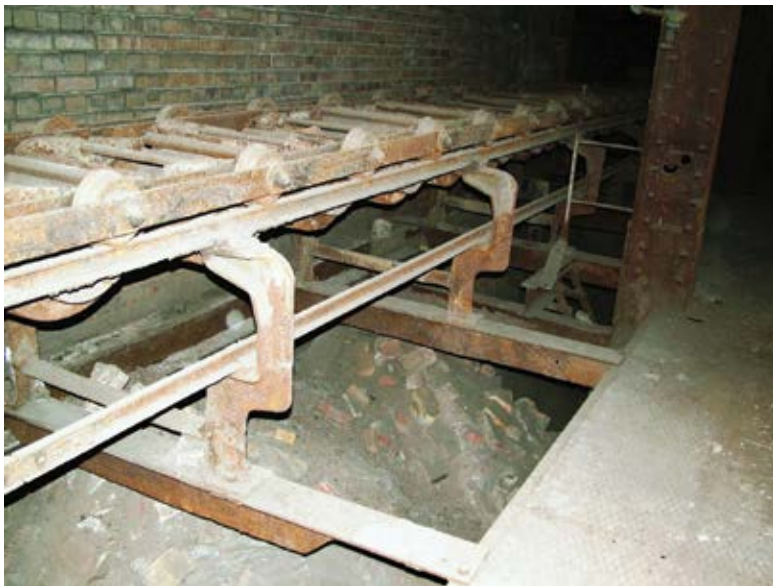
Existing coal conveyor boiler feed system

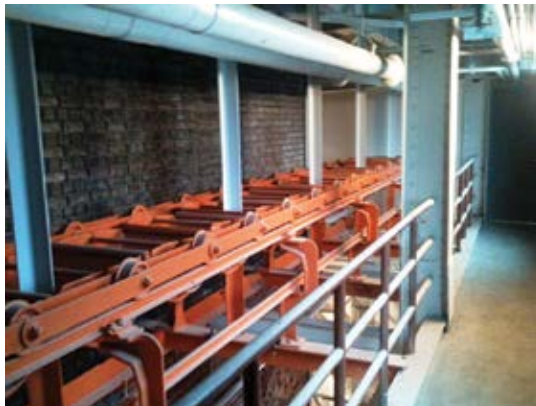
Restored conveyor system

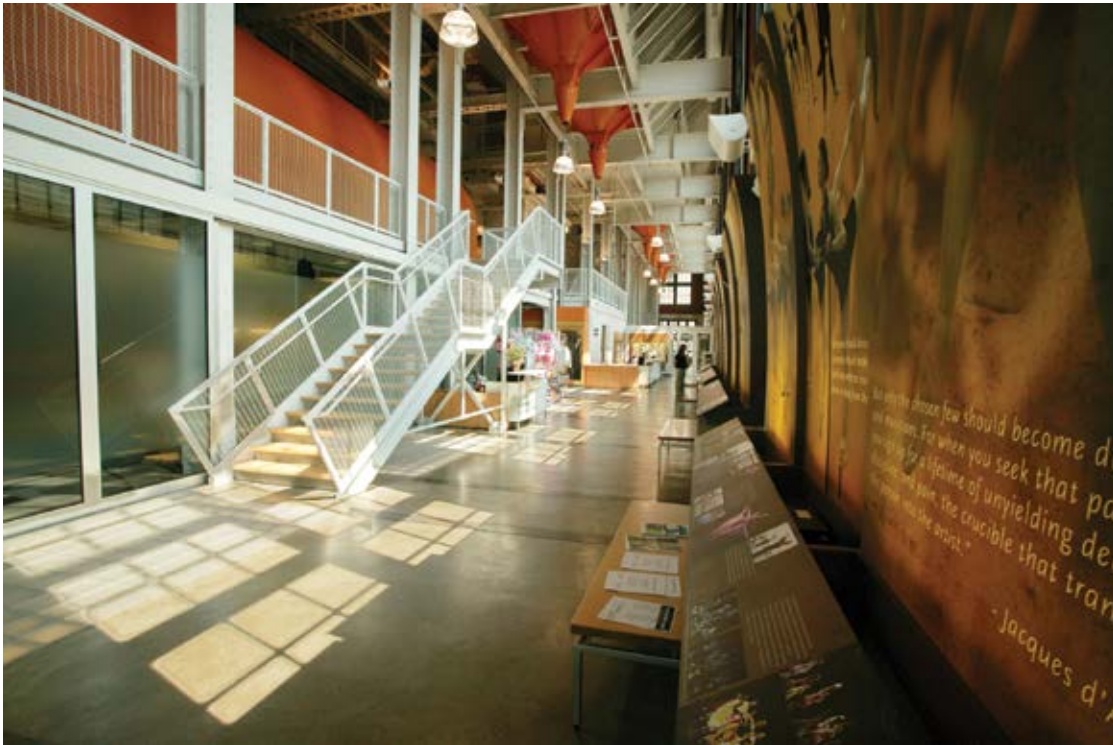
Restored interior view of hallway and upper mezzanine

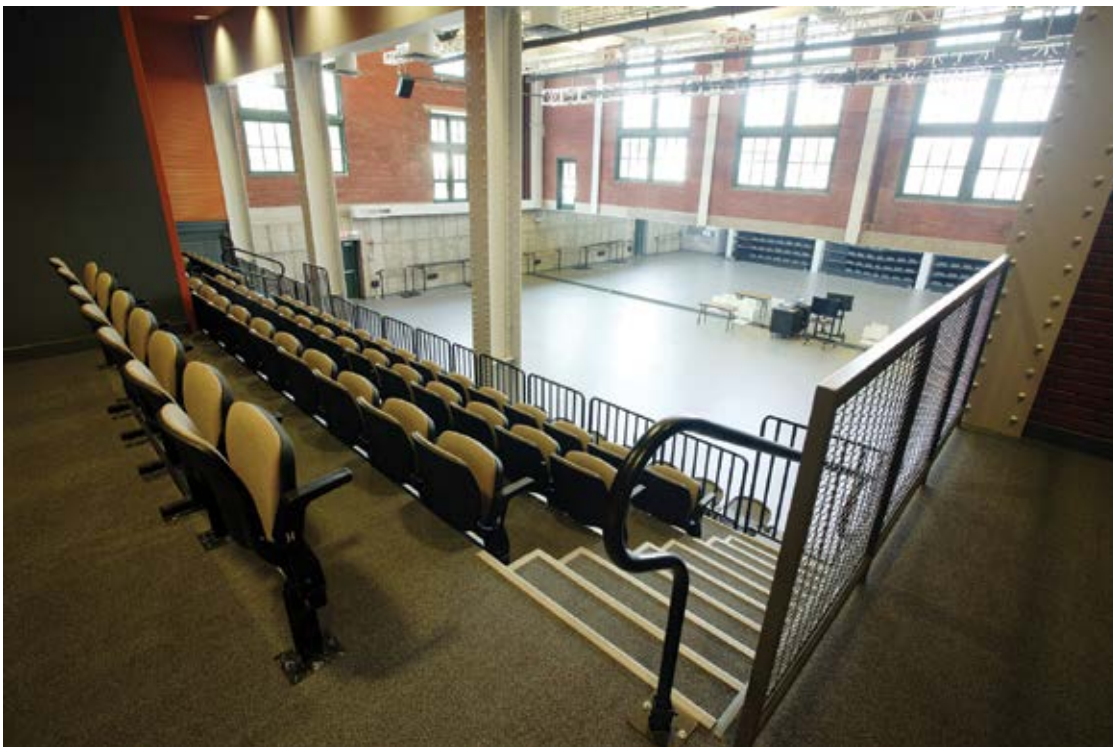
Restored interior view of dance studio

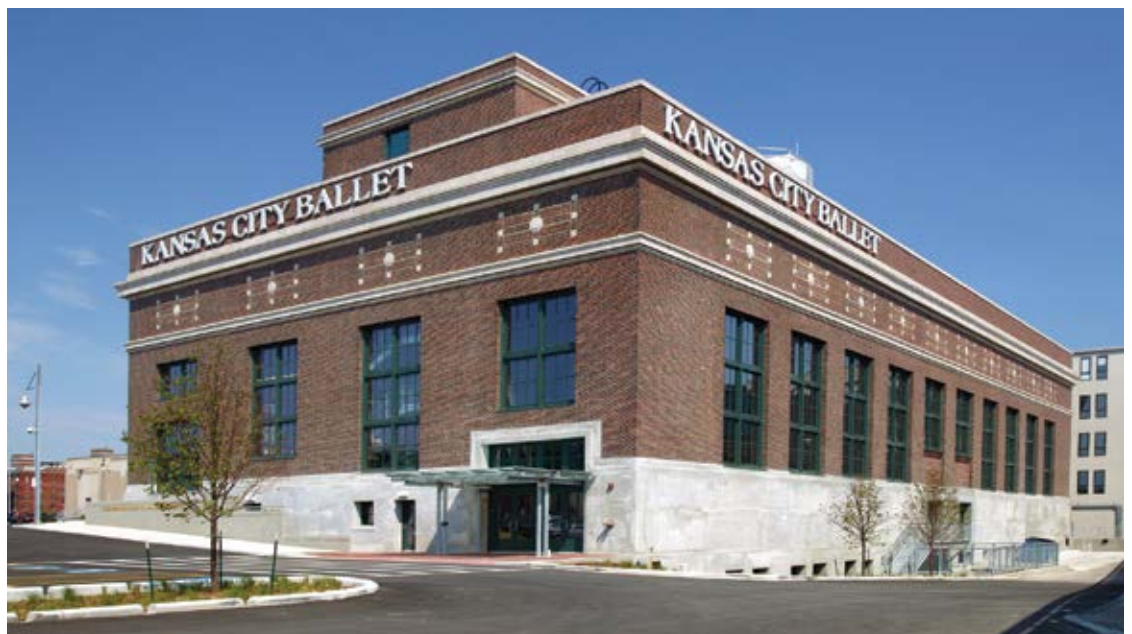
Exterior view of restored structure
