# Hotel Monaco Historic Cornice Repair Project

Washington, DC

Submitted by Smislova, Kehnemui & Associates, PA

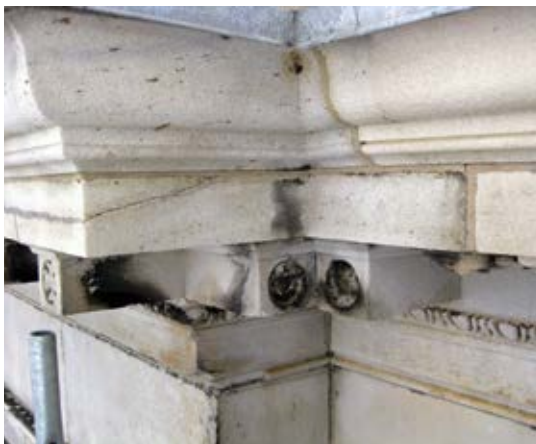
On July 15, 2010, a nearly 7 ft (2.1 m) long section of the lower cornice containing five dentils suddenly fell. The marble failed approximately 11 in. (279 mm) back from the face and the remaining surrounding marble was determined to be in sound condition. Initial investigations revealed that the failure was due to water infiltration through cracked and open mortar joints in the parapet capstone and cornice that expanded during multiple freezing-and-thawing cycles.

Atmospheric staining was present along 80% of the length of the break, suggesting that the crack had been there for some time prior to the failure. As the crack expanded and separated, the unaffected adjacent marble could no longer support the weight of cantilevered marble that had separated; eventually, the piece broke off. The capstone was found

*Condition of cornice prior to restoration*

cornice slab directly above the failed cornice was observed to have a significant crack that extended through its full thickness and a re-entrant corner piece of the lower cornice had a large crack. Both exhibited evidence of a similar delaminated condition due to moisture infiltration. There were also a number of rosette medallions found missing and 50% of those remaining were severely weathered and loose.

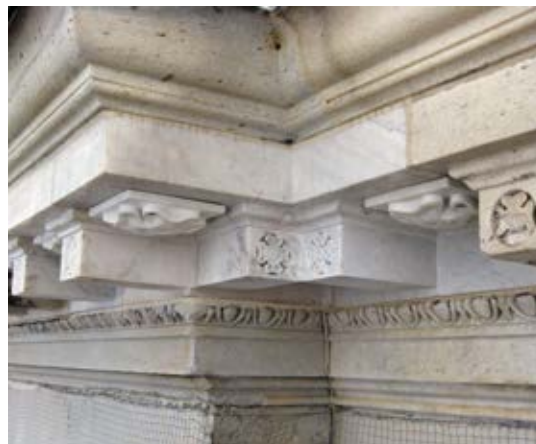
*Repaired cornice area*

While fabrication of the replacement cornice pieces and rosette medallions was underway, crews in the field meticulously removed the unstable portions of the cornice. Limits of replacement were carefully selected to minimize the number of parapet capstones that would need to be removed to access and install the replacement cornice elements beneath.

Upon successful installation of the cornice pieces, the sheet metal flashings were replaced in a better configuration. Joints between the sheets were fabricated to channel water away on either side of the joint so there is redundancy and the sealant joint is not the only means of waterproofing.

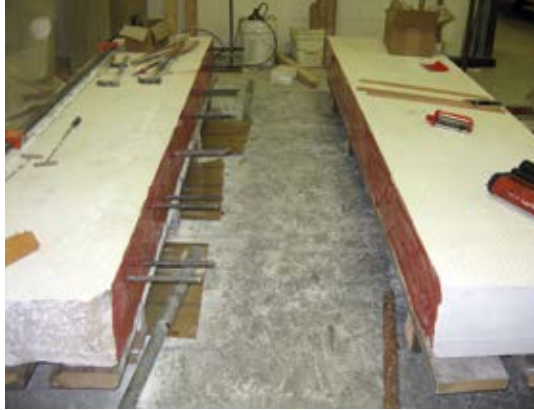
*Larger section being fabricated from smaller marble pieces*

Because there was virtually no lead time for the locally available salvaged Beaver Dam marble, fabrication of the replacement pieces began almost immediately. Slabs of the salvaged marble were not available in sizes large enough to fabricate the upper or lower cornices, so replacement cornice pieces were fabricated as two separate pieces and were doweled and epoxied together prior to site delivery. The doweled joints were embedded in the cornice assembly and were not visible to the exterior.

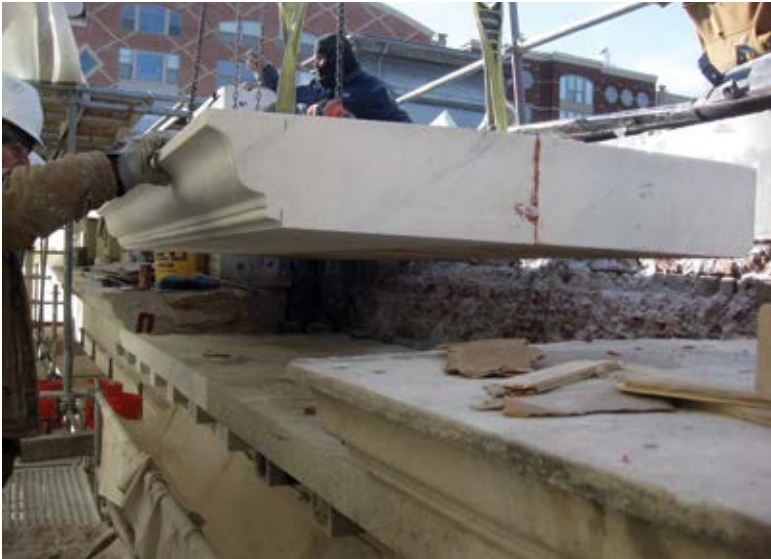
*Setting new cornice section*

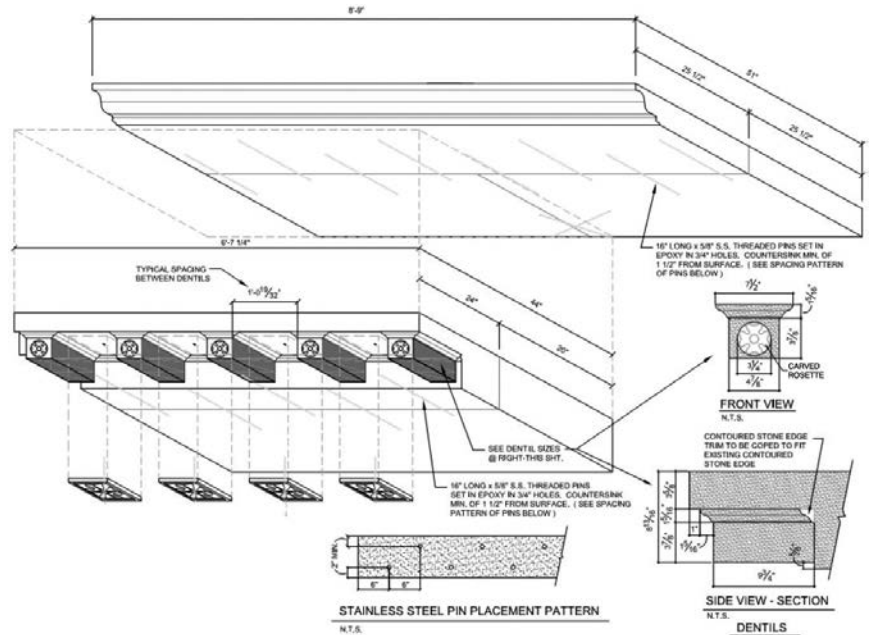
Diagram of repairs (Note: 1 ft = 0.3 m; 1 in. = 25.4 mm)

In addition to the replacement of the failed pieces, a number of other proactive repairs, including repointing, Dutchman repairs, face patching, epoxy crack injection, and pinning and stabilization of loose and/or exfoliating façade elements. General cleaning of the marble façade within the repair area was also included as part of the scope of work.
