Rehabilitation of Kellogg Grain Storage Silos

Querétaro City, Qro., Mexico

Submitted by BASF

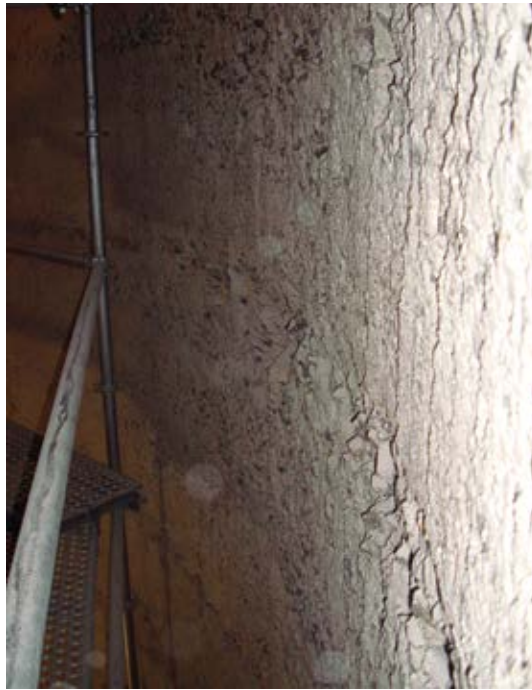
The newer batteries of the silos had a significant number of construction joints that were in such poor condition that some of the silos had been deemed unusable and were not in operation, despite the client's storage needs. The construction joints were found to be highly porous with delamination and extensive cracking present. Due to the number and proximity of some construction joints, the grain stored in several of those silos had eroded the interior surface of the concrete walls to such an extent that the cementitious matrix had almost disappeared, leaving the coarse aggregates barely fixed in a reduced wall section. In addition, large cracks were present throughout the interior walls.

Existing condition of silo wall prior to rehabilitation

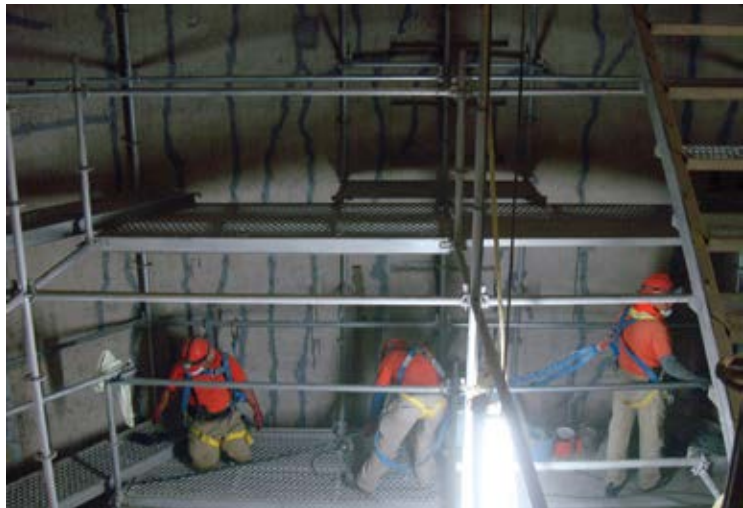
Epoxy injection of cracks

Structural integrity of the silos was restored by a number of remediation measures that included epoxy resin injection of cracks and concrete patching of construction joints. Concrete patching without risking the formation of cathodic areas was possible because of the relatively low and localized chloride content. Structural section restoration and strengthening of the walls in the silos with an improved resistance to abrasion was achieved by the installation of an FDA-approved epoxy lining reinforced with glass cloth.

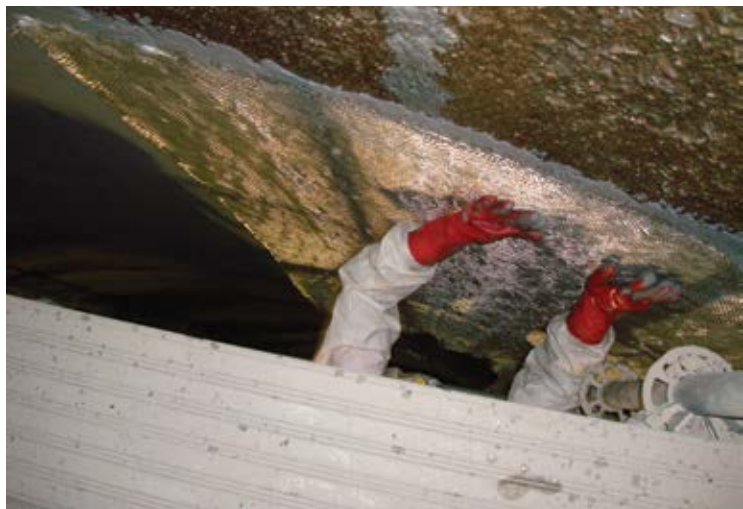
Worker applying reinforcing mesh to silo wall

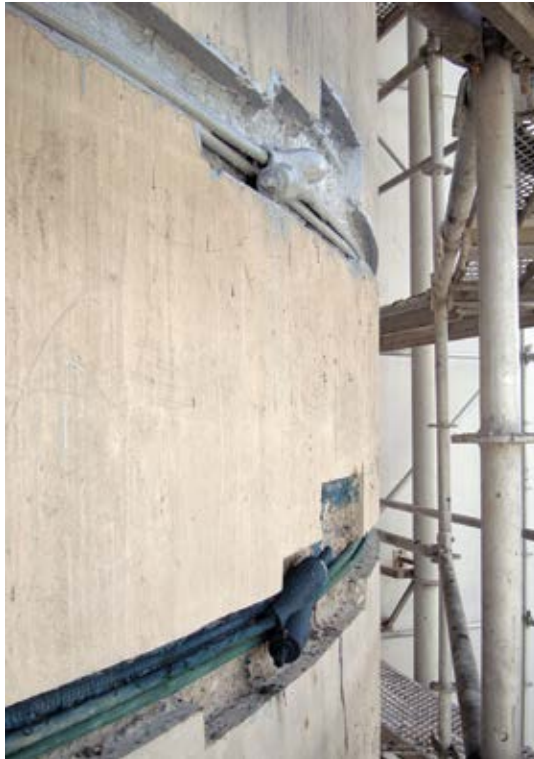
Post-tensioning cable installation

Because of the continuity of the silo walls within a given battery, an extremely detailed design of the post-tensioning system was developed. The system involved drilling through both ends of common walls and opening small boxes in the interior of the silos to allow for the placement of tendons. Drilling to that length was not possible without potentially damaging both the existing steel reinforcement and concrete. This also provided a means to control the levelness of the cables. Change of direction in the cables was carefully designed so as to achieve a smooth change in the local direction of the stresses within the concrete.

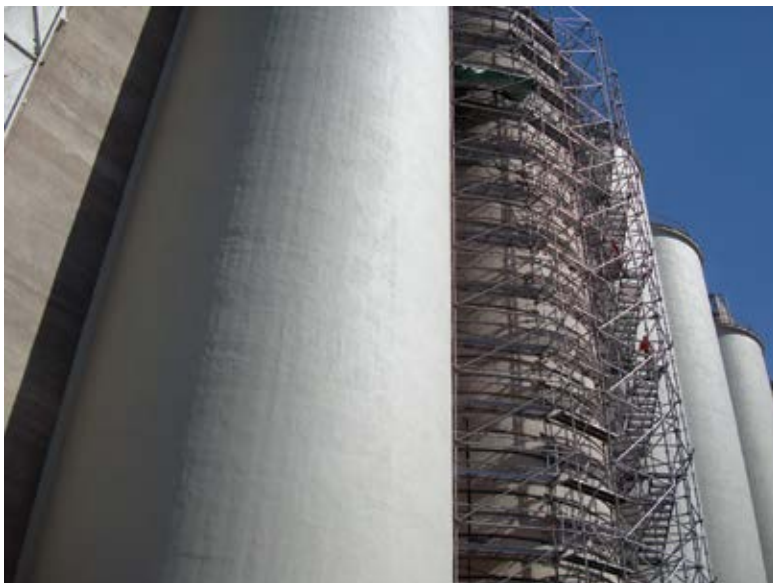
View of finished exterior covering post-tensioning cables

To protect the concrete in the system of silos from additional carbonation, a carbon dioxide diffusion barrier system was applied on the exterior. The system used was a both a modified polymer and an elastomeric acrylic coating.
