Repair and Preventative Maintenance of the East Monroe Street Parking Garage

Chicago, IL

Submitted by Walsh Construction Company

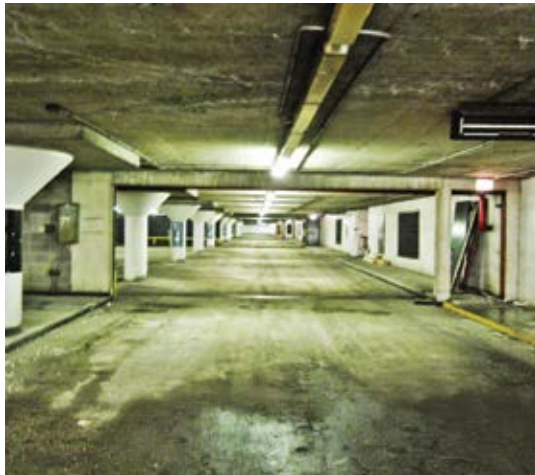
Existing drive lane of the parking garage prior to repair

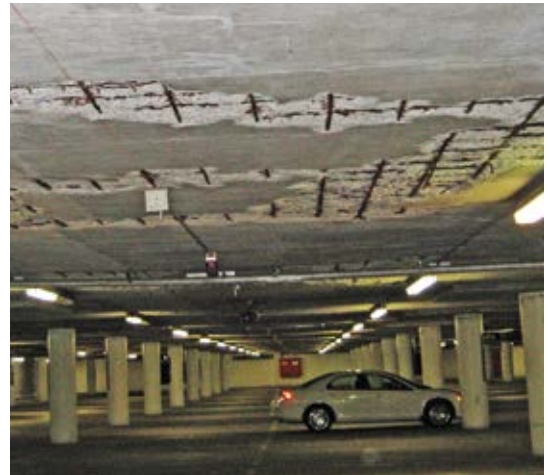
Existing ceiling of the lower level prior to repair

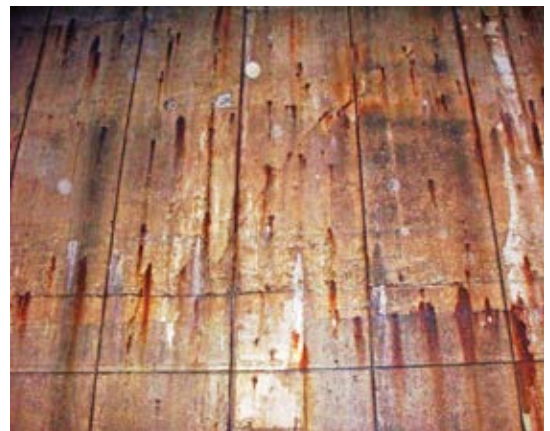
Existing conditions on the north wall prior to repair

The north exterior wall showed severe deterioration from years of exposure to moisture and deicing salts that leaked through a failed expansion joint from the public sidewalk area above. The delaminated concrete was removed from the wall surface, then sandblasted and inspected, and new reinforcement was placed. The wall needed to be framed and saturated until placement. The concrete was placed mainly by truck, pumping self-consolidating concrete along with hand-mixed material into a framed cavity. All the work was done off of swing stages.

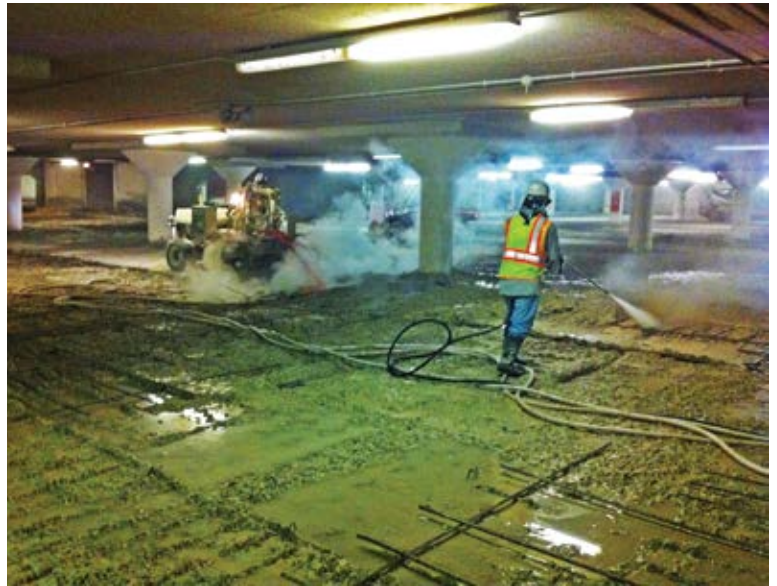
Up to five hydrodemolition machines working at once

Hydrodemolition (milling) was chosen as the most efficient approach. The combination of underground work and hydrodemolition posed distinct challenges not typically present in most projects. The roaring noise coming from the specialized equipment was over 100 decibels, creating a communication challenge. Furthermore, 36,000 psi (248 MPa) of water pressure was used to selectively remove portions or, in some areas,

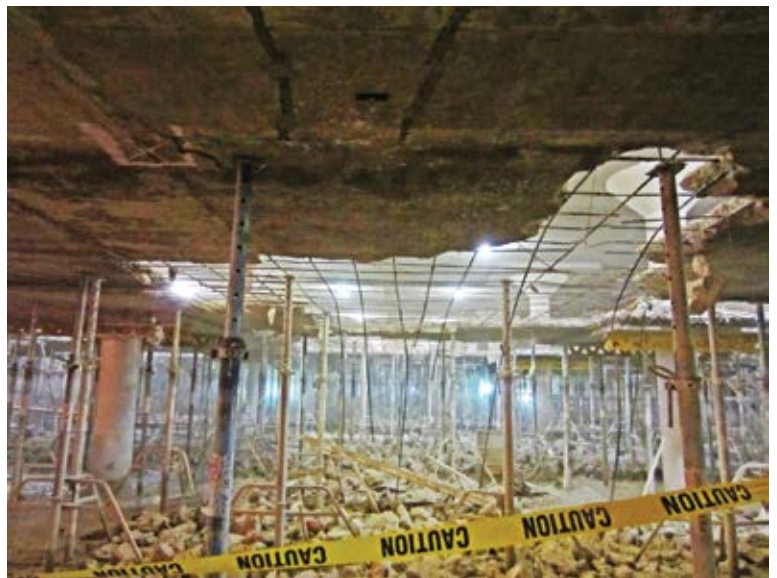
Lower-level shoring and reshoring due to unforeseen conditions

Unexpected and unforeseen conditions that presented unique challenges to the team included reshoring column drop heads due to the extensive amount of full-depth repairs, which compromised

the drop head connection to the existing floor. A complete redesign of fire suppression systems was necessary based on the City of Chicago requirement of a two-sourced water supply for the dry sprinkler system, which involved direction boring to tap into the waterline from Monroe Street.

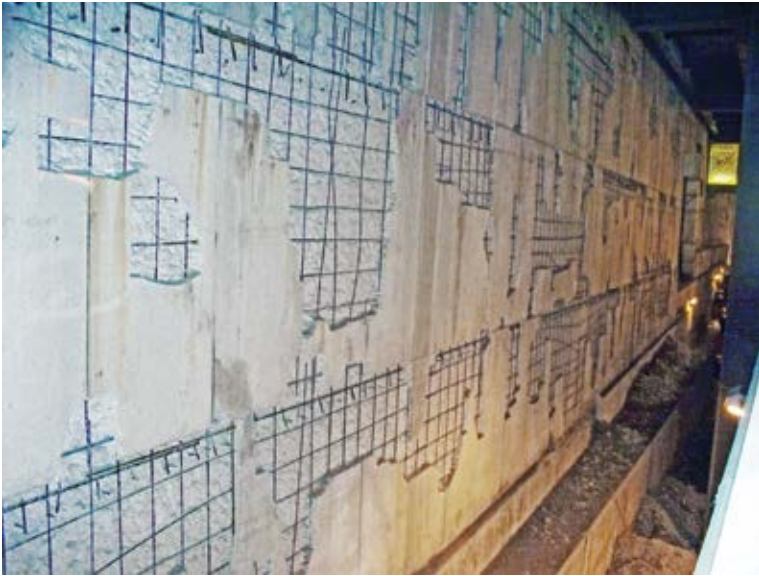
North wall demolition and prep for receiving concrete

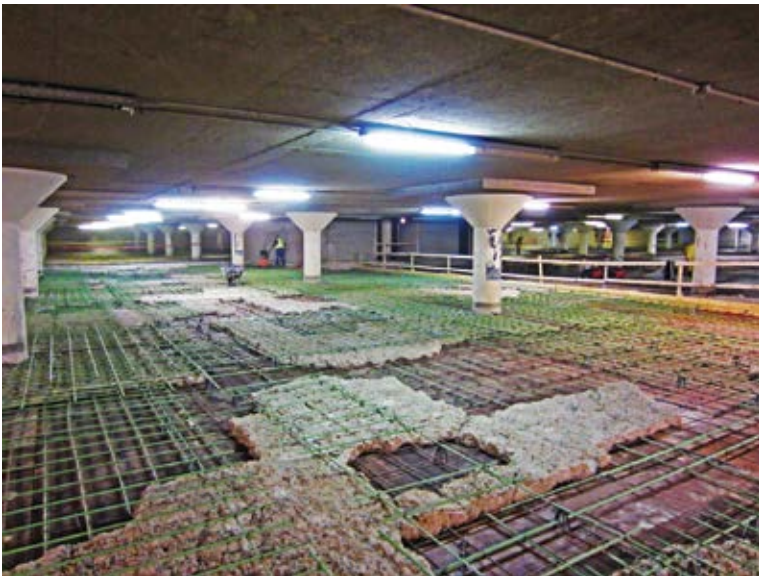
Prepour inspection of a concrete slab that includes full-depth repairs

Each full-depth area was framed, and new epoxy-coated steel was installed in the top mat of reinforcing as well as in the bottom mat in full-depth areas. Concrete was placed from the top surface through air shafts by truck pumps. A pipe system was brought in to be used once underground to transport the concrete to the placement area. From that point, the slabs were water cured according to the specifications.

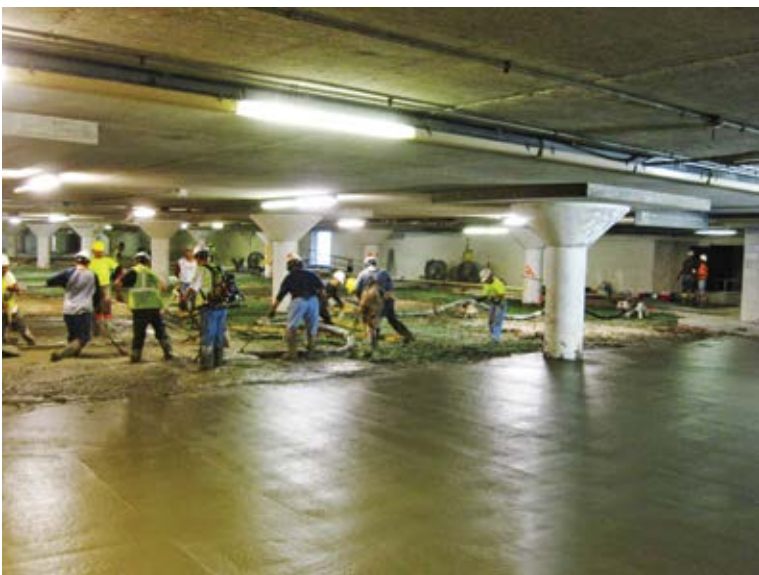
Crews placing concrete

The next step of the process was saturating the surface with water, covering it with wet burlap, and then covering it with plastic to retain the moisture for a minimum of 24 hours. The plastic and burlap were peeled back one bay ahead of the pour on the day of placement. The slabs were placed in 14 ft (4.3 m) bays at an average of 18,000 ft² (1672 m²) per placement. The surface was then wet-cured using the burlap and plastic from the saturated-surface dry (SSD).

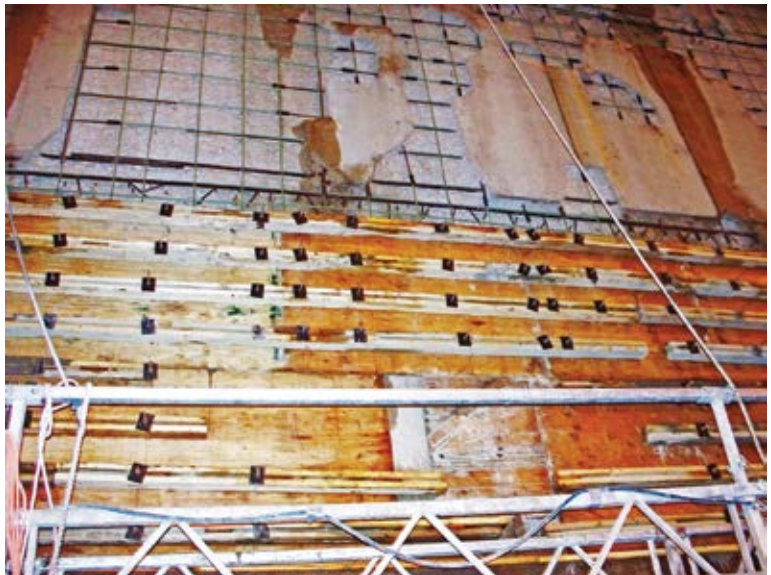
Placing of concrete at the north wall

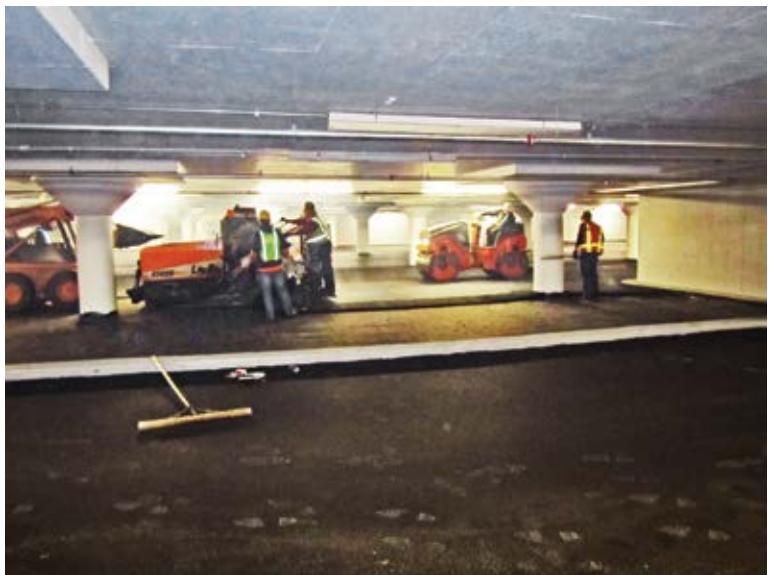
Waterproofing and asphalt process on the upper level

To ensure the longevity of the new structure, low water-cement ratio concrete, epoxy coated steel, and a polyester-reinforced, hot rubberized waterproofing membrane was placed over the water-cured slabs. This high-performance waterproofing system was then protected by a minimum 1.5 in. (38 mm) thick, asphalt-paved driving surface. The new slab surfaces were shotblasted clean to ensure proper bond of the membrane to the slab.

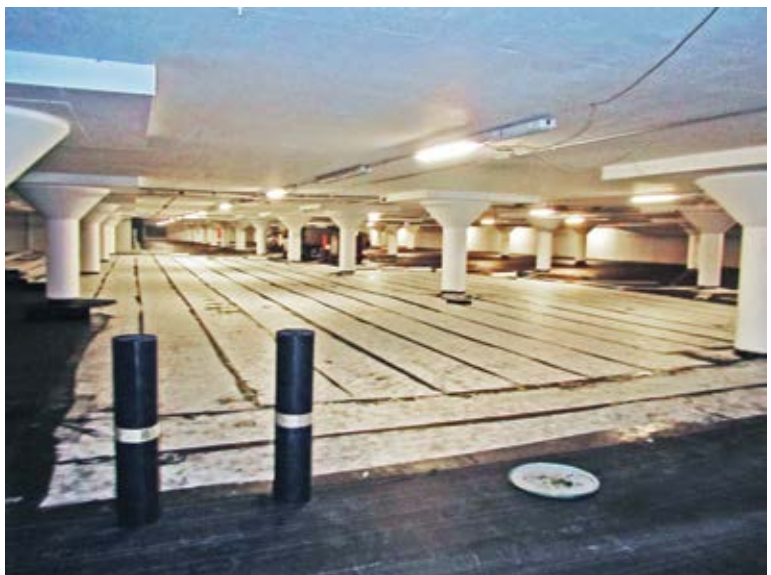
Waterproofing of the parking garage and repaired ceiling prior to painting

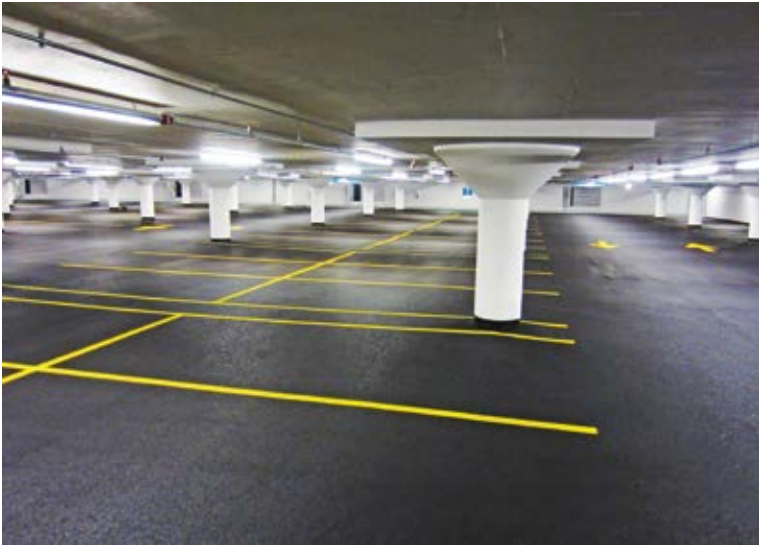
Finished drive lane of the parking garage

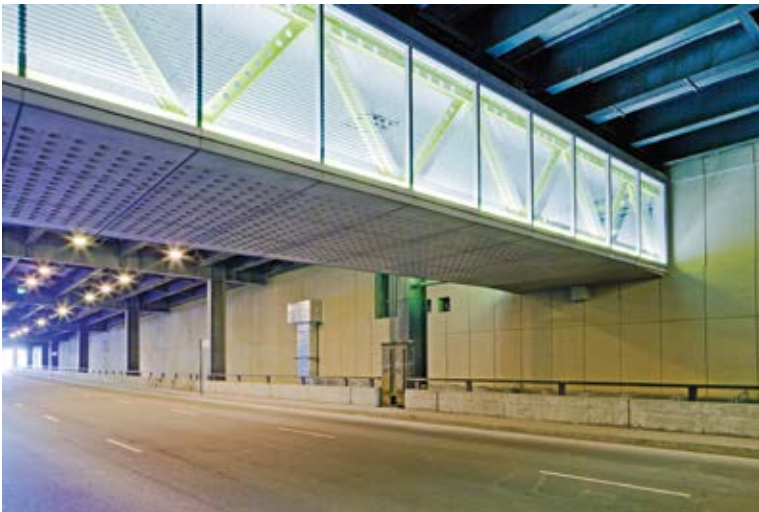
North wall finished

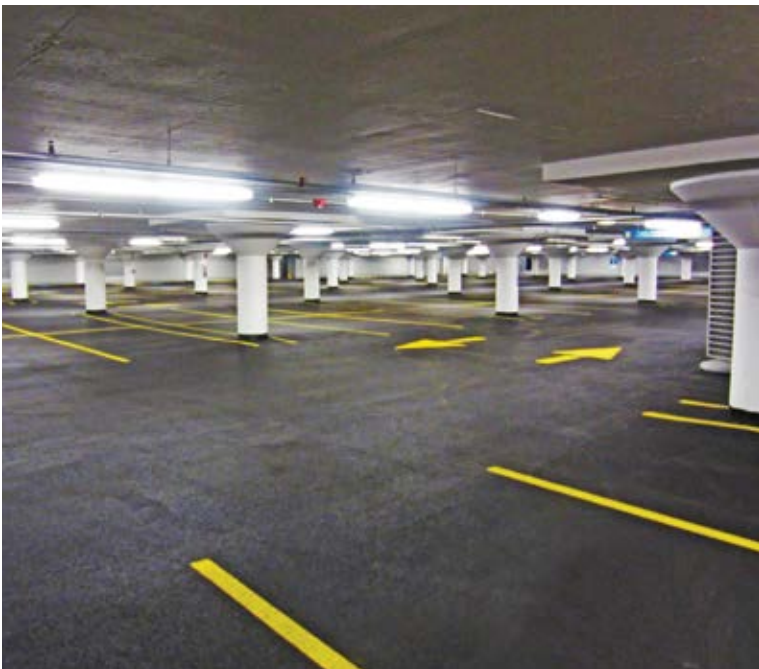
Finished parking garage
