# Houston Hobby Airport Parking Structure Rehabilitation

Houston, TX

Submitted by Whitlock Dalrymple Poston & Associates, Inc.

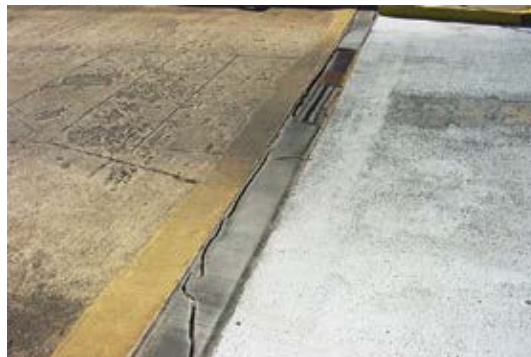
Most of the expansion joints (approximately 7000 ft [2130 m]) had failed (Fig. 1). Joint sealants between precast and cast-in-place concrete elements had also deteriorated. The ingress of water through the joints not only created a serviceability problem but also left the anchorages of the slab post-tensioning vulnerable to corrosion.

Fig. 1: Expansion joint failure

Expansion joint seals were replaced throughout the structure and incorporated the use of prefabricated, compartmentalized, elastomeric joint seals with integral flanges (Fig. 4). The flanges were bonded to the adjacent concrete using an elastomeric concrete header material, providing a robust expansion joint system. Prior to installation of expansion joint seals, extensive concrete repair was performed at the edges of the joints, which included reconditioning and select relocation of corroded post-tensioning anchorages.

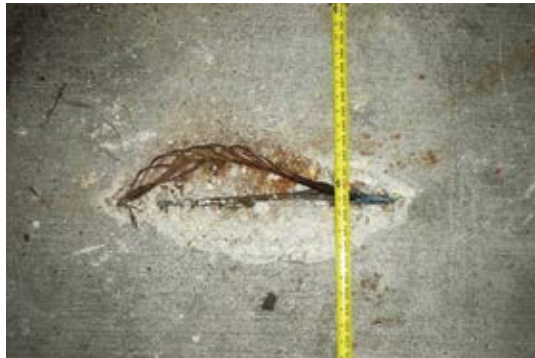
performed at select locations, which revealed the tendons to be in generally good condition. Significant levels of deterioration were only observed when the tendons were exposed and their sheathing was compromised. Additional tendon failures occurred between the investigation and repair phases (Fig. 2). Corrosion testing did not indicate a significant level of corrosion activity where deterioration was not present. The slab had not, in general, experienced widespread corrosion of the embedded steel reinforcement, including the post-tensioned tendons.

Fig. 2: Post-tensioned tendon failure

Broken post-tensioning tendons that were discovered during the investigation and repair were replaced by extracting the existing steel strands,

pushing new strands through the existing sheathing, and stressing the strands.

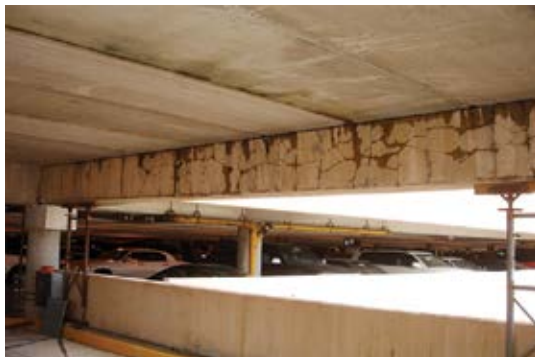
The bridge structures, which link the main parking structure to the entrance and exit helixes, were identified as a potential safety concern by the engineering consultant and were immediately shored as a result. The investigation revealed some progressive deterioration of these structural elements, evidenced by significant cracking in both transverse and longitudinal directions on each face (Fig. 3). Additionally, the precast hollow-core concrete slab units that were supported by the girders were experiencing significant deterioration evidenced by cracking, efflorescence, and failure of prestressing strands.

Fig. 3: Deteriorated bridge beam (inside face)

As a result of the extensive deterioration discovered during the investigation, the bridges connecting the main parking structure to the helixes were replaced. The bridges were gen-

erally replaced in kind, except that solid prestressed slab units were used instead of hollow-core slab units. The new bridges were sandblasted to achieve a uniform, exposed aggregate surface finish similar to the existing, adjacent precast concrete façade panels.

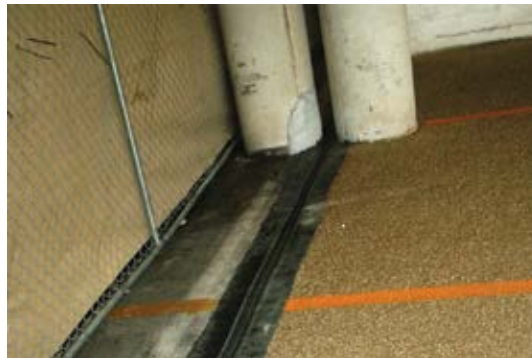
Fig. 4: Replacement expansion joint (epoxy overlay on right; existing concrete slab on left)

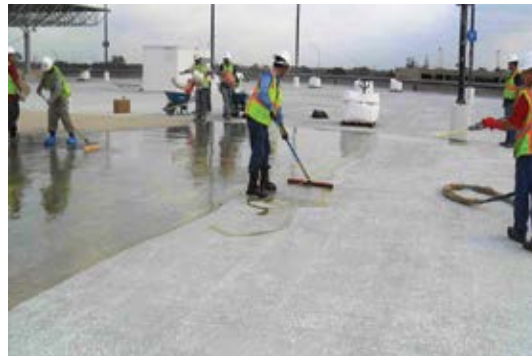
Fig. 5: Epoxy overlay installation

To reestablish concrete cover and provide added protection for the post-tensioning components, a low-permeability multiple-layer epoxy overlay was installed (approximately 1 million ft<sup>2</sup> [92,900 m<sup>2</sup>]). For this particular application, the epoxy overlay (Fig. 5 and 6) was a cost-effective, impermeable, robust overlay with an extended service life in comparison to other coating systems, such as concrete sealers and elastomeric membranes. To provide additional leakage protection for the interior space below a portion of the second level, a hybrid urethane/epoxy waterproof overlay system was provided in this area.

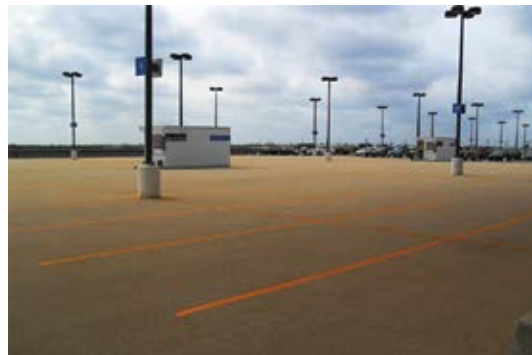
Fig. 6: Epoxy overlay
