Strengthening the Structure of St. Nicholas Church

Cracow, Poland

Submitted by Sika Corporation

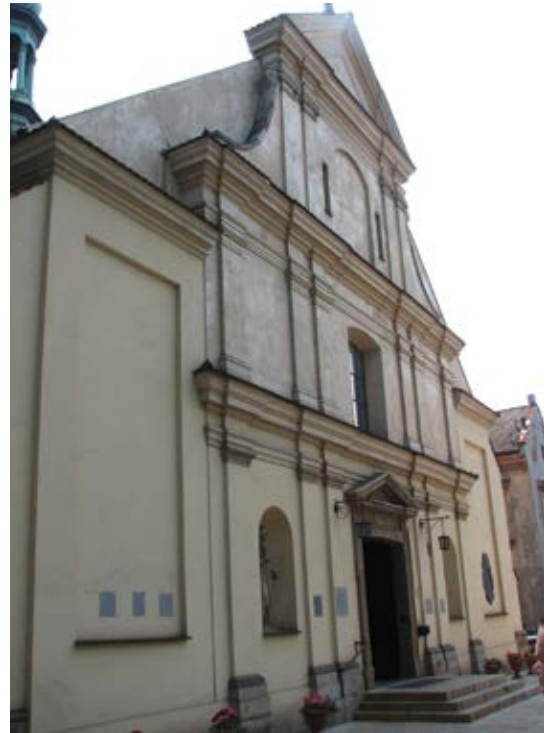
View of front façade

phenomenon over the centuries, leaving severe degradation within the foundation. Acid waters washout, as well as vibrations caused by increasing traffic—especially on the train track located just behind the church—were other causes of the severe deterioration of the foundation. This all led to the front wall deviating from vertical and falling away from the structural walls.

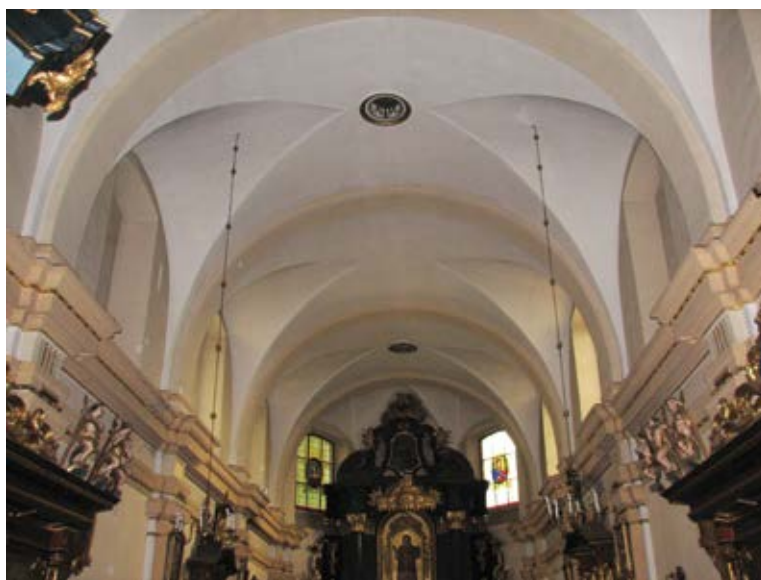
View of the vaults over the chancel

More carbon fiber reinforcement was used at the top and bottom of the cracks in the keystone vaults over the chancel and apse. The most severely cracked area, however, was over the lunettes in the chancel. The plaster was removed and the reinforcement strips were placed perpendicular to the crack.

The vaults were strengthened using a unidirectional carbon fiber fabric which was fixed to the brick using a high-modulus, high-strength impregnating resin. The fabric was fixed perpendicular to the cracks and also adhered to a minimum anchoring distance of 20 in. (508 mm) beyond the end of the crack.

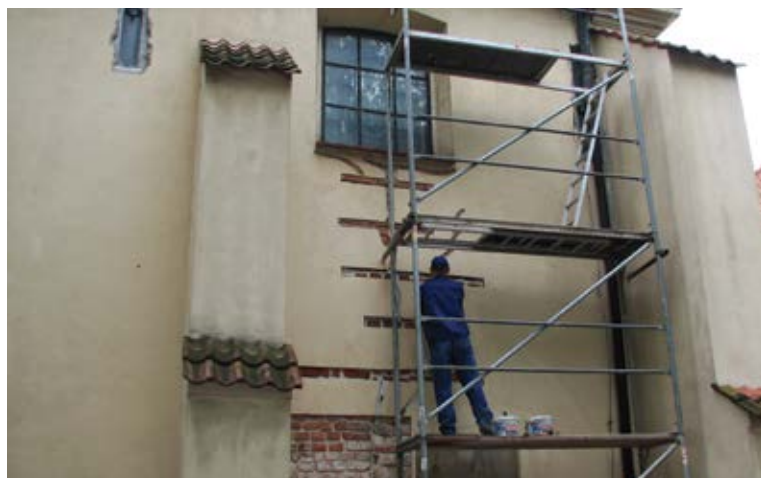
Preparation work on the substrate prior to applying the carbon fiber laminate strips and fabrics

The next stage of repair consisted of placing carbon fiber laminate strips and fabrics, as well as cement grout pressure injection, into wall cracks. The carbon fiber-reinforced polymer (CFRP) laminates and fabrics were chosen because of their high strengths, small dimensions, and minimal interference into the structure, together with the fact that all strengthening jobs could be easily hidden under wall-covering plasters and façade coating. The injection material was specially formulated based on white cement and included additives that modified the rheological properties to increase the ease of injection. Once the cracks throughout the structure were stabilized by repairing the foundation and attic framing and through pressure injection, work could begin on repairing them.

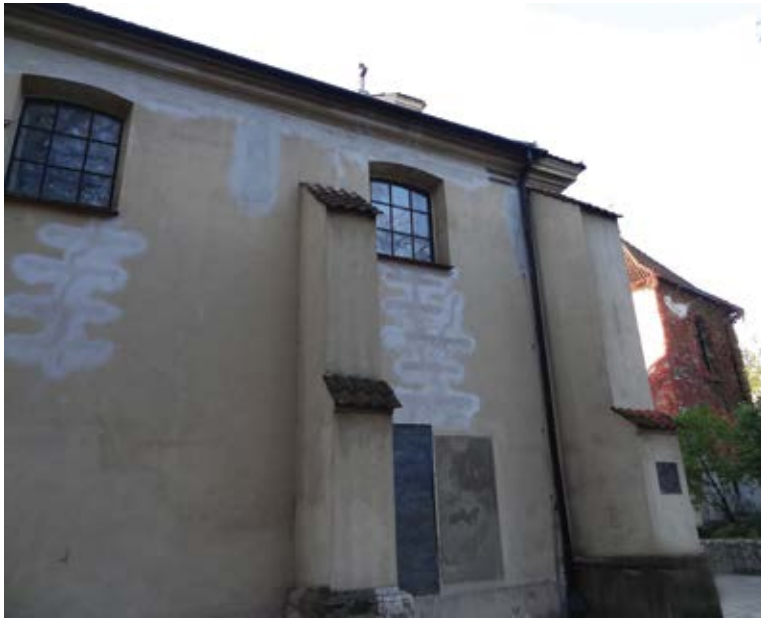
Finishing the wall with the mortar in the places of carbon fiber laminate strips and fabrics

Once the carbon reinforcement was cured, the areas were filled with a vertical repair mortar and finished with the same on-site, prepared, calcium-based plaster mixture used to fill the static cracks. After the completion of strengthening and plaster applications, all elevations were covered with a special silicate paint which completely hid all repaired zones. After the repairs were completed, the building was opened back up to the public in 2012. As required by the Cracow Monument Preservation Office, a yearly inspection is made on the entire structure to check for durability of the repair, and if any issues do arise, they can be addressed as quickly as possible.
