# Winnipeg Aqueduct Water-Leakage Repair

Winnipeg, MB, Canada

Submitted by Vector Construction, Ltd.

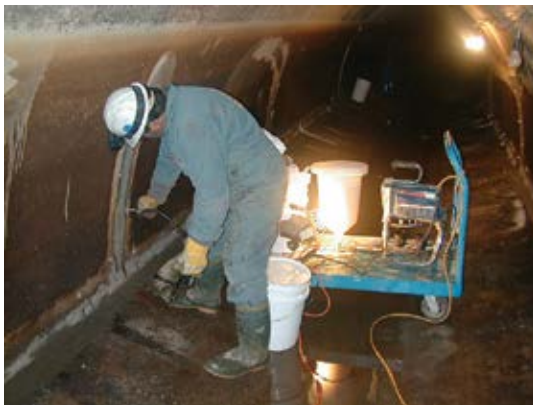
*Worker preparing to inject urethane*

Urethane injection was chosen for a number of reasons: ease of application, compatibility with potable water, relative cost, and expandability when

it reacts with water in the cracks. Expansion was a key consideration. During installation, the grout was injected through port holes drilled to the center of the wall and the inside surface of the crack was sealed. With this configuration, once the grout expanded in the crack, it was stopped by the inside surface seal and the expansion squeezed the grout out of the crack at the exterior of the pipe creating a double seal. This way, the crack was filled and an exterior dam seal was created on the outside of the wall.

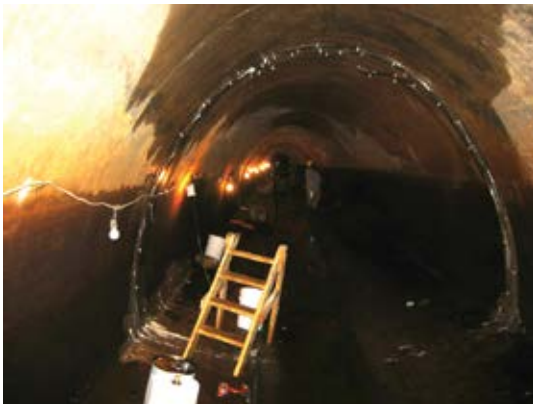
*Inside of aqueduct after injection*

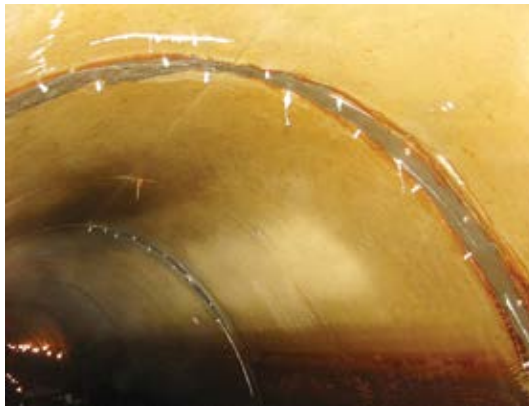
of the city and investigate the aqueduct. The physical investigation of the aqueduct showed the concrete was in excellent condition, but that due to settlement/movement over the years, a consistent cracking pattern existed along much of the length of the pipe. Although the unreinforced arch was fully capable of carrying the design load, it was cracked in the roof and often part way up the walls. The engineers also determined that the actual flow at the outlet was only 85 million gal. (321,760 kL) per day, which was barely more than current demand. Approximately 15 million gal. (56,780 kL) per day was leaking out of the aqueduct along its length.

*Sealed joints and cracks*

The project was started in 1994 and continued over 10 years. In total, over 150,000 ft (45,720 m) of crack and joint were injected using over 25,000 gal. (94,635 L) of urethane chemical grout.
