# Roof Sundeck Rehabilitation at a Chicago Condominium Complex

Chicago, IL

Submitted by CTLGroup

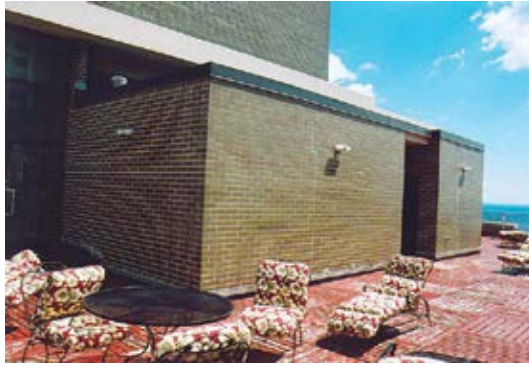
By 2005, the 17-year-old roofing system on the sundecks was showing signs of widespread water leakage into the storage space below the sundecks. Accelerated decay of the modular wood decking was evident due to long-term exposure to the elements. The original steel perimeter railings and rope descent systems also exhibited severe corrosion-related deterioration.

*View of south sundeck prior to repair project; north sundeck is identical*

- Replace existing roofing with a liquid, hot-applied bituminous waterproofing membrane system.
- Replace wood decking with precast concrete pavers to improve durability performance and meet the Class A fire-resistive code requirements. To address the significant wind uplift forces at the building roof, tie downs were incorporated at each corner of paver grid with inverted steel angles along the perimeter edges of the paver grid.
- Concrete patch repairs on localized concrete delaminations and spalls of the floor slabs were performed using form-and-place methods.
- New galvanized flush tiebacks were mounted below the elevated precast pavers for use during routine façade maintenance operations.
- Replace the steel railings with surface-mounted aluminum railings with tempered clear glass panels to enhance durability performance and aesthetics.

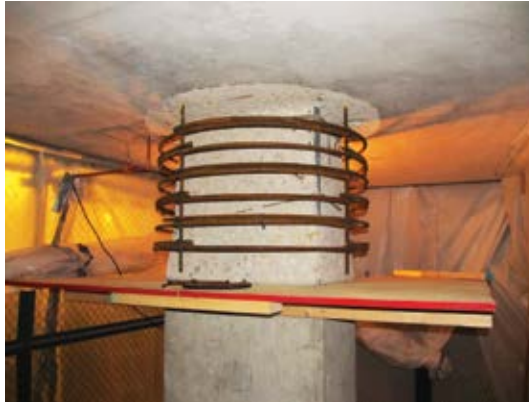
Deficiencies in punching shear resistance were identified at a total of six slab-column interfaces.

*Typical interior column strengthening with hoop reinforcement for shear collar*

accommodate design dead and live loads. At interior columns, strengthening was accomplished by increasing the shear perimeter using shear collars with hoop reinforcement. At edge columns, strengthening was achieved with shear corbels to the side faces of the columns. These corbels increase the effective width of the slab for unbalanced moment resistance (transferred through flexure and shear) while increasing the punching shear perimeter.

At interior columns, hoop reinforcement was installed for the shear collars. At edge columns, new reinforcing steel was installed through holes drilled in existing columns. The engineers used nondestructive testing methods to locate existing column reinforcing bars and thus avoid cutting existing column steel when drilling holes.

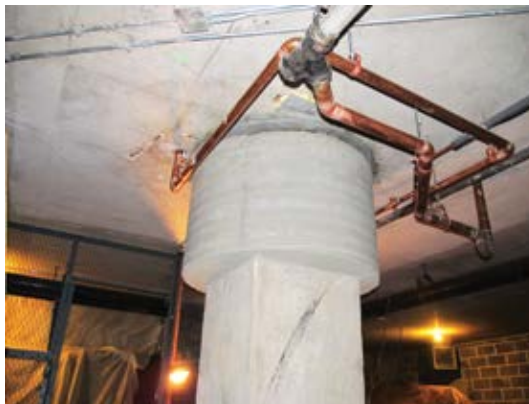
*Typical interior column with shear collar*

**Concrete Placement**—The form-and-place method was performed. Access holes were cored in roof slabs to facilitate placement of structural concrete from top of slabs.

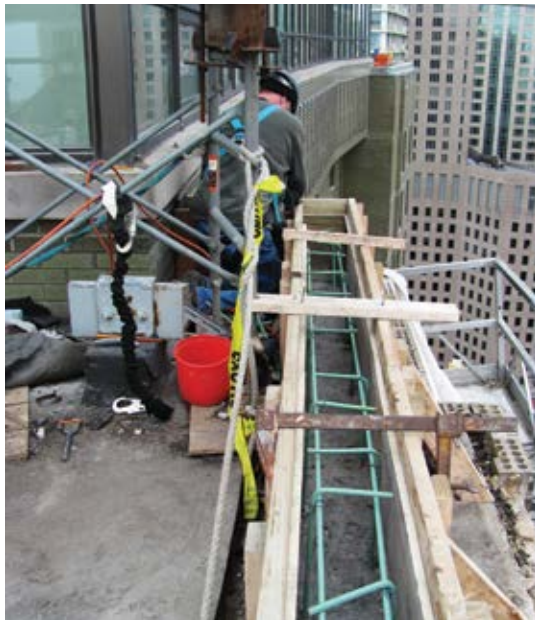
*Typical perimeter concrete curb prior to concrete placement*

**Roofing Replacement**—New cast-in-place concrete curbs were constructed adjacent to the outer edges of the sundecks to provide the following:

1. Proper detailing of terminations for new sundeck roofing system and roof edge flashing; and
2. Edge restraint detailing for the precast pavers.

Reinforced curbs were constructed using air-entrained concrete. After curing, a waterproofing membrane was applied on the curbs.

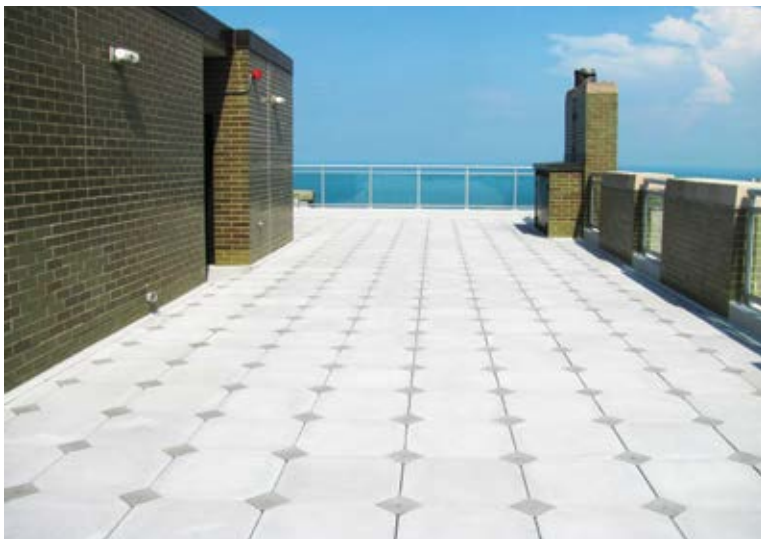
*View of completed south sundeck; north sundeck identical*

**New Pedestal Pavers**—A new precast concrete open-joint pedestal paver system was installed.

**New Railings**—New aluminum surface-mounted railings with tempered glass panels were installed along the new concrete curbs.
