Dolphin Tower Condominiums Emergency Structural Repair

Sarasota, FL

Submitted by Concrete Protection & Restoration, Inc.

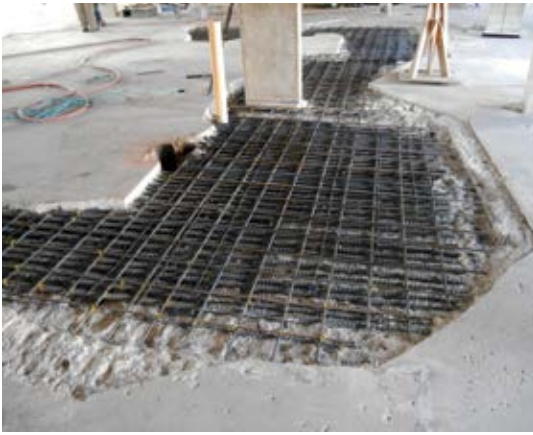
Fourth-level transfer slab crack repair after demolition

The first phase of the repair was to fix the large shear failure crack within the fourth-level transfer slab, which spanned four column bays. The repair

comprised conventional selective demolition and replacement along with epoxy injection. This would further weaken the already damaged transfer slab, so additional shoring was installed. Additional steel was added to the repair areas where concrete was removed, and the floor was re-placed to its original level.

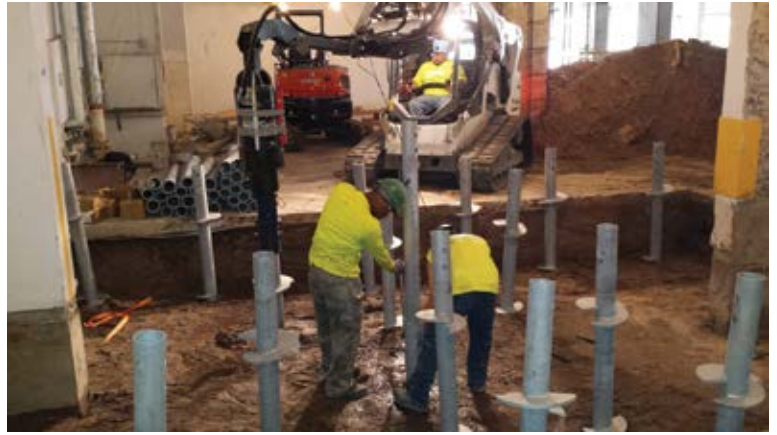
Helical pile installation in the foundation area

Simultaneously, work began on Phase 1 of the foundation strengthening, which consisted of areas that fell outside of the existing shoring and could easily be accessed. The foundation work consisted of demolishing and removing the slab-on-ground concrete, excavating down to the existing concrete pile caps, installing new steel helical piles, placing steel reinforcement, and placing of the new expanded pile caps.

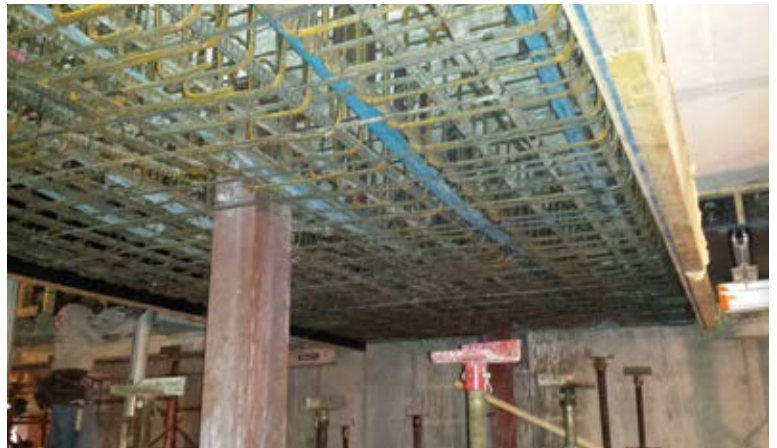
Post-tensioned drop panels with formwork

The second phase of the project was to install the post-tensioned drop panels on the underside of the fourth-floor slab. The ceiling was prepped using hydrodemolition, and then column enlargements were installed on Level 3. Six-hundred 8 in. (203 mm) holes were cored through the fourth-level slab to install “shear lug keys.” These would tie the new drop panel to the fourth-level overlay, creating a new composite slab.

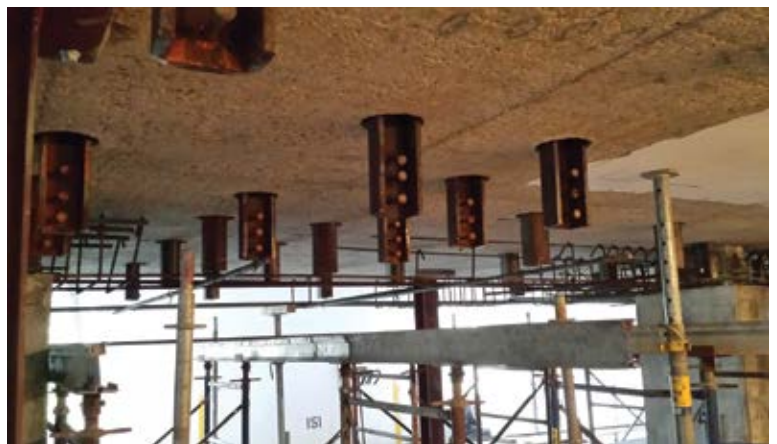
Steel lug keys and reinforcing bars in the drop panels

panels were hung from the lug keys, and the post-tensioning cables were installed within the cage. Post shores were installed underneath the drop panel formwork and across 100% of the tower area on all three levels of the garage. This shoring would support the new construction of the drop panels and overlay. In total, 2800 post shores and 200 shoring towers were used for the drop panel and overlay construction.

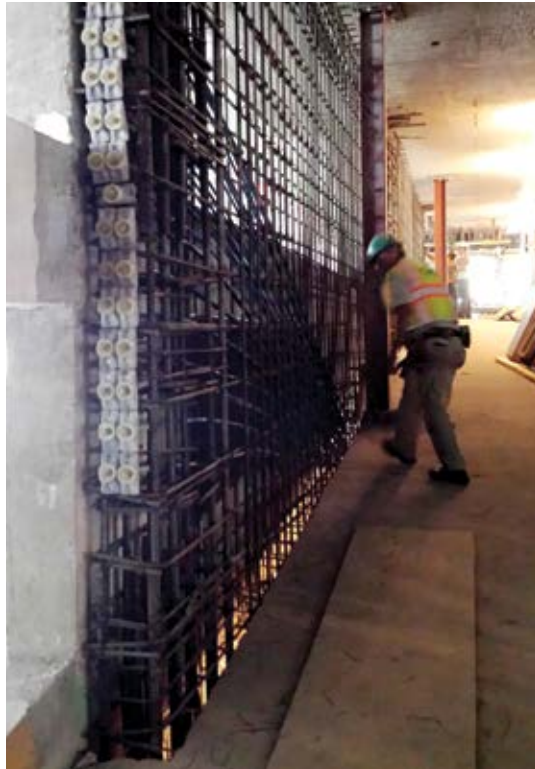
Steel and cables in the post-tensioned beam

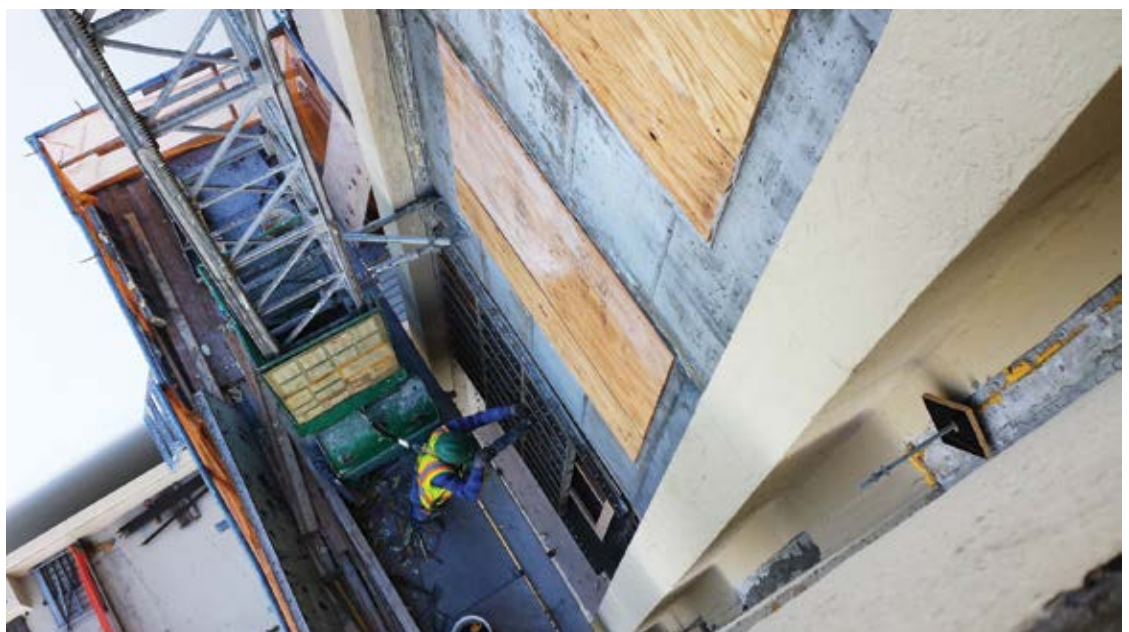
Exterior shear walls

Also during the second phase, exterior wall segments at the four corners of the building were

converted to concrete shear walls. The existing windows and concrete masonry unit (CMU) walls were removed, reinforcing steel was installed, and concrete was placed.

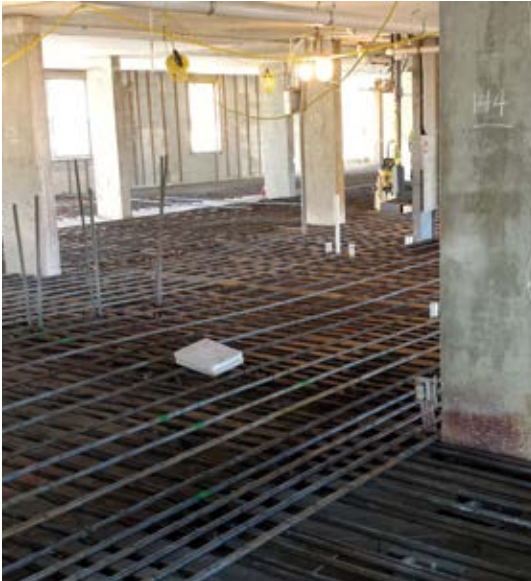
Steel overlay

The third phase commenced with construction of the fourth-level overlay slab. The overlay was roughly 13,500 ft² (1250 m²) split into two subphases. Over

68 tons (61,700 kg) of reinforcing steel and 300 yd³ (230 m³) of concrete was used. Additionally, because the floor height was being increased by 6 in. (152 mm), the two elevator doors required relocating.
