# Post-Tensioned Balcony Slab Evaluation and Repair

By James A. Wilson

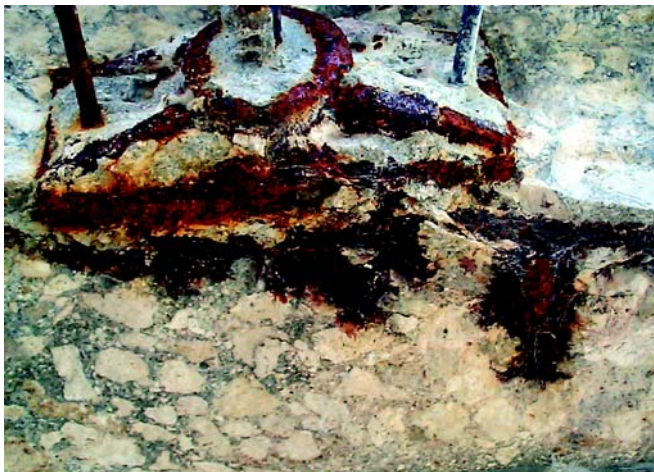
*Anchor with spalled concrete exposing corroded bursting bars*

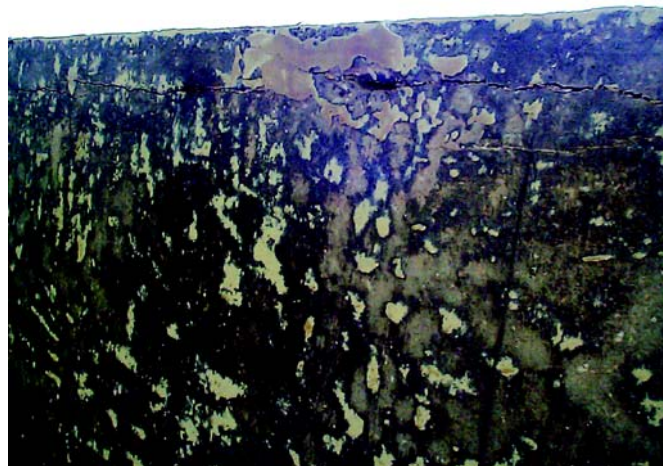
*Balcony slab edge with severe cracks, evidence of corroded bursting bars*

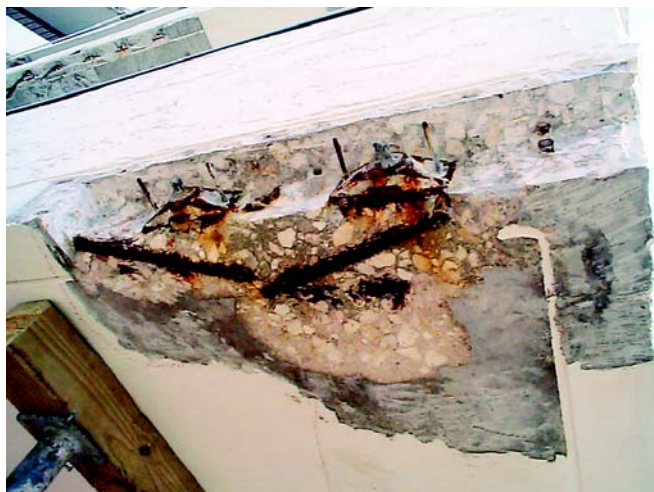
*Anchors with spalled concrete exposing corroded bursting bars*

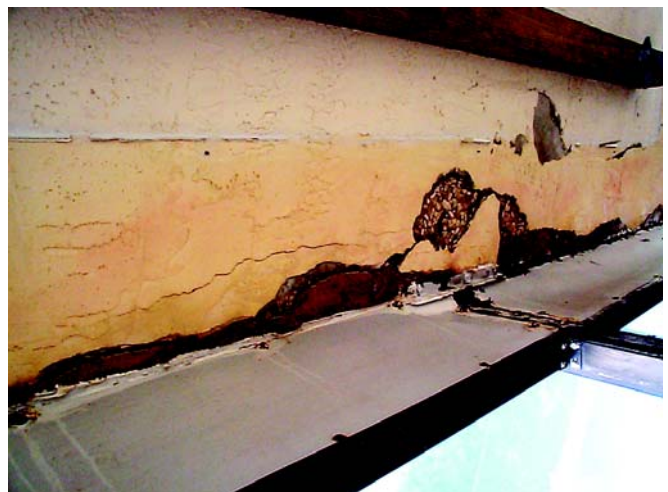
*Balcony slab edge showing previous repairs that have failed and are spalling*

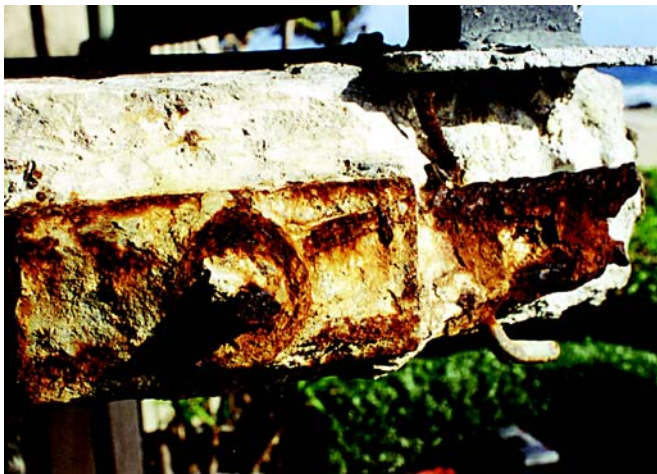
*Anchor with spalled concrete exposing corroded bursting bars*

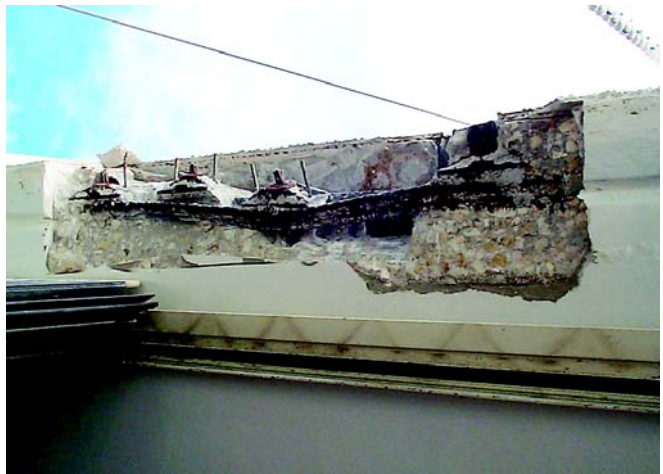
*Top edge of slab showing improper repair demolition (Note corroded reinforcing steel and cracks in concrete behind anchor)*

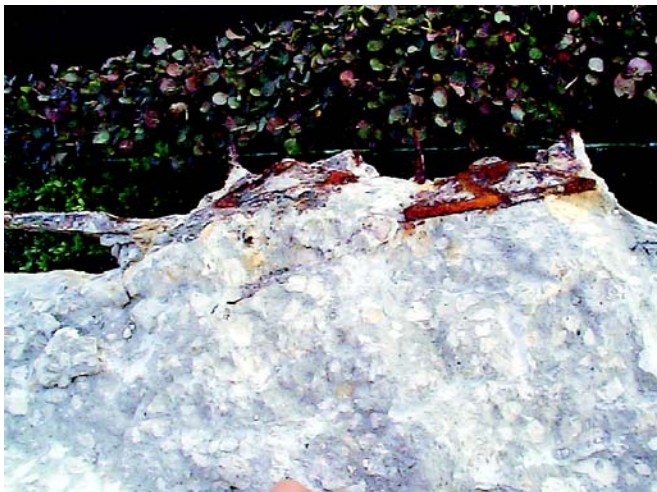
*Anchor that is still under tension and has burst out of concrete during repair demolition*

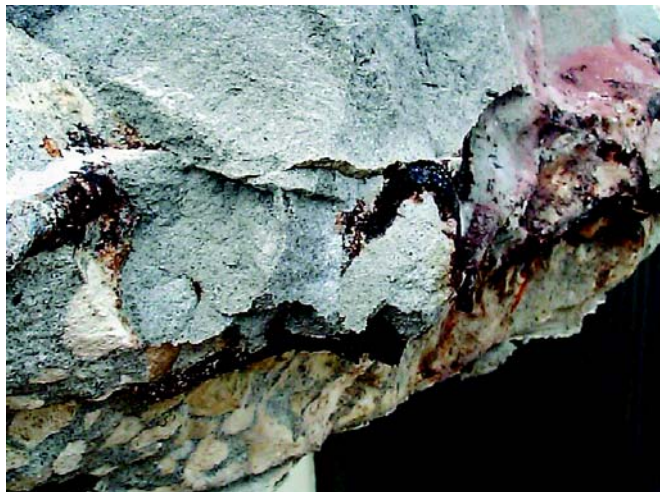
*Improper slab edge repair that has failed (Note new mortar on top, old substrate below, and bursting bars sandwiched between)*

If the bursting bars are not properly excavated during the repair, then the existing reinforcing bar and post-tension anchors will be sandwiched between the old concrete and the new repair mortar. This sandwiching of the reinforcing bar between two vastly dissimilar concrete materials creates an accelerated corrosion condition. Rather than fixing the slab edge, a new problem has been created that is at least equal to or arguably of greater magnitude than the original condition.

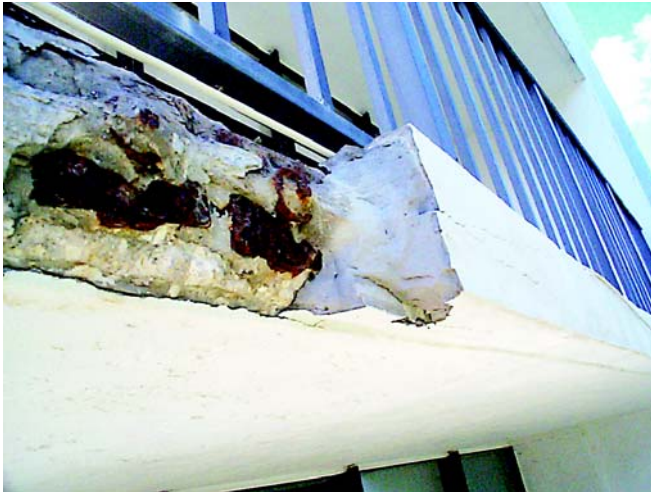
*Improper slab edge repair that has failed  
(Note bursting bars and anchor are sandwiched  
between new mortar and old concrete)*

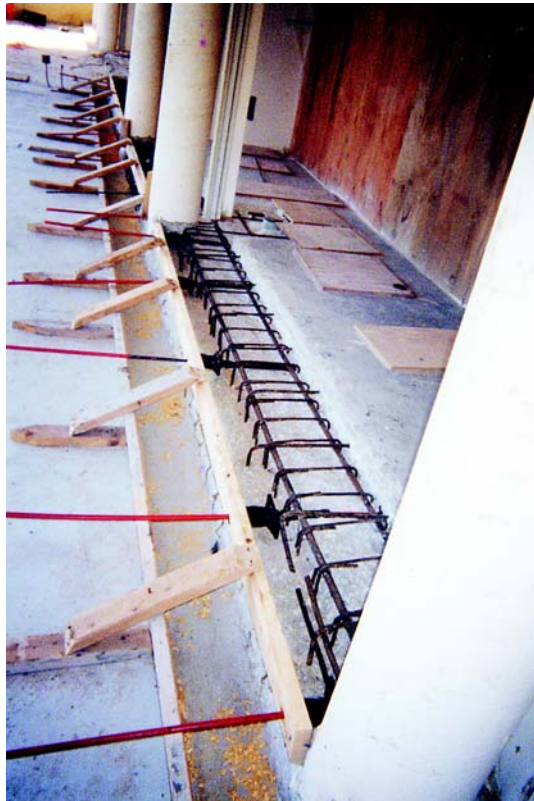
*Correct repair of post-tensioned slab edge/beam*

What this means is that in order to properly excavate the corroded reinforcing bar at the slab edge, the post-tensioning forces must be temporarily relocated from the existing anchors at the slab edge to an anchor inserted elsewhere on the effected tendon. The slab edge can now be properly repaired and the post-tensioning restored to its original configuration.

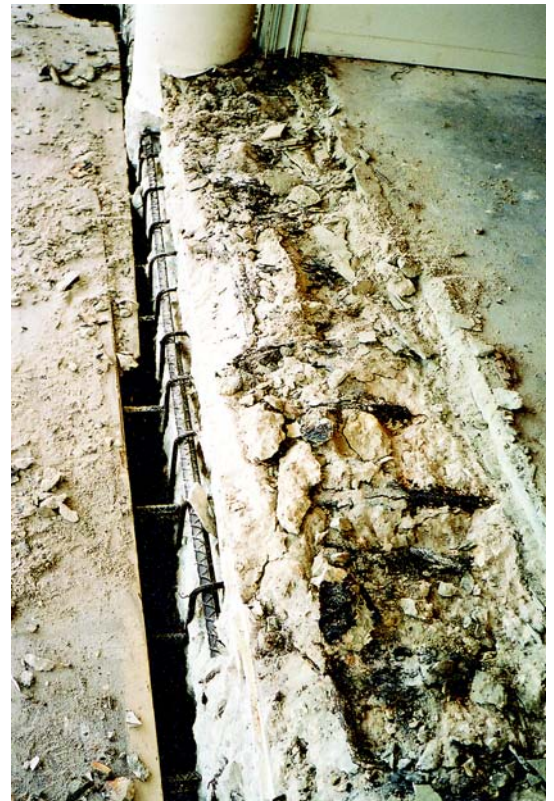
*View of same area before repair*

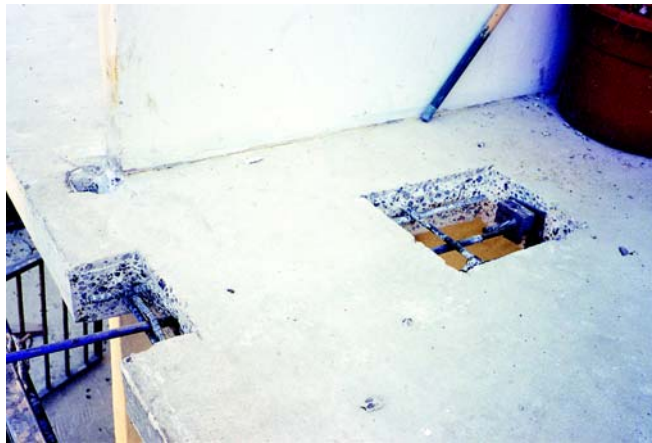
*“Text book” repair of slab edge (Note the temporary lock off and slab edge with excavation per ICRI guidelines)*

Most engineers in the concrete repair industry subscribe to the concrete preparation guidelines outlined by ICRI. ICRI conventions on excavation around embedded reinforcement call for a minimum clearance of 3/4 in. (2 cm) (or 1/4 in. [0.6 cm] greater than the largest aggregate) behind the reinforcing bar. If this recommendation is followed, then the concrete around and behind the bursting bars and post-tensioned anchors must be removed. Due to the enormous loads residing on the anchors, however, the concrete cannot be safely removed while the anchors are still under tension.

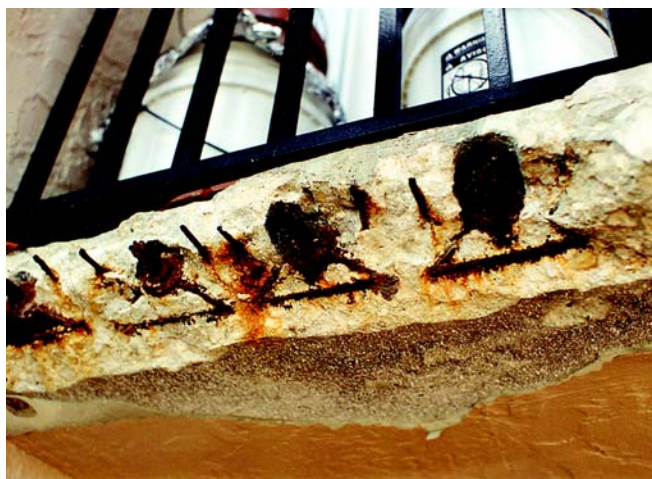
*Close-up of balcony slab edge with spalled concrete exposing corroded bursting bars*
