From Olympic Swimming Stadium to Community Center

LA Swimming Stadium

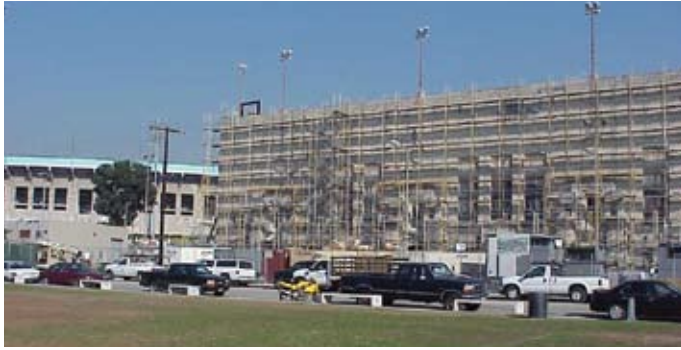
Extensive scaffolding was necessary for repairs

To begin the repairs, a large scaffolding system (see photo, top left) was erected to allow the contractor access to all of the wall surfaces. To chip away the bad concrete, the contractor used small-sized jackhammers (less than 20 lb each) to prevent micro-cracking to the original concrete. Because the spalls were on a vertical surface, however, the perimeter cut was made with a small grinder equipped with a 4 in. (10 cm) diamond blade.

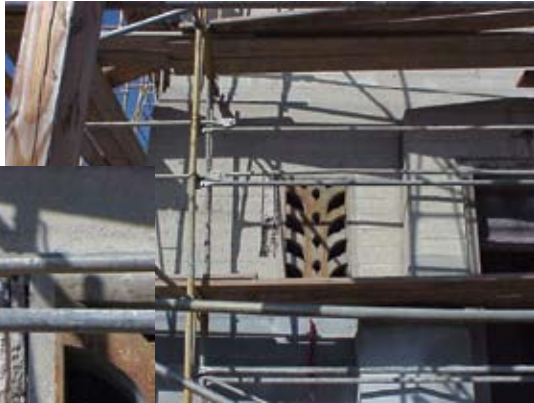
Ornamental detail repair

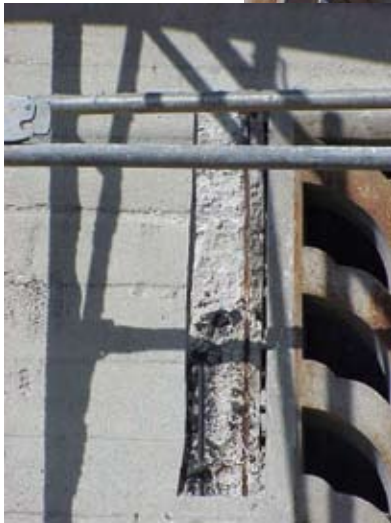
Close-up of ornamental detail repair

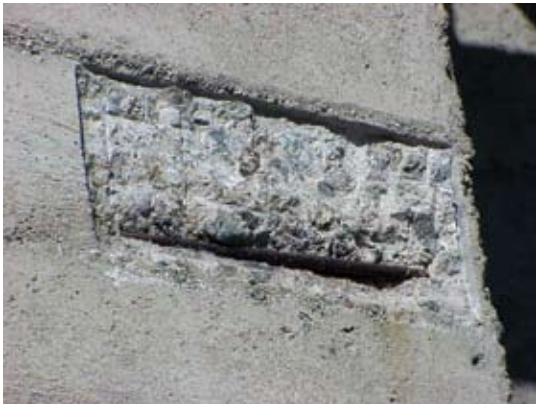
Over the years, corrosion had caused extensive spalling within the Olympic Swimming Stadium structure walls and architectural concrete at the arches and overhangs. There was also extensive cracking within the stadium structure walls and architectural concrete at these same locations.

Close-up of spall prior to repair

1. Creating a rectangle perimeter for the removal geometry;
2. Creating a 1/4 in. (0.6 cm) deep perimeter cut;
3. Providing a minimum of 3/4 in. (1.9 cm) clearance beneath the reinforcing steel; and
4. Sandblasting the corroded steel to remove rust and clean the resultant surface.

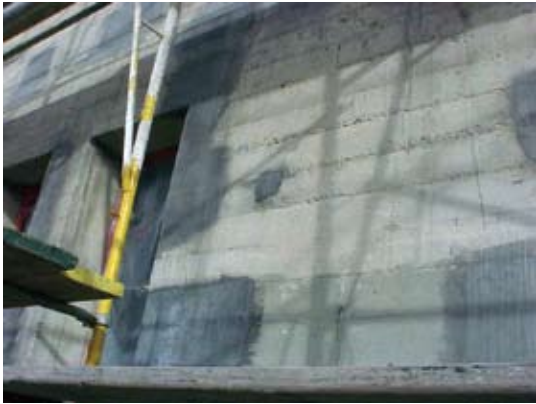
There were several special challenges on this project due to the historical value of the original structure and the need to comply with historical preservation and restoration standards. For example, the repair of the spalls and cracks created a patchwork appearance that did not comply with the project objective of restoring the original appearance of the building and needed to be redone.

Patched area before coating

The cracks were repaired first using epoxy injection. Repairs to all the spalled areas followed, and the repair mortar was hand-troweled into place. Finally, the cementitious coating was applied with a spray application and then brushed to conform to the previous surface finish. Care had to be taken to not hide form marks.

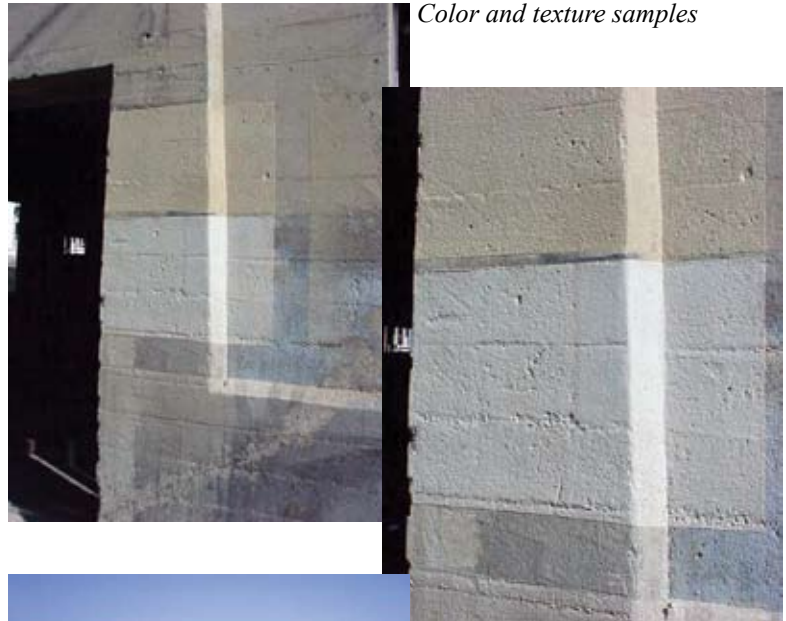
Color and texture samples

The chosen cementitious coating was available in two colors: white and grey. Neither color matched the original concrete. The product was therefore blended at the project site. The color blend consisted of the following: 70% grey and 30% white with an integral color pigment added to achieve color.

Several tests with the above formula matched the aged, warm-tone concrete. White and grey colors of the cement coating were used to achieve the tone, whereas the addition of integral powder pigment achieved the color. Color pigment powders were limited to prevent impact to the performance characteristics of the cement coating.

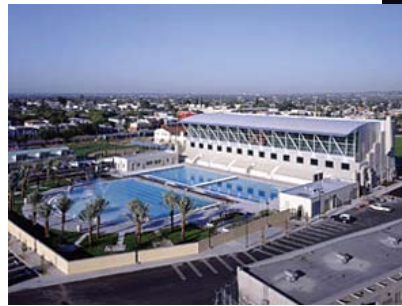
Overall view of completed project
