THE BREAKERS PLAZA CONDOMINIUM COMPLEX

BY JOHN WEISBARTH

The Breakers Plaza Condominium Complex had several structures in need of repair: a three-story low-rise condominium building, a one-story parking garage with sports courts on the roof, and an 18-story condominium high-rise.

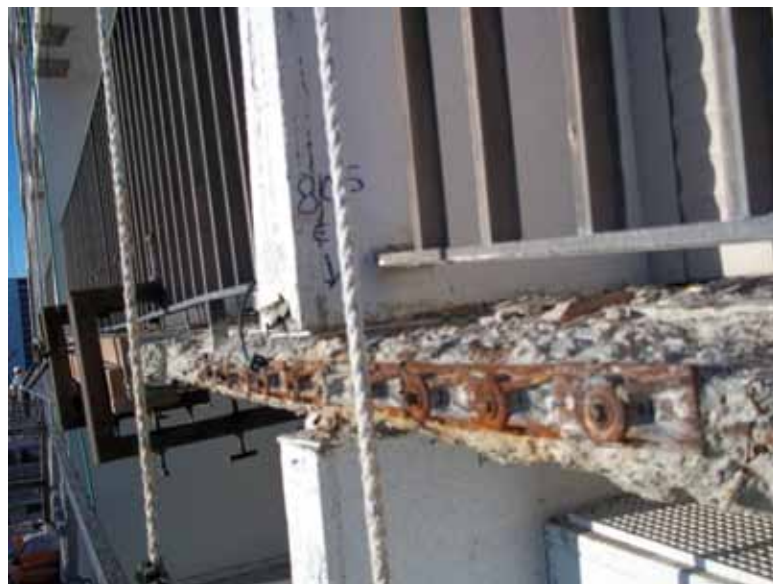
almost all of the post-tensioned anchors were corroded. Many of the balcony edges had cracking.

Corroded post-tensioned anchors

Once the deteriorated concrete was removed, the contractor treated or replaced any damaged reinforcing steel. Most of the balcony edge steel that was situated in the post-tensioned anchor zone needed to be replaced. Special custom-made forms and clamps were used to reduce the time required to erect shoring for each balcony.

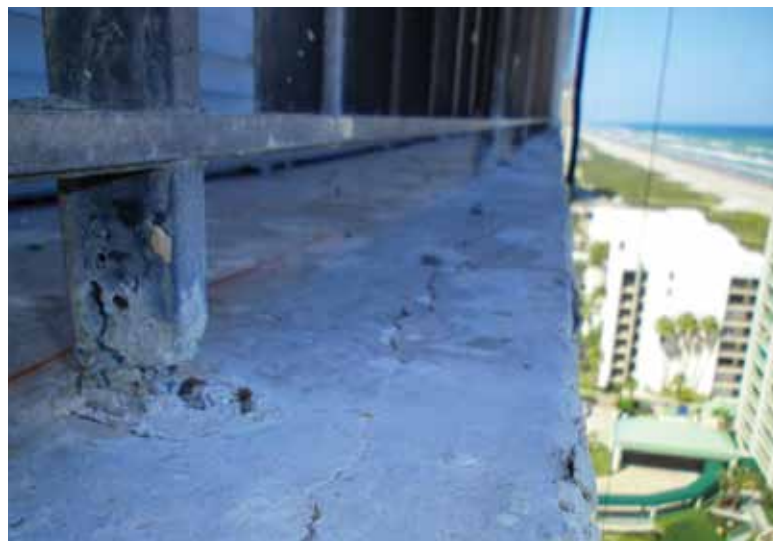
Both directions of the two-way post-tensioned slab had deterioration. Care needed to be taken when replacing the metal balcony railings so the post-tensioned cables would not be damaged.

Deteriorated balcony slabs

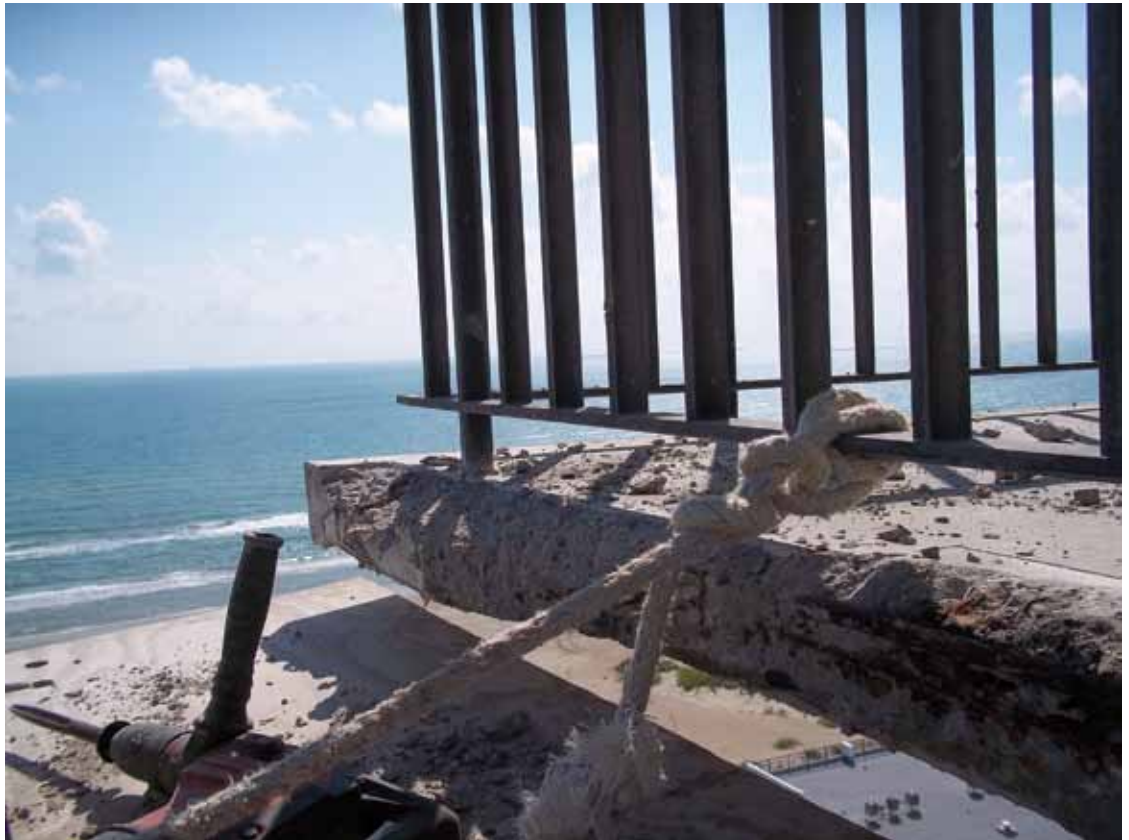
Concrete being removed from balconies

ICRI surface preparation guidelines were followed. All the deteriorated concrete was removed until sound concrete was exposed. Surface preparation was done with concrete saw cutting and chipping hammers. Plywood was placed on the swing stage beneath the balcony to catch the small fragments. The deteriorated concrete was gathered by hand and placed into empty buckets on the swing stage, then lowered to the ground for disposal.

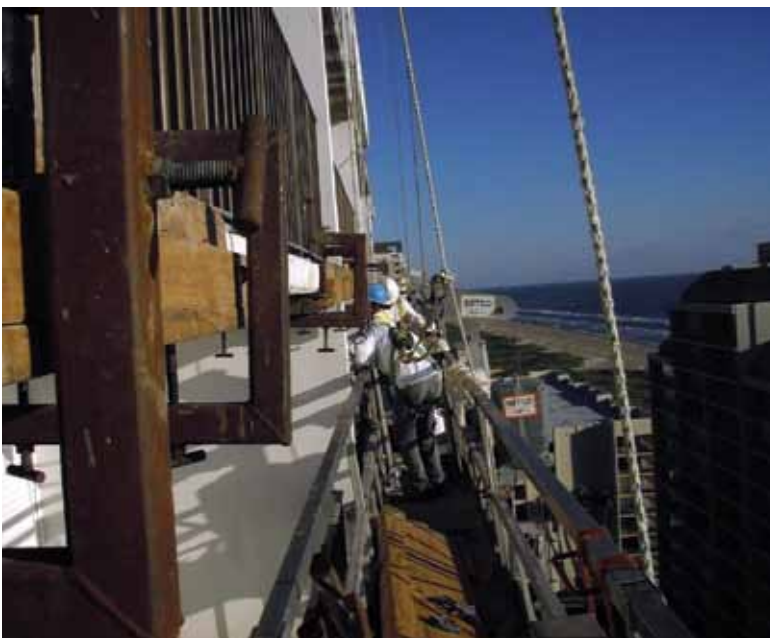
Repair work accomplished using swing stages

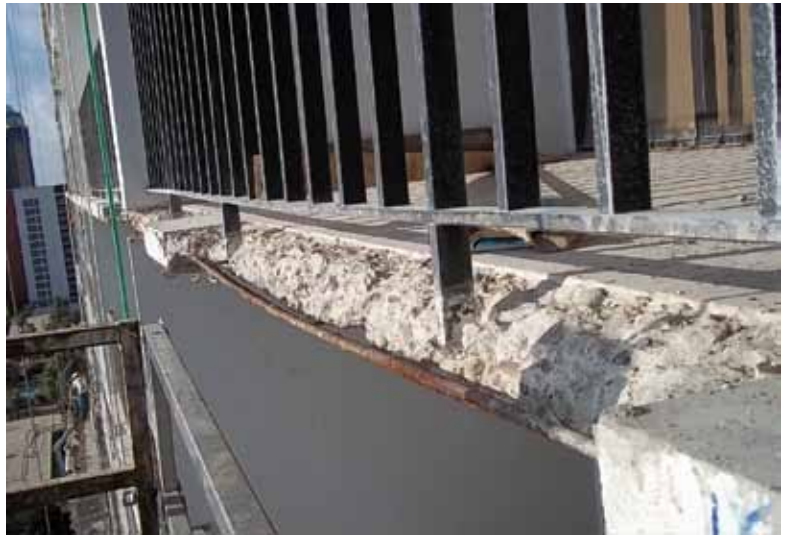
Balcony ready for repair material

All of the exposed steel was treated with a corrosion inhibitor to protect the steel and also act as a bonding agent for the form-and-pour repair material. Anodes were used in strategic locations to provide additional cathodic protection in the high-chloride environment.

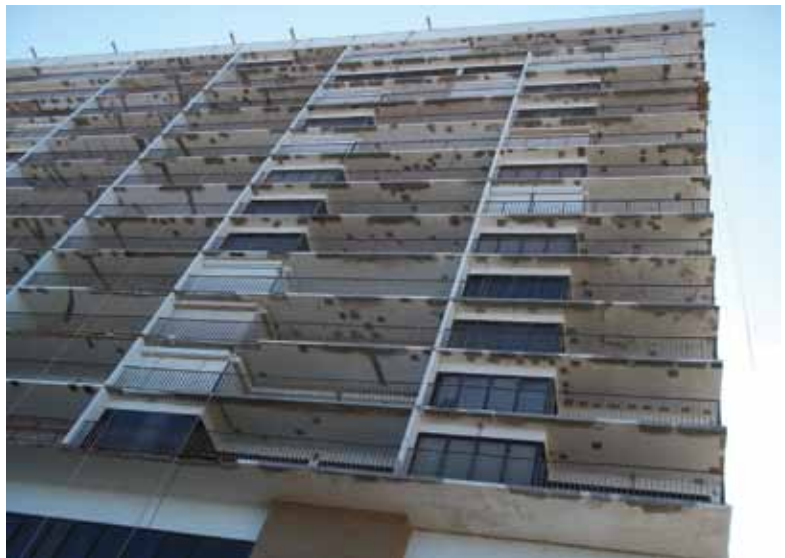
An extensive amount of concrete repairs were required for the balcony edges and soffits

Overhead repairs were made to the underside of every balcony where reinforcing steel support chairs had rusted.

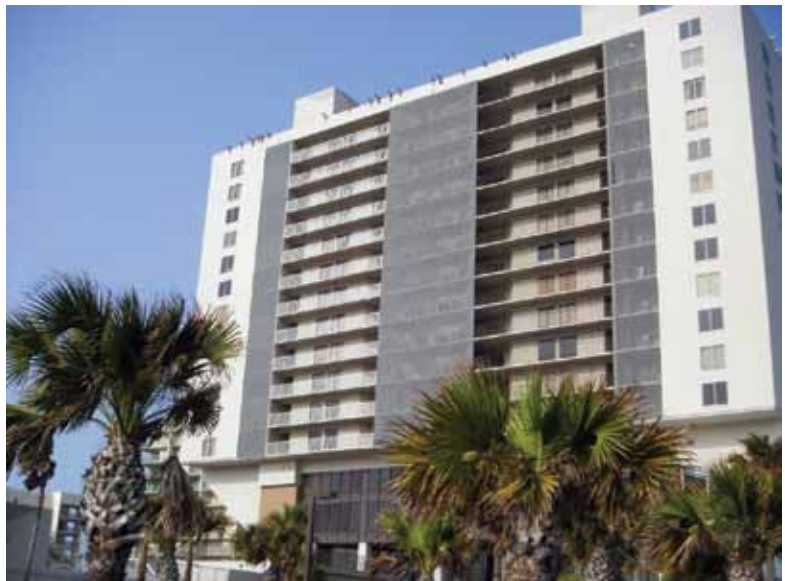
Completed project

Two coats of a waterproofing coating were placed on the balconies, terminating on the bottom of the slab drip edge. An elastomeric coating was applied to the vertical surfaces for aesthetic purposes. Fog commonly caused delays during the application of both types of coatings. On several occasions, it took until mid-afternoon for the extremely moist fog to be burned off by the sun and conditions to become dry enough for the coating to be applied.

The final details of the project involved applying ceramic tiles on the balconies and installing side-mount railings, which were necessary because the specified cored-in-place railing mounts could have damaged the post-tensioned strands.
