# WEST TOWER FAÇADE RESTORATION: FIRST NATIONAL BANK BUILDING

BY KURT BERGLUND

**T**he West Tower of the First National Bank Building in St. Paul, MN, is an iconic building on the St. Paul skyline (Fig. 1). Built in 1931, the building is best known for the neon red “1st” sign that can be seen as far as 20 miles (32.2 km) away on a clear day. The tower was the tallest building in St. Paul for nearly six decades (1930 to 1986).

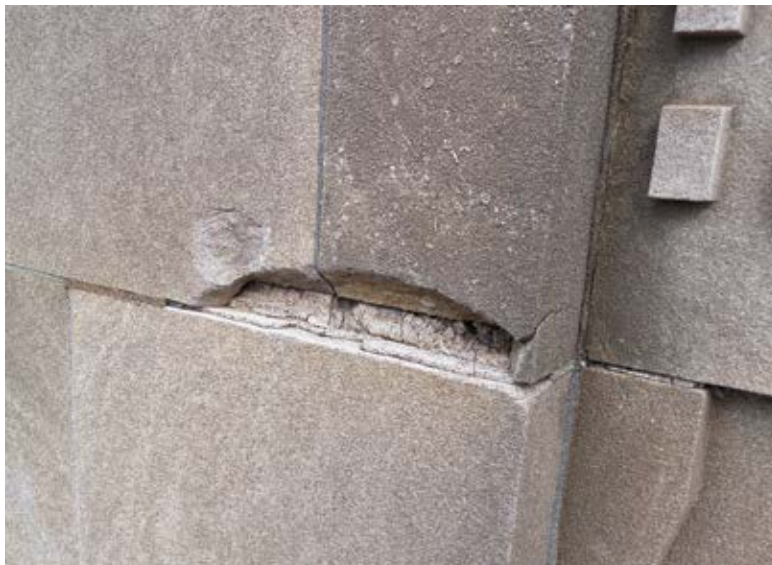
Upon the purchase of the building in 2012, the owner noticed many façade issues that raised concerns. Further investigation of the building’s façade found that many of the building’s mortar joints between the limestone panels had failed and a significant number of stones had delaminated (Fig. 2). Failed sealant joints were also observed around the spandrel panels that were located above and below the windows. The extent of the deterioration led to concerns that pieces of the stones would fall from the building’s façade to the pedestrian sidewalk areas surrounding the building.

Fig. 2: Spalled stone observed during condition survey of façade

The restoration documents outlined the entire façade to be tuck-pointed and the sealant around the spandrel panels to be replaced. The documents also specified approximately 1000 ft<sup>2</sup> (93 m<sup>2</sup>) of stone repair and 100 ft (30.5 m) of stone crack repair. The owner also requested that the entire building’s façade be washed after each drop of repairs had been completed.

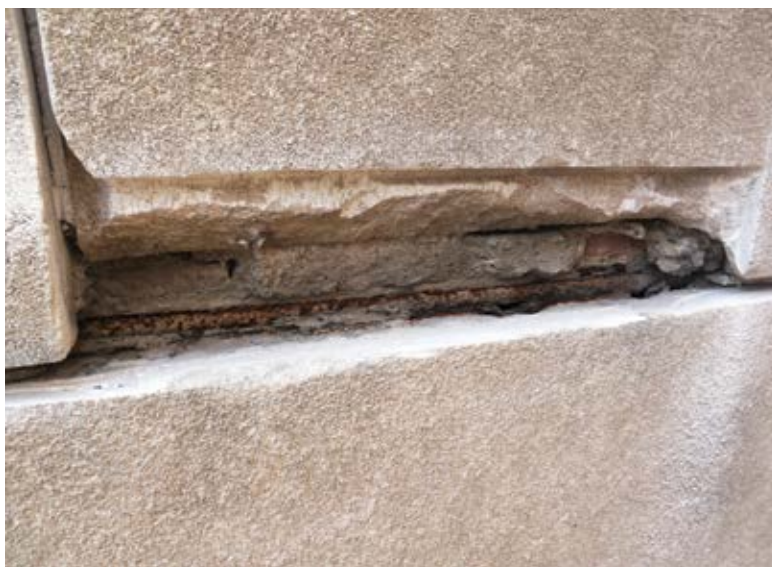
It was soon realized that the majority of the stone distress was located at the steel relief angles that were used to support the stone façade, and was caused by corrosion of the steel angles (Fig. 3). Saw cuts were made at the perimeter of the repair areas and chipping hammers were used to remove the unsound portions of the stones. The demolition of the stone exposed the steel relief angles, with varying stages of corrosion observed. The steel angles were cleaned and painted with a zinc-rich primer to prevent further corrosion. As soon as the steel relief angles were restored, the stones were repaired. Corrosion-resistant screws were installed into the stone within the repair areas to provide mechanical anchorage of the repair mortar (Fig. 4).

Fig. 3: Corroded steel relief angle

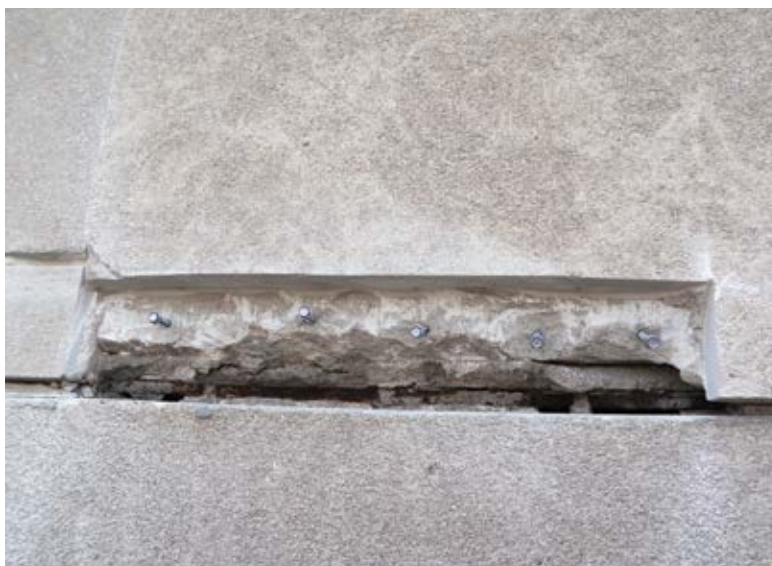
Fig. 4: Corrosion-resistant screws installed for anchorage of repair material

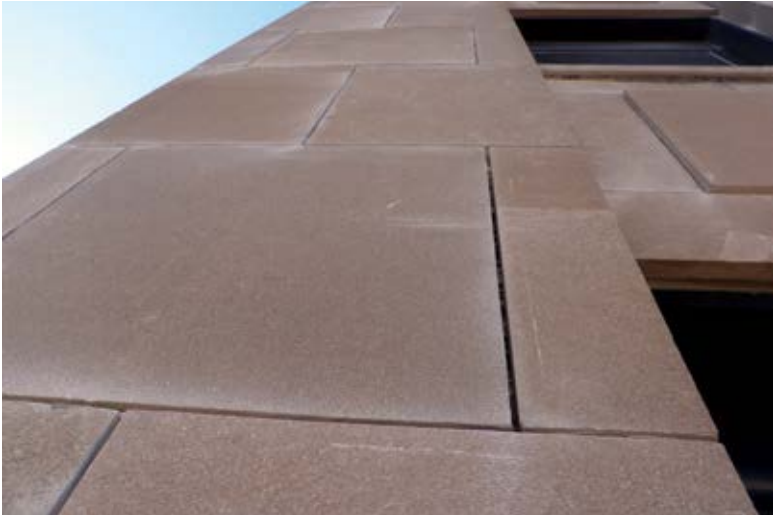
*Fig. 5: Existing mortar at stone panel joints was removed prior to tuck-pointing*

The mortar joints throughout the entire building façade were also tuck-pointed (Fig. 5). The owner requested that the dust and small debris from the grinders used to remove the mortar be collected and not be allowed to become airborne. Vacuums were placed on all swing stages where mortar removal for the tuck-pointing took place. The new mortar used to replace the existing mortar also needed to be similar in color and composition to the existing mortar to maintain the original appearance (Fig. 6). Multiple Type N mortar mixtures were tested and

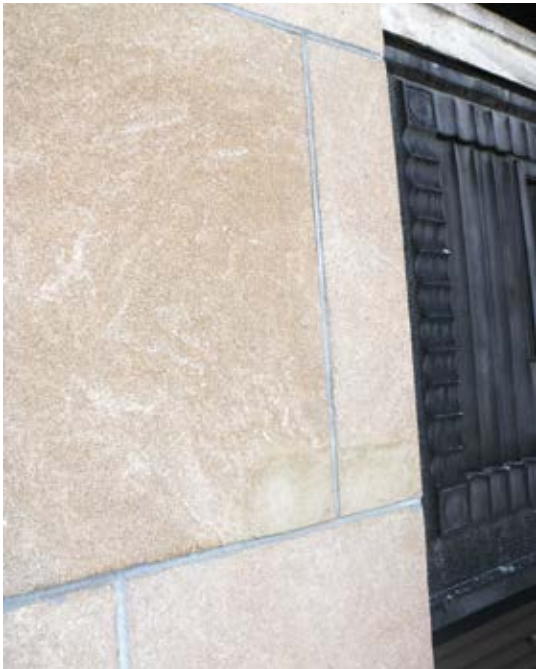
Fig. 6: Completed tuck-pointing of joints at stone panels

an appropriate mixture was selected to create a similar look.

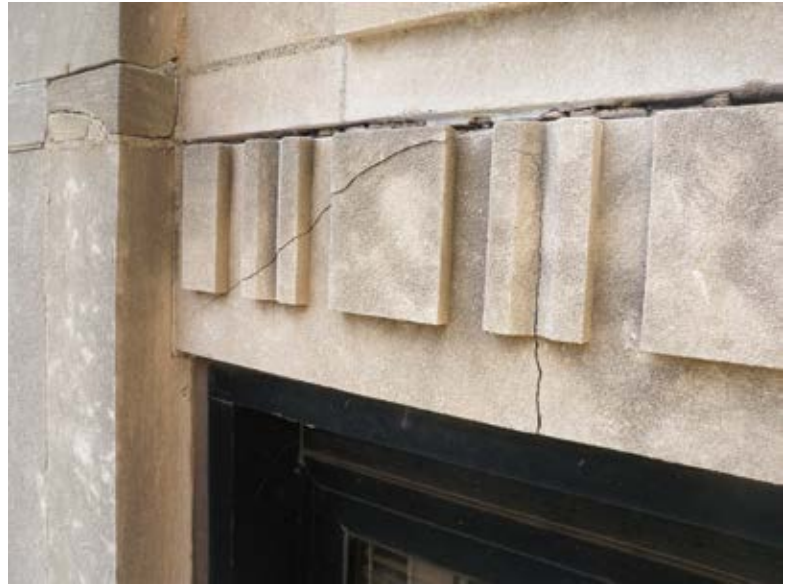
Cracks in the limestone panels were also repaired. The cracks often occurred in the stones above the window heads (Fig. 7). If the stone that was cracked did not show any other signs of distress, the crack

Fig. 7: Cracking in stone panel above window head

was epoxy-injected. To hide the epoxy-injected crack, granular material was placed in the epoxy along the surface of the crack (Fig. 8).

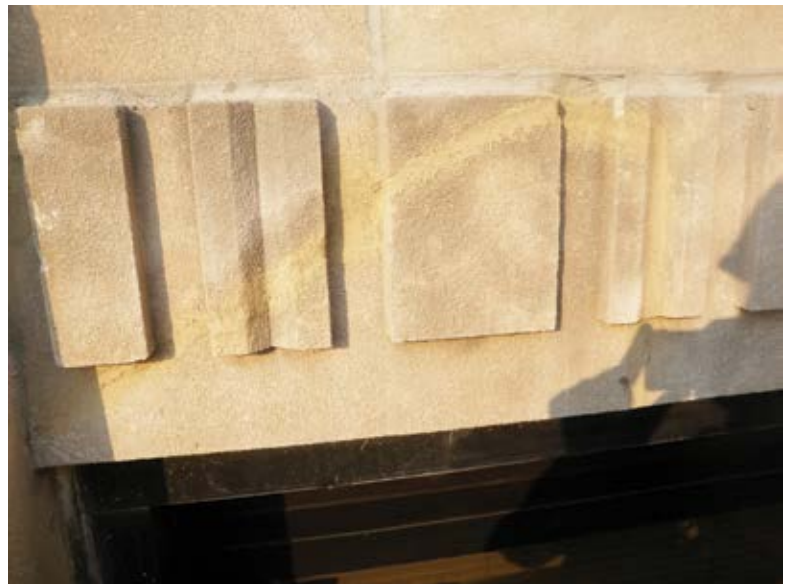
Fig. 8: Repaired crack shown in Fig. 7
