UNDERWATER HYDRODEMOLITION AT THE CANYON FERRY DAM STILLING BASIN FLOOR REPAIR PROJECT

BY FRANK IMMEL

Canyon Ferry Dam Stilling Basin Floor Repair Project Helena, Montana

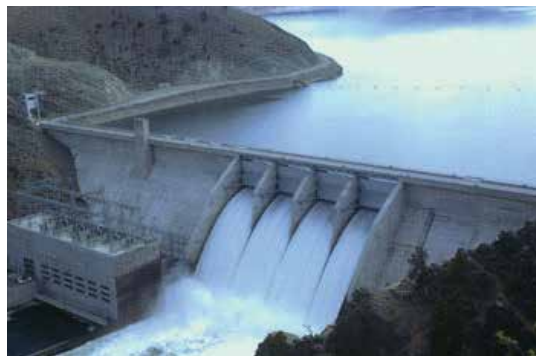
Fig. 1: Canyon Ferry Dam

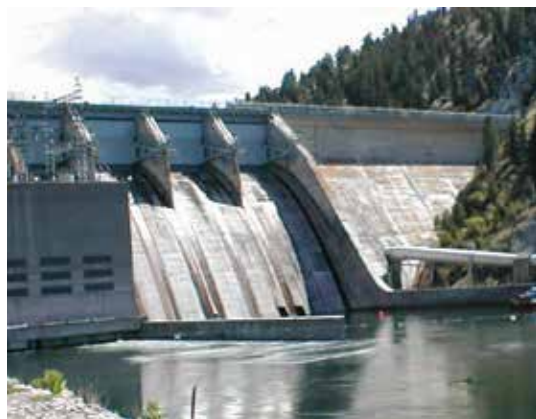
Over time, the water flow (Fig. 1) over the spillway at the Canyon Ferry Dam, along with rubble, had eroded large areas of the stilling basin (Fig. 2) floor. Several of the eroded areas were up to 24 in (610 mm) deep and disrupted the flow of water across the basin floor. Since it was anticipated that the turbulence would lead to further erosion and damage, but at an accelerated rate, a repair program was implemented at the structure in 2004.

Fig. 2: Canyon Ferry Dam spillway, stilling basin and training wall

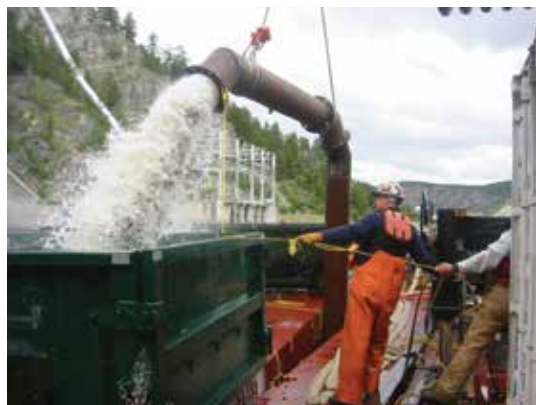
Fig. 3: Airlift system used to vacuum debris from the basin floor

The first step of the operation was to remove a large quantity of debris that had accumulated on the basin floor. Approximately 1.2 million pounds (544,311 kg) of loose stone and gravel were removed from the work area. This was accomplished using a 16 in (406 mm) airlift system that deposited the dredged material onto a barge (Fig. 3). The debris was transported to shore where it was used for fill (Fig. 4).

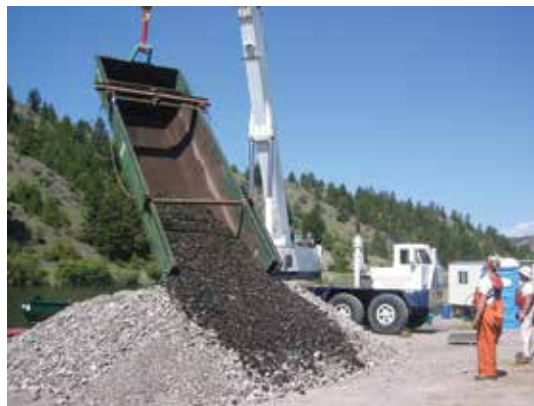
Fig. 4: Rubble removed from the basin floor

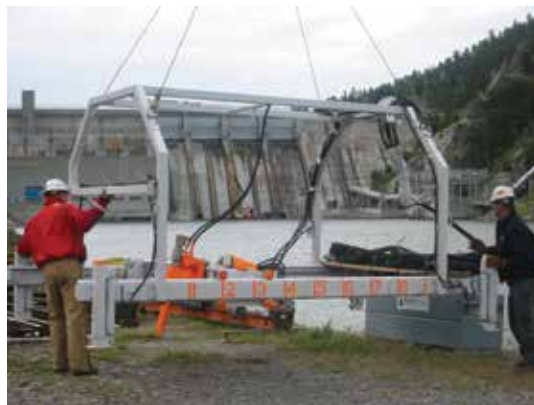
Fig. 5: Hydrodemolition cutting frame

A special 6 ft x 10 ft (1.8 m x 3 m) frame (Fig. 5) was constructed that allowed for two dimensional movement of the waterjet over the surface. Each leg was hydraulically operated and could be extended 12 in (305 mm) to allow the diver to level the frame on the basin floor. Each leg could be operated independently by the diver using one of four control levers located on the frame.

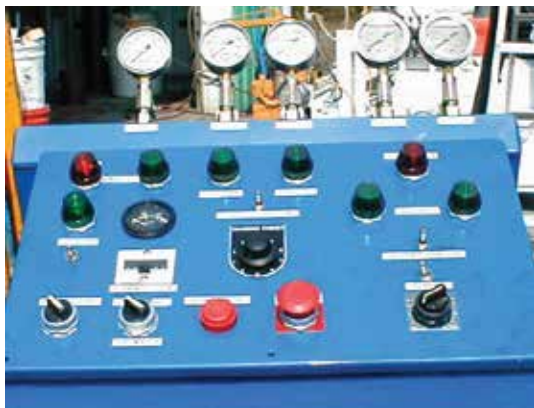
Fig. 6: Hydrodemolition control panel and hydraulic power pack

All functions on the frame were hydraulically operated including the traverse, advance, and rotation of the waterjet nozzle in addition to the hydraulic legs. An electric hydraulic power pack was built to provide the hydraulic power and control of the hydrodemolition functions (Fig. 6). The hydraulic fluid used was vegetable-based biodegradable oil that would not pollute the water in the event of an accidental leak or damage to a hydraulic line. The control panel allowed the operator to program and control the functions of the hydrodemolition cutting frame.

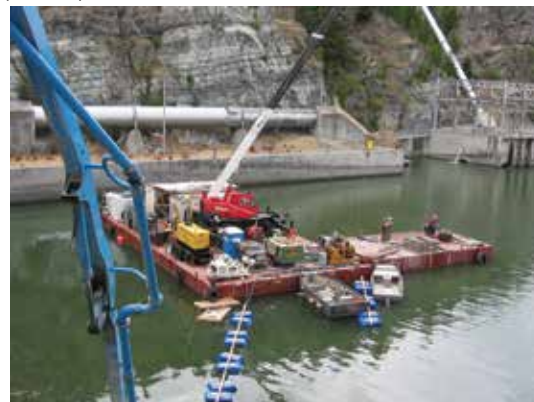
Fig. 7: Work barge in basin

The hydrodemolition pumps remained on shore while the hydrodemolition frame and hydraulic control unit were placed on a barge and moved to the stilling basin over the area to be hydrodemolished (Fig. 7). A crane

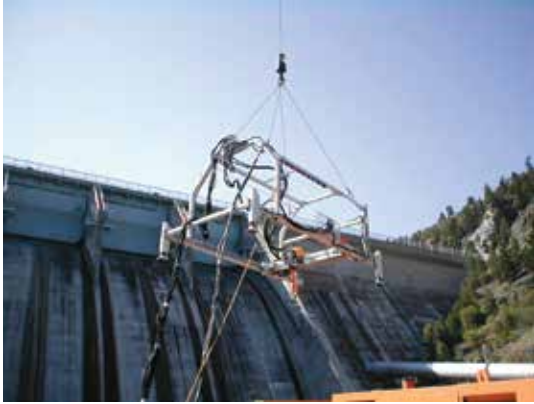
Fig. 8: Hydrodemolition cutting frame attached to crane

on the barge lifted the frame and lowered it to the basin floor (Fig. 8 and 9). Water was transported to the hydrodemolition pump trailer via flexible hose (fire hose). Twin pumps on the unit pressurized the water to 36,000 psi (248 MPa). The water was transported to the cutting frame via specially designed ultra-high pressure (UHP) hoses which were rated at 40,000 psi (276 MPa) operating pressure with a burst pressure of 105,000 psi (724 MPa). The equipment's standard operating pressure of 36,000 psi (248 MPa) and 32 gallons (121 liters) per minute water flow rate were used during hydrodemolition.

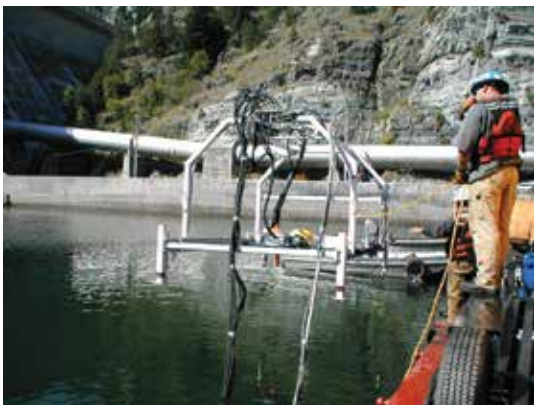
Fig. 9: Hydrodemolition cutting frame being lowered to basin floor at 50 ft (15 m) below the surface

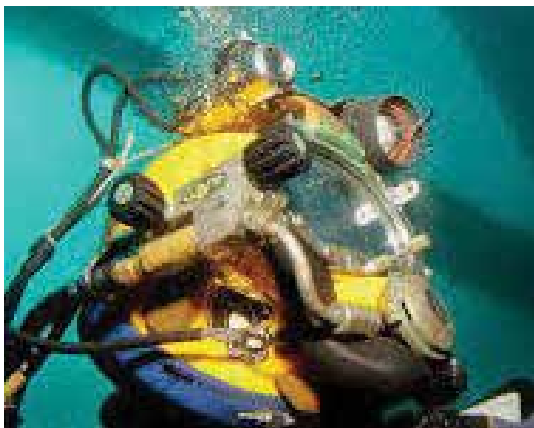
Fig. 10: Diver's helmet contains air, communications, video, and lighting

The diver was equipped with a diving helmet that not only supplied the nitrox air mixture, but also two-way communications and video feed (Fig. 10). Dry suits were used to protect the diver from the cold water (Fig. 11).

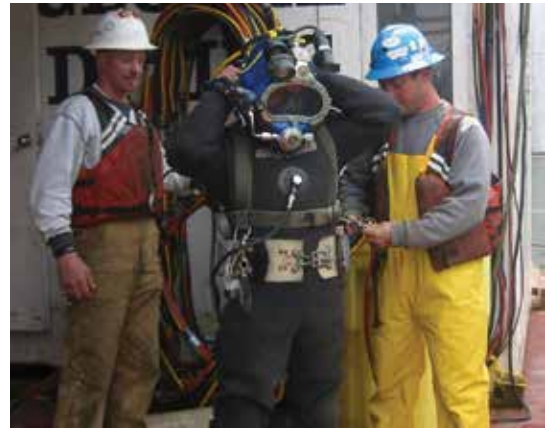
Fig. 11: Diver suited and ready to work

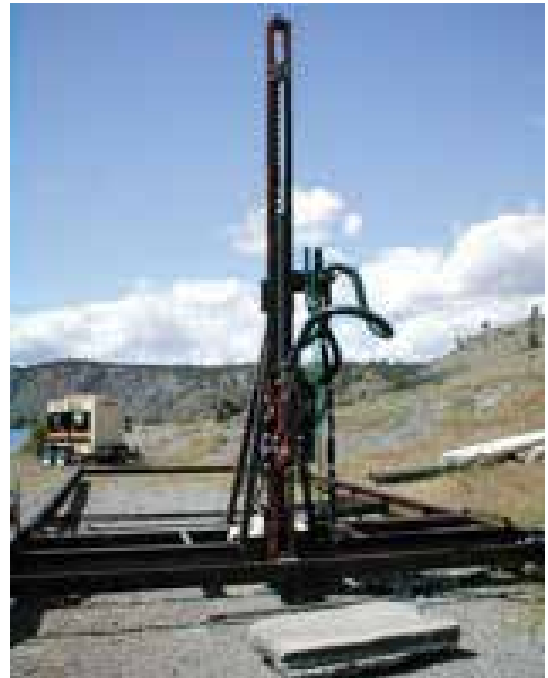
Fig. 12: Custom 2-1/2 in x 37 in (64 mm x 940 mm) deep hydraulic percussion drill for rock anchors

Other critical design features of this project included the requirement to maintain the existing construction joints in the original stilling basin floor and tying the new concrete slab to the existing floor using rock anchors. Over three hundred (300) 2-½ in (64 mm) diameter by 37 in (940 mm) deep holes were drilled into the floor using a hydraulic percussion drill mounted to a custom-designed frame (Fig. 12). In order to maintain specified concrete coverage over the rebar, it was necessary to counter bore these holes to allow for coupling rebar to the bolts. A No. 8 (1/2 in [13 mm] diameter) rebar mat was affixed to the anchors, mechanically bonding the two slabs together. In addition, the rebar mat was also tied to the existing training wall located in the center of the stilling basin using anchor bolts. Over one hundred sixty (160) 2-½ in by 20 in (64 mm by 508 mm) deep holes were core drilled horizontally into the base of the intermediate training wall using a hydraulic core drill for anchor installation.
