# 2024 SPRING CONVENTION

# Restoration of 12 Utility Tunnels at Northwestern University

Predrag Popovic, Dunja Vla and Tracy Naso

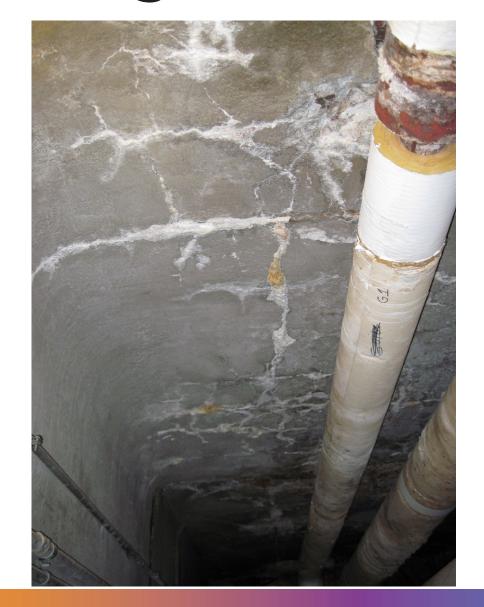
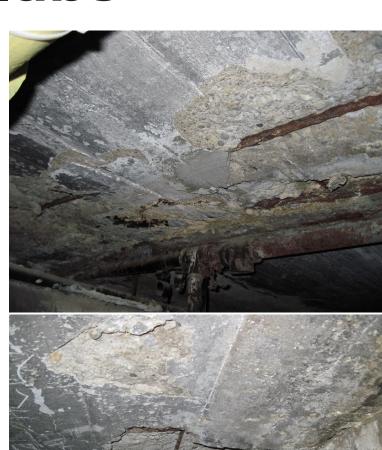
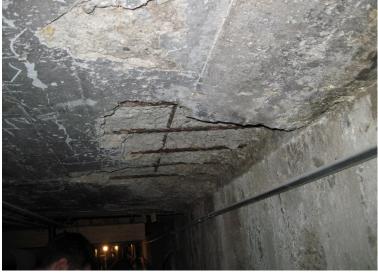
# Damage at Roof Slabs

- Extensive corrosion of reinforcing steel was present at walls and roof slabs, resulting in delaminations and spalling.
- Depth of spalls in some areas reduced the load-carrying capacity of the tunnel, including some under roadways.
- The challenge of the restoration project was that utility tunnels has to remain operable with all piping systems in place. The work had to be coordinated in one of the tunnels with a separate project for replacement of steam and fire protection pipes.
- Repair of tunnels was phased over several years, starting in 2012.

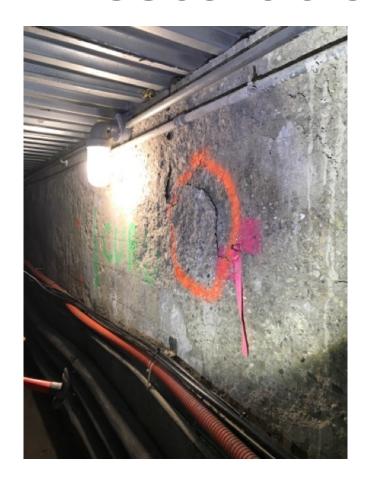
New spalls observed at small number of locations

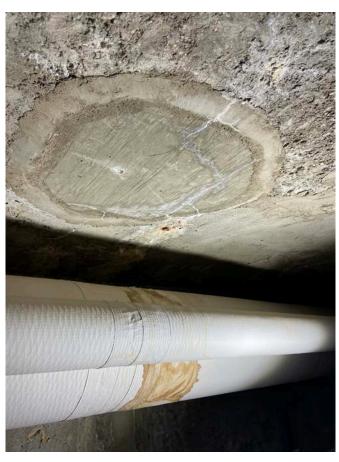
Small overhead repaired areas with leaking cracks but sound

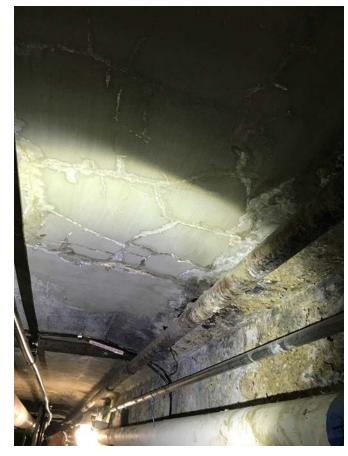
Larger overhead repaired areas with leaking cracks but sound

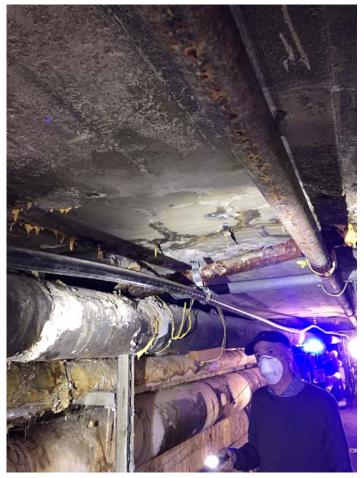
Injected cracks in good condition, new ones have formed

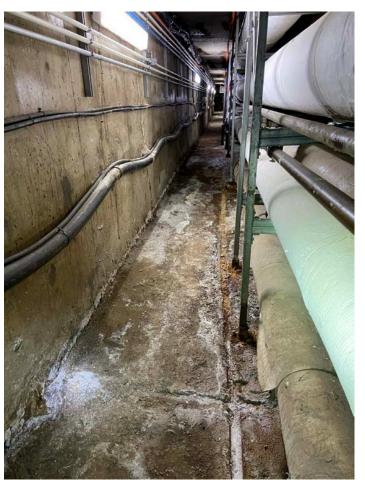
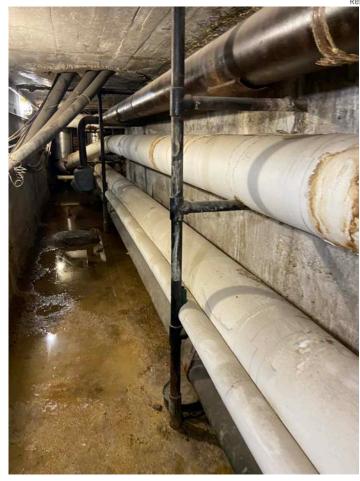
Created trenches created in a floor Water is infiltrating select tunnels' help with infiltrating water, but lack sections maintenance

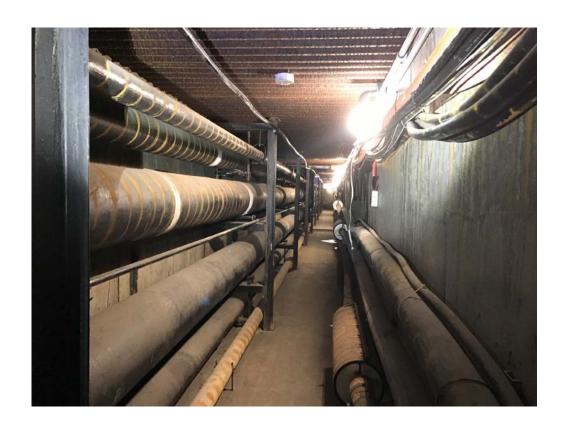
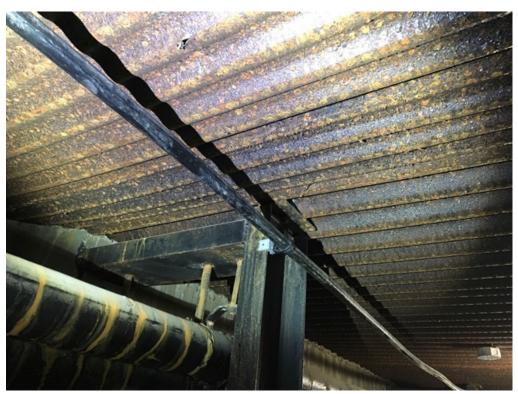
No change in the level of corrosion was observed at corrugated metal ceilings
