# 2024 SPRING CONVENTION

# CHICAGO RIVER WALL CAP REPAIRS

DUNJA VLA

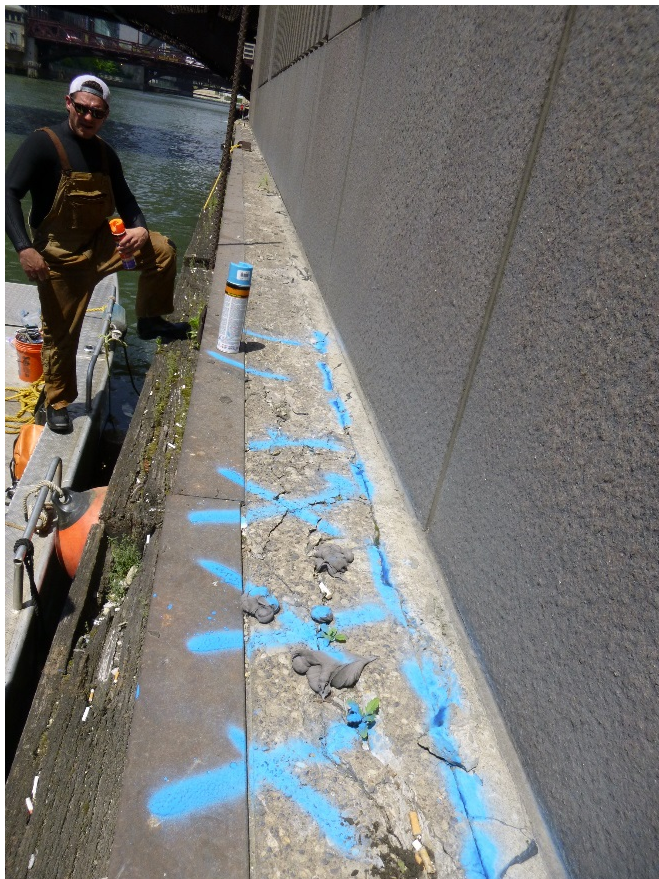
Concrete distress across the full width of the top surface of the cap

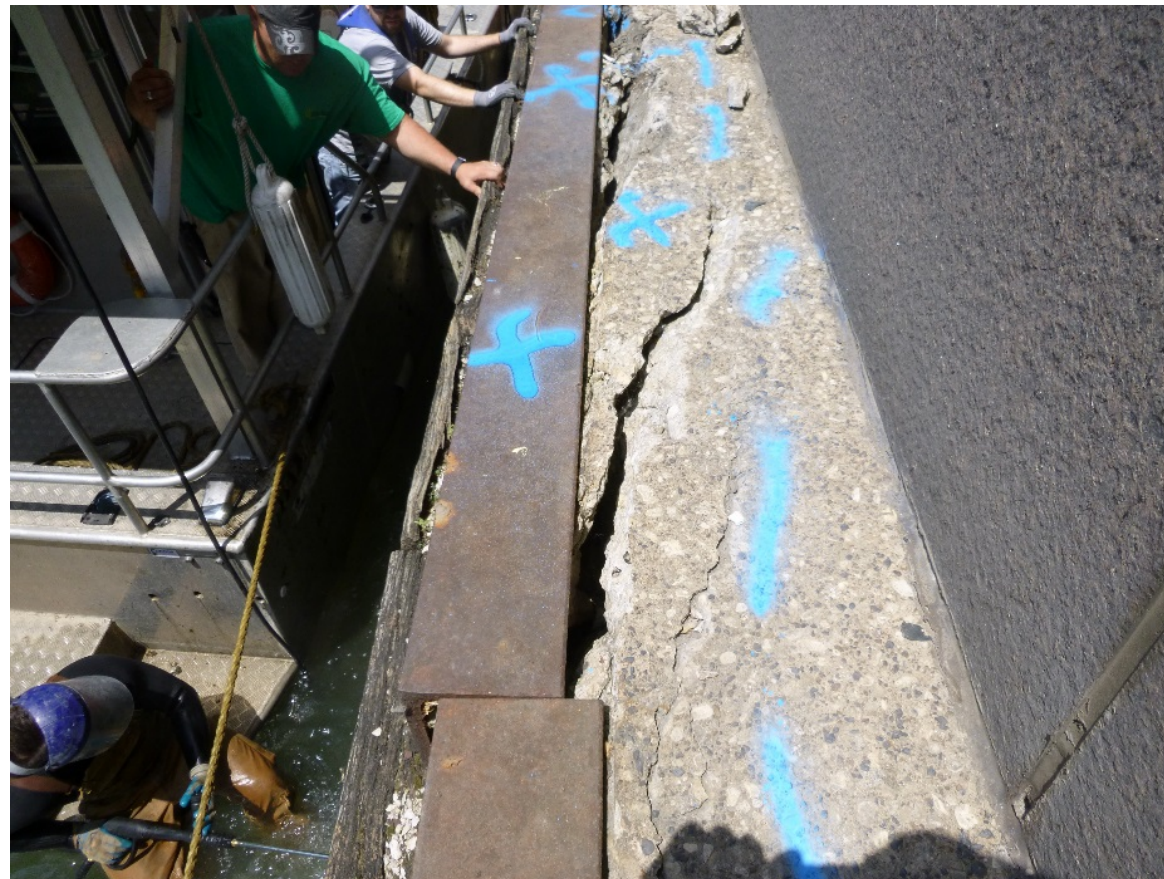
Spall behind angle at Station 2+30

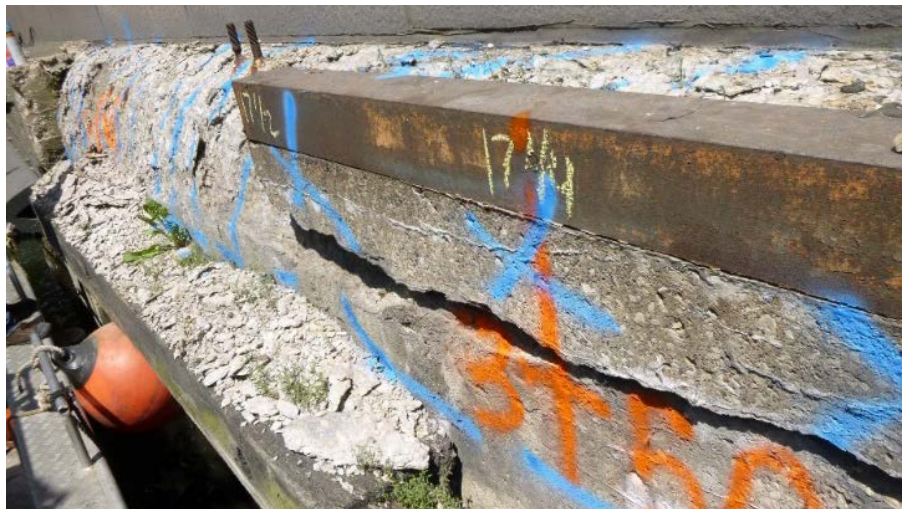
Concrete spall between  
Station 3+50 and  
Station 3+60

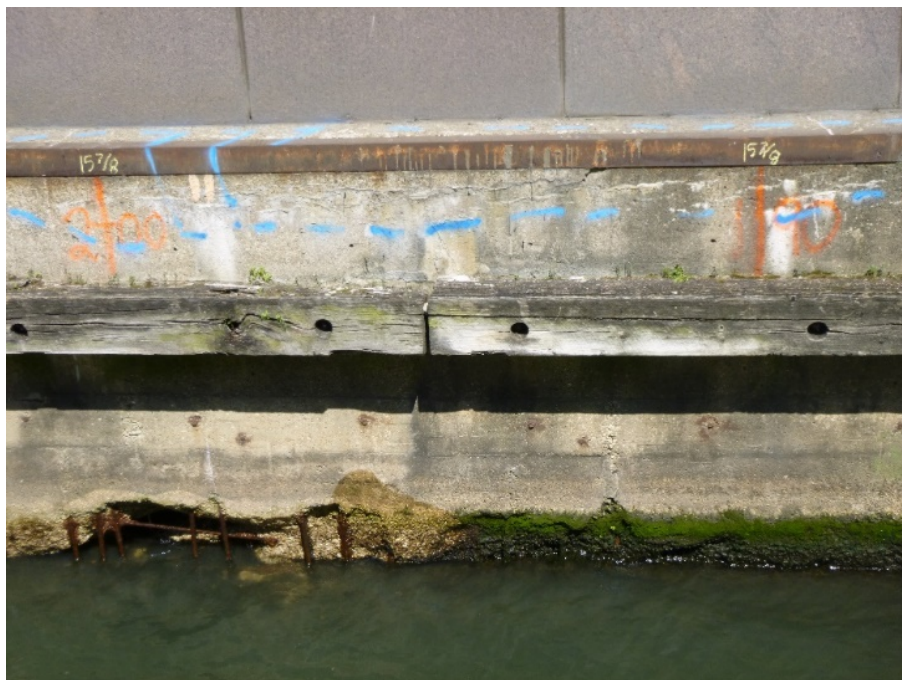
Typical concrete distress (outlined in blue paint)  
at top of concrete cap

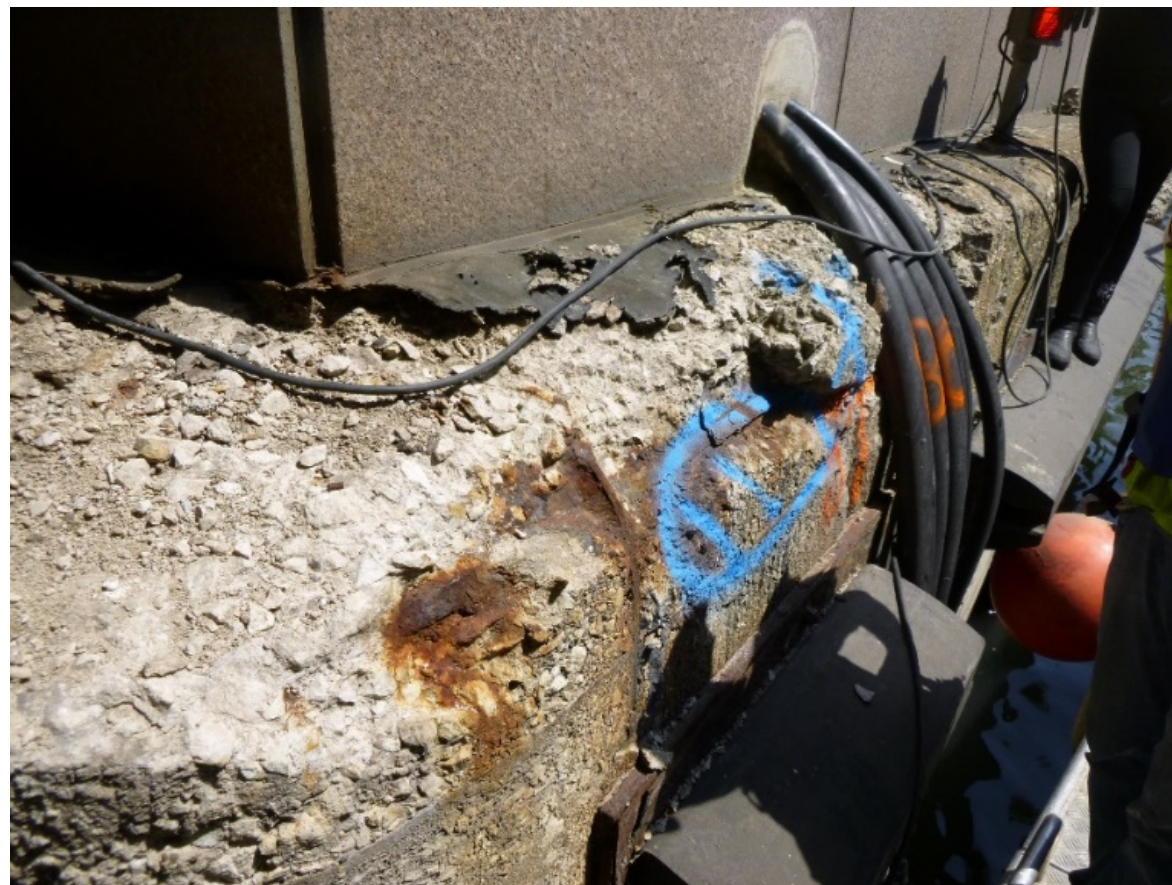
Spalling on top of timber pile river wall  
(City's property)

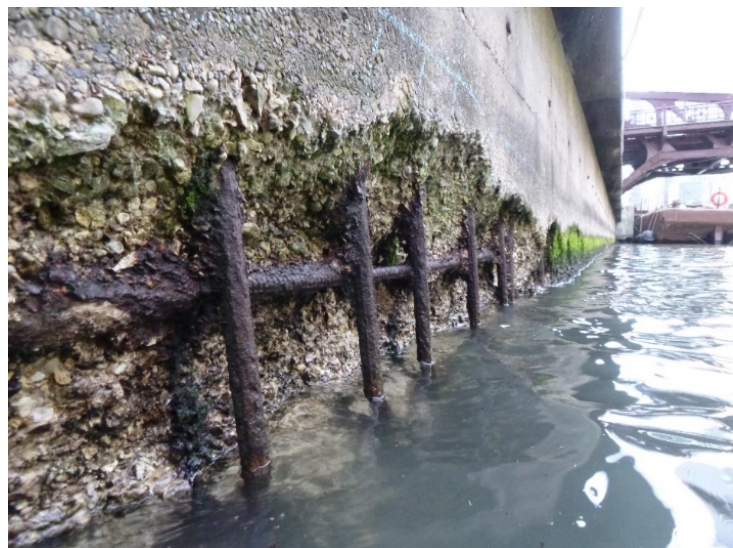
Severely eroded concrete at waterline

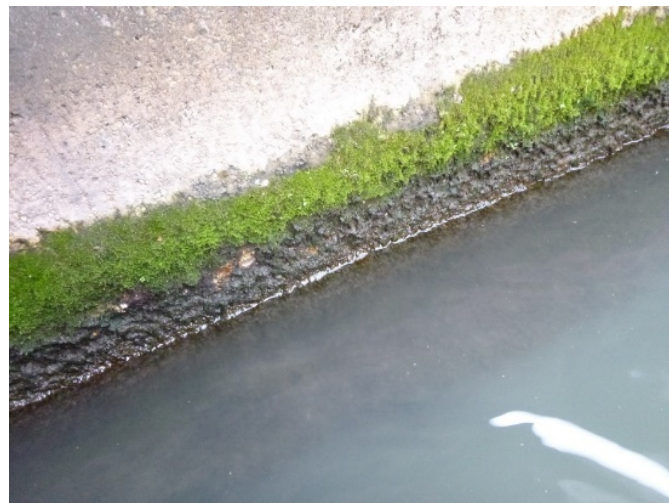
Surface erosion and marine growth at bottom of concrete cap

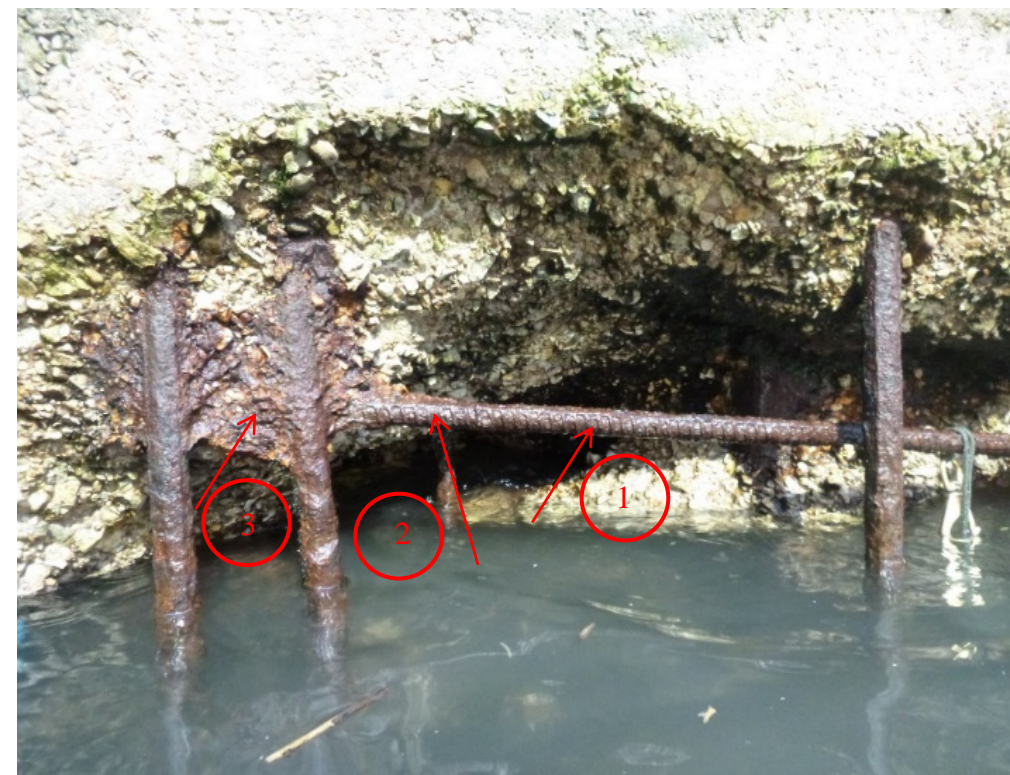
Spall at waterline exposing inside face of sheet piling

(1) Condition of rebar exposed at water line

(2) Minor corrosion

(3) Advanced corrosion

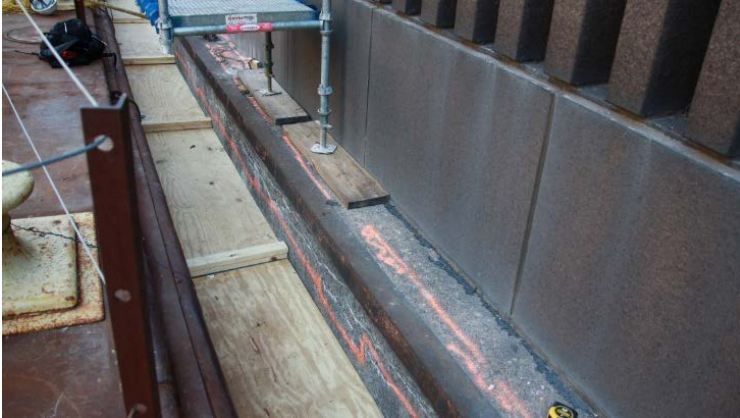
Overall and close-up views of delaminated concrete at the river wall concrete cap marked for removal

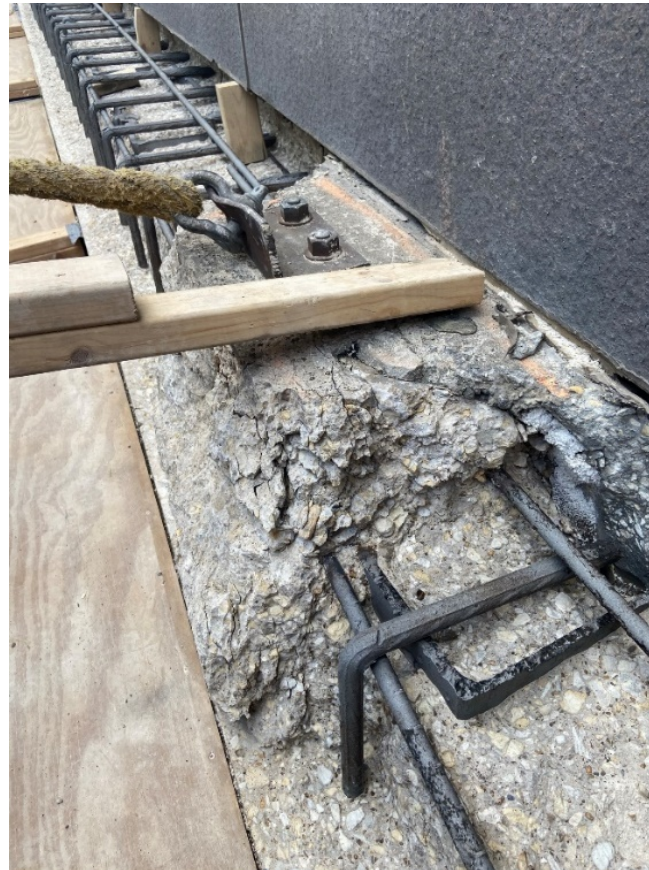
Section of delaminated concrete at the wall cap where boat tie-off is used for the barge

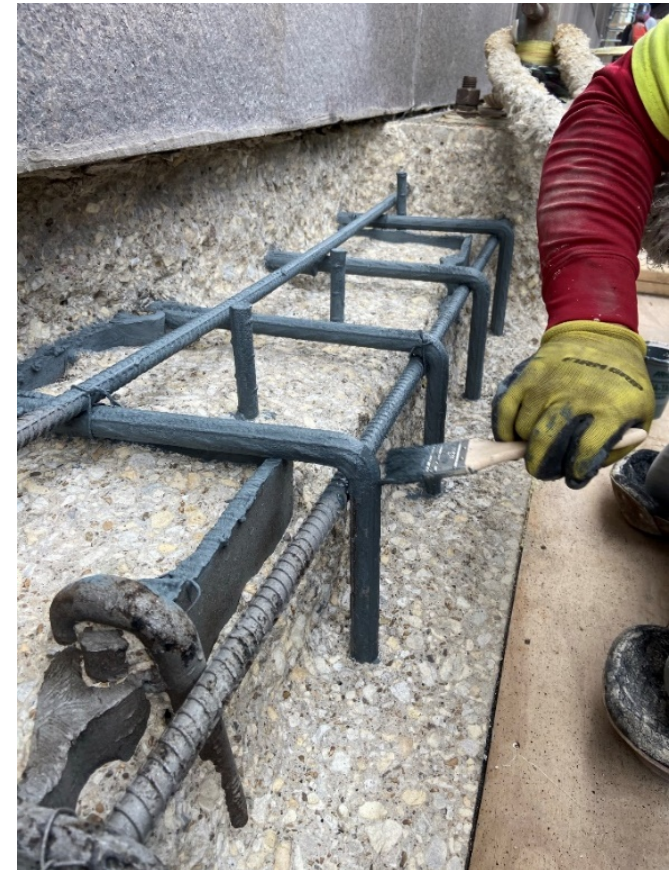
Painting of reinforcing bars with corrosion inhibiting paint

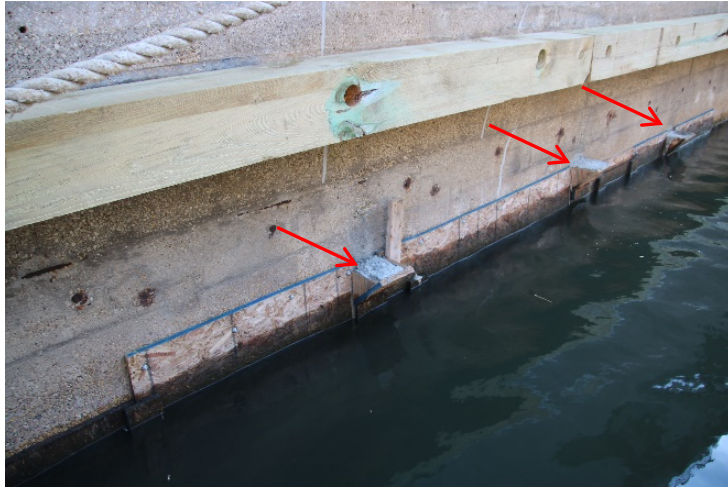
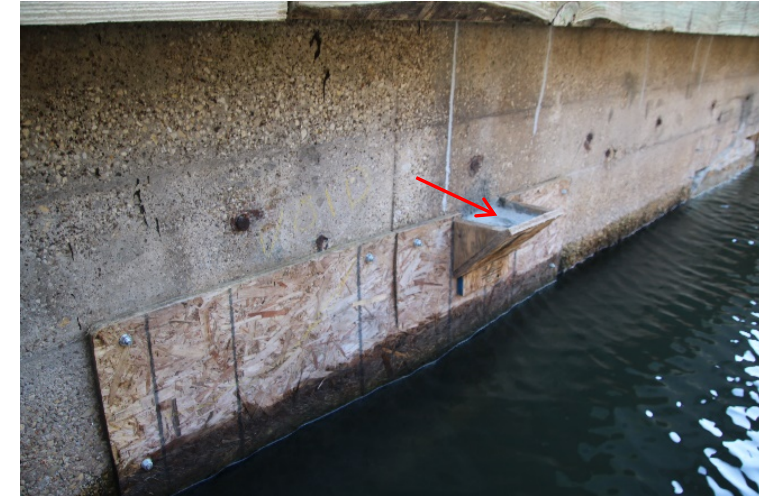
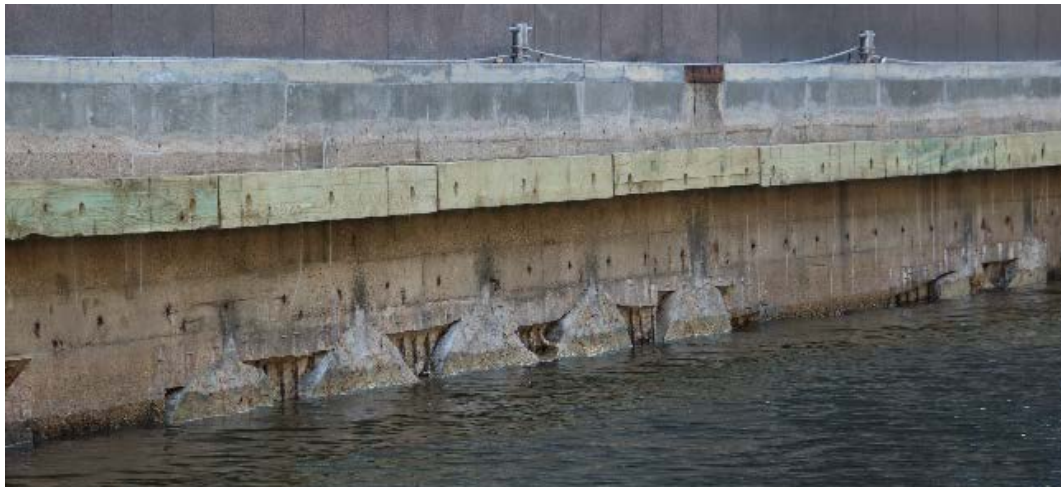
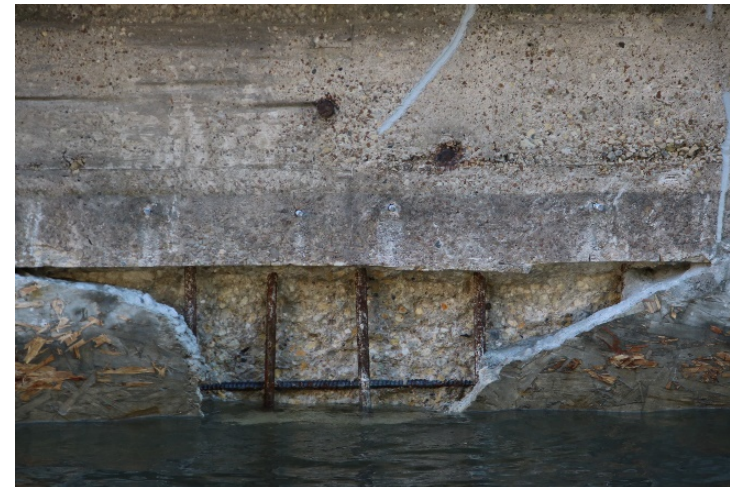
Birds mouth were spaced too far apart

Concrete placement created voids in shape of cones. The sections with voids needed to be reformed and repoured

Allied had to learn the nuances of placing underwater concrete. There ended up being voids which we had to later return to fill

- Obtaining a permit for this type of projects can take over a year. Reflect that in your bid price.
- Develop a logistics plan to the smallest detail when access to area of work is challenging.
- Space concrete pour pockets “bird mouths” at no more than 24 inches apart.
- Have different expectations for “cleaned” bars at the water level than above it.
- Sounding and inspecting repair openings at the water level from the boat platform is challenging and time consuming.
- Number of divers that do concrete repairs is very limited.
